Accident  
Investigation Board  
Norway

# REPORT

SL 2012/04

REPORT ON AIRCRAFT ACCIDENT ON  
10 OCTOBER 2006 AT STORD AIRPORT,  
SØRSTOKKEN (ENSO) NORWAY INVOLVING A  
BAE 146-200, OY-CRG, OPERATED BY ATLANTIC  
AIRWAYS

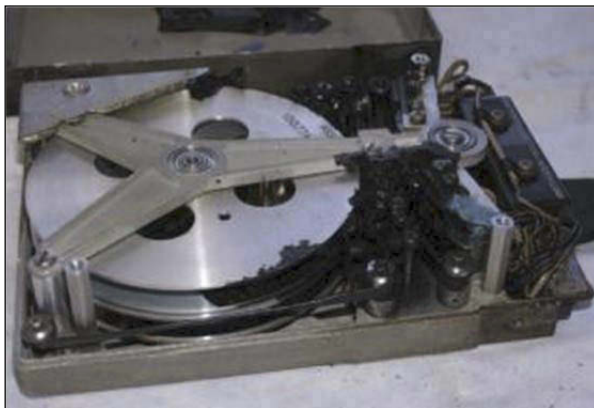
Figure 16: Heat-damaged storage unit in FDR.

- 1.11.2.3 The AIBN therefore brought the storage unit on to the manufacturer L3 Communications in Sarasota, Florida, USA, where they were able to repair the circuit board and recover the data stored on it.
- 1.11.2.4 The quality of the CVR recording was good. The recording was of the pilots' communication amongst themselves, their two-way communication with the various Air Traffic Control units and cockpit sounds. The recording was of 30 minutes duration as expected, and covered everything from starting the plane at Sola until the power supply failed as a result of the accident.

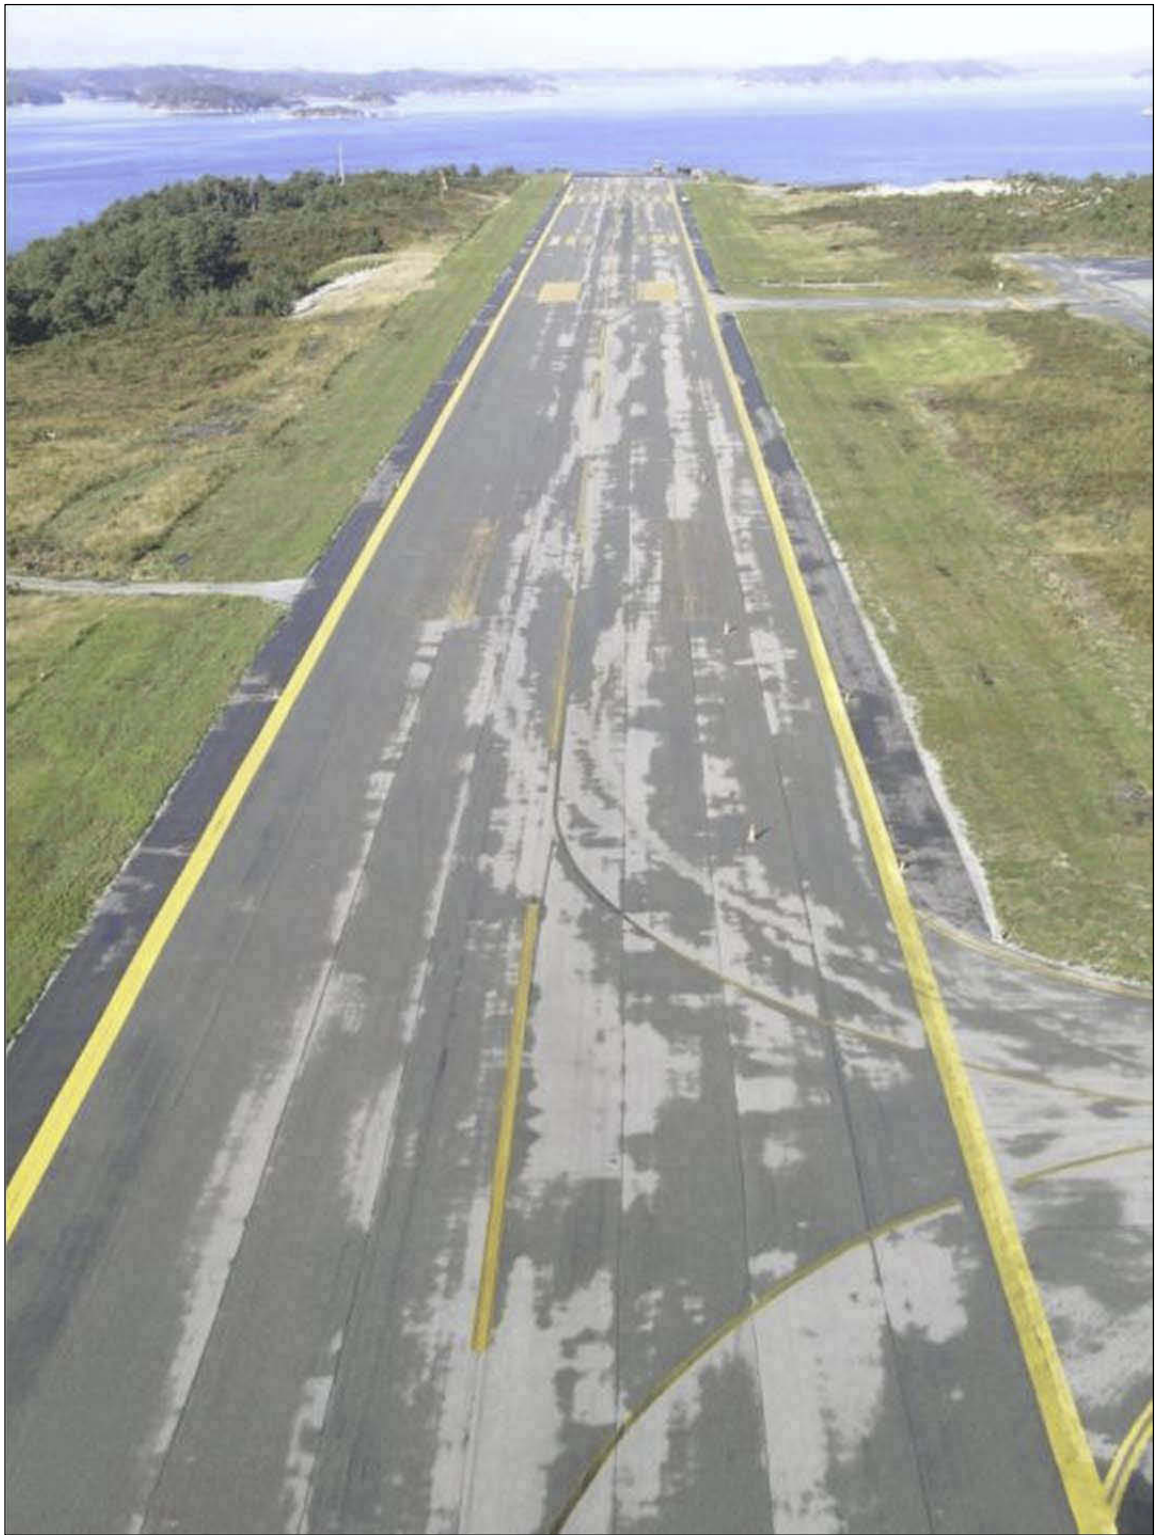
When the AIBN arrived at Stord airport by helicopter at 1308 hours, the runway still had dark patches of dampness (see Figure 19). From the air, it was also possible to glimpse the skid marks left behind by the aircraft. These skid marks were initially difficult to spot from the ground, but they became clearer as the runway dried out.

*Figure 19: The runway photographed from the helicopter at 1308 hours.*

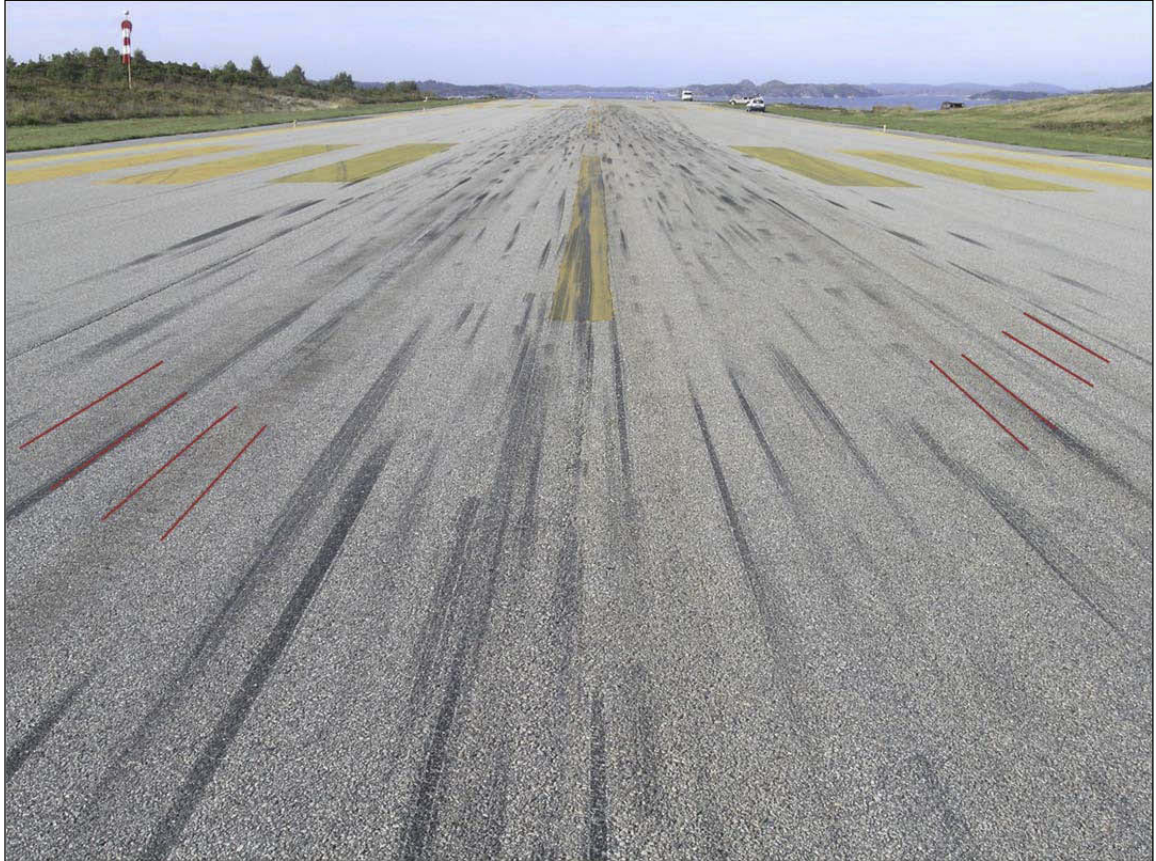
The skid marks left by OY-CRG were different from other skid marks left on the runway. There were no rubber deposits in the microstructure on the runway surface, which was typical of the black brake skid marks left by other aircraft (see Figure 20). The skid marks left by OY-CRG were lightly defined and partially unclear skid marks of a light brown colour. Many small bits of rubber were left outside the skid marks, most of them between one and eight millimetres wide (see Figure 22). Some bits of rubber were found several metres from the skid marks.

*Figure 20: The skid marks left by OY-CRG on the runway. The red guiding lines show what route the main wheels took.*

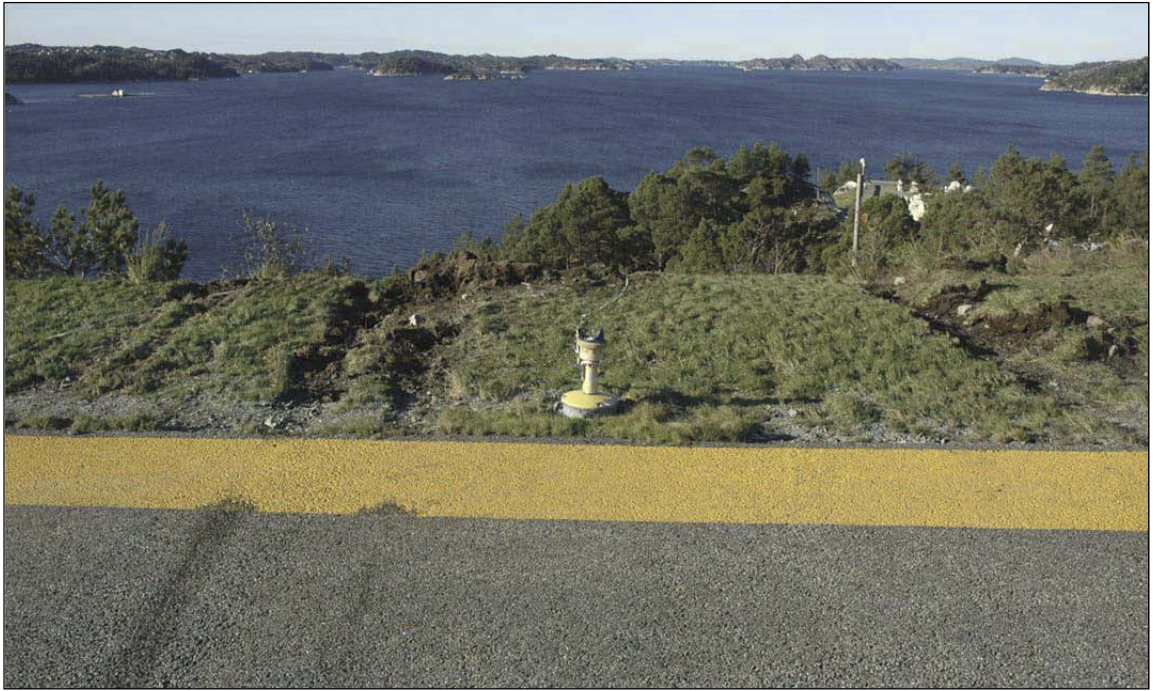
*Figure 21: The end of the runway with skid marks left by the tyres. The nose landing gear on the left, followed by the left main landing gear, which left black stripes on the paved surface, and, to the far right at the edge of the photo, the skid mark left by the right main landing gear.*

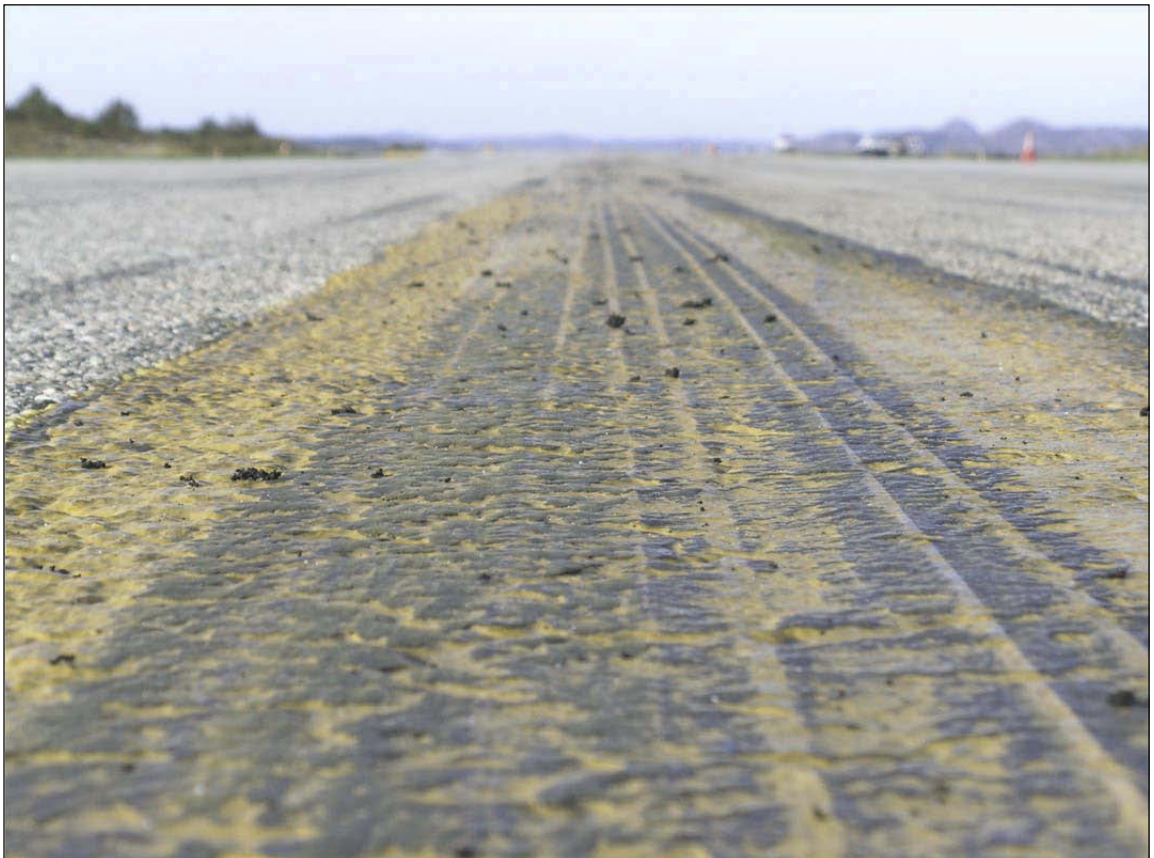
*Figure 22: Close-up of small bits of rubber that were spread across the runway on both sides of the skid marks left by OY-CRG. (The black skid marks on the yellow runway markings are not from the aircraft involved in the accident).*

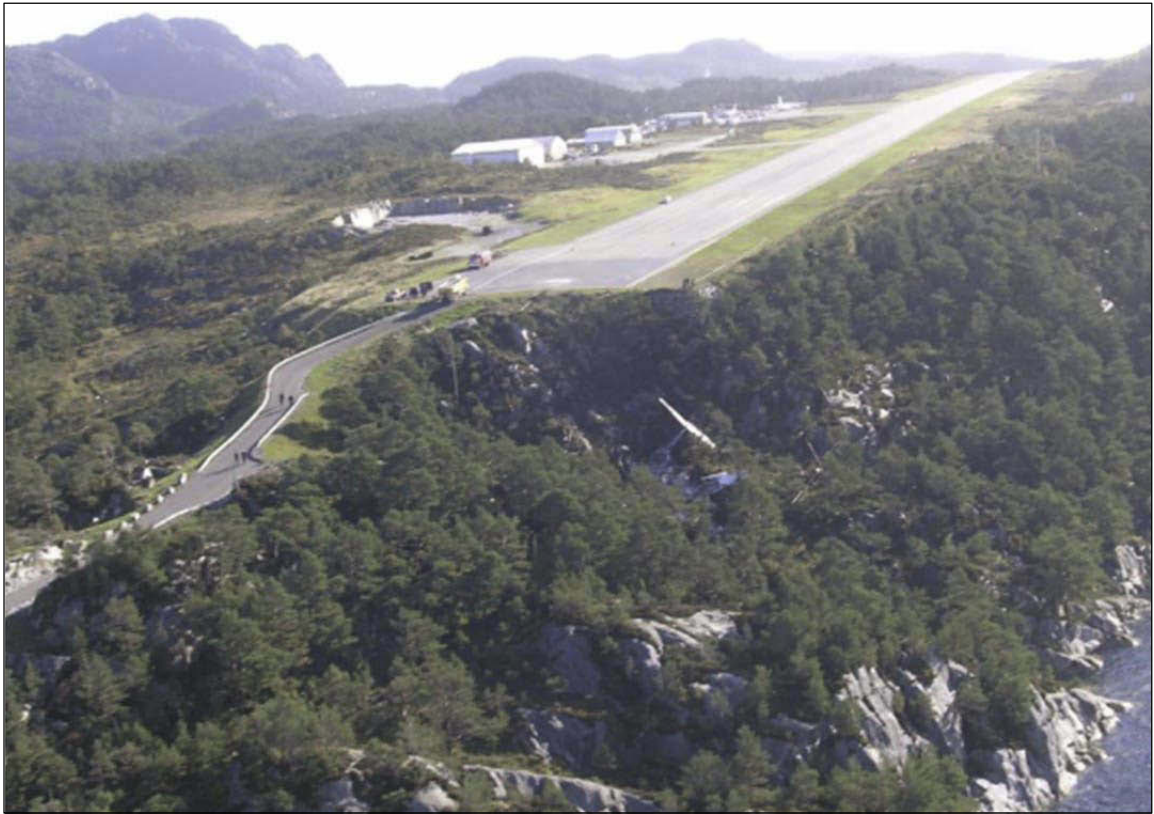
*Figure 23: The airport viewed towards the south-east with the aircraft wreckage, the slope and the northern end of the runway closest to the camera.*

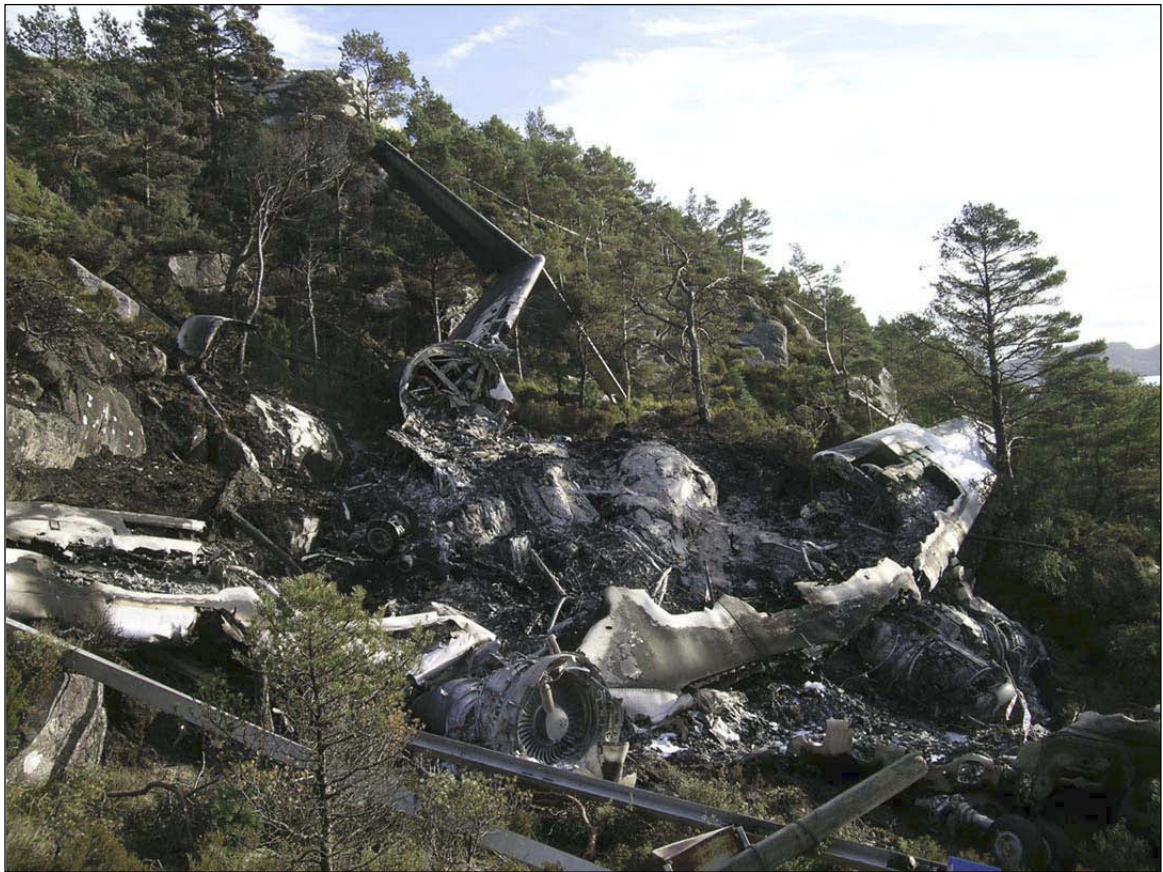
Virtually all the wreckage came to rest in one place 46 m from the end of the runway and approximately 55 m from the sea. The aircraft came to rest with its nose pointing down and banking a few degrees left. Of the major objects found between the runway and the wreckage, were both main landing gear doors, one engine cowling detached from the outer right engine (engine no 4) and engine no 4. The engine cowling lay approximately half-way between the end of the runway and the aircraft wreck. The engine was found 4.3 metres from the right wing tip. It had not been damaged by exposure to heat. The aircraft wreckage generally showed clear signs of exposure to fire and high temperatures. Large parts of the fuselage and wings had burnt up completely or melted.

Figure 24: The aircraft wreckage with parts of the approach lighting system in the foreground.

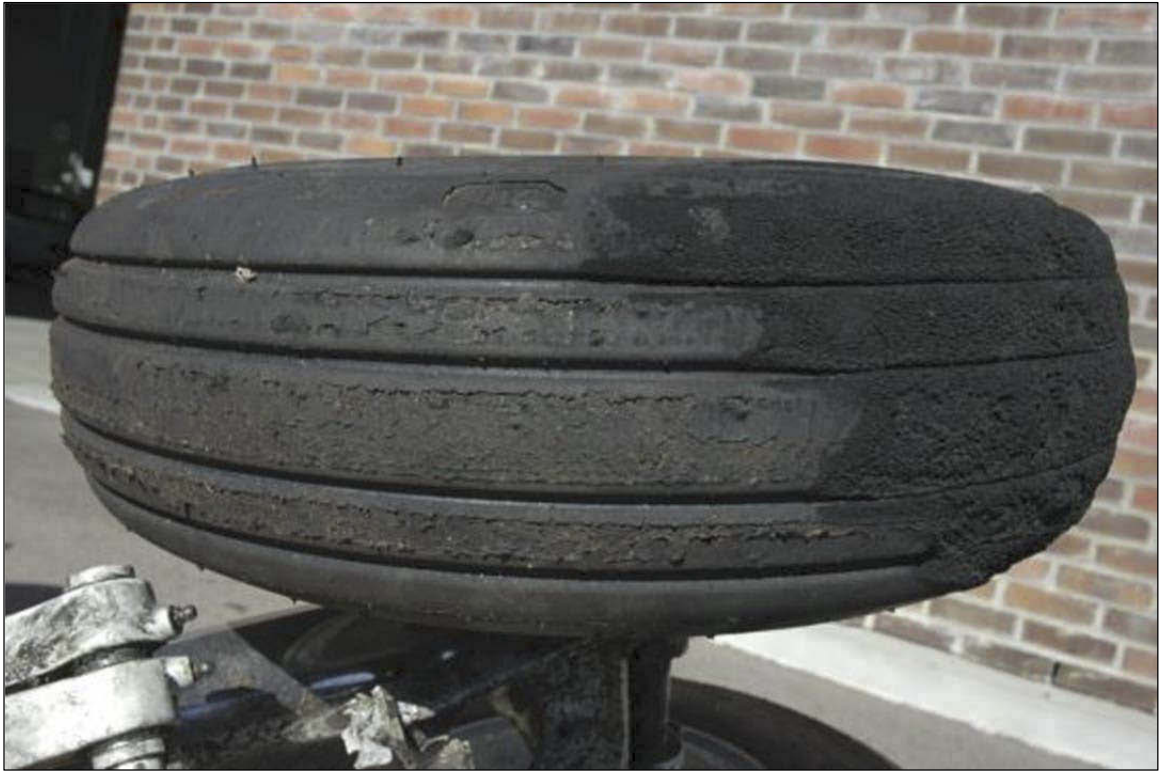
The whole nose landing gear had been ripped off and was lying to the right of the cockpit. Wear marks were clearly evident on the right nose wheel (see Figure 25). Similar wear marks were found to a lesser degree on the left nose wheel. Both wheels had sustained heat damage, but were otherwise intact.

*Figure 25: Right nose wheel. Clear wear marks on the left and heat damage on the right.*

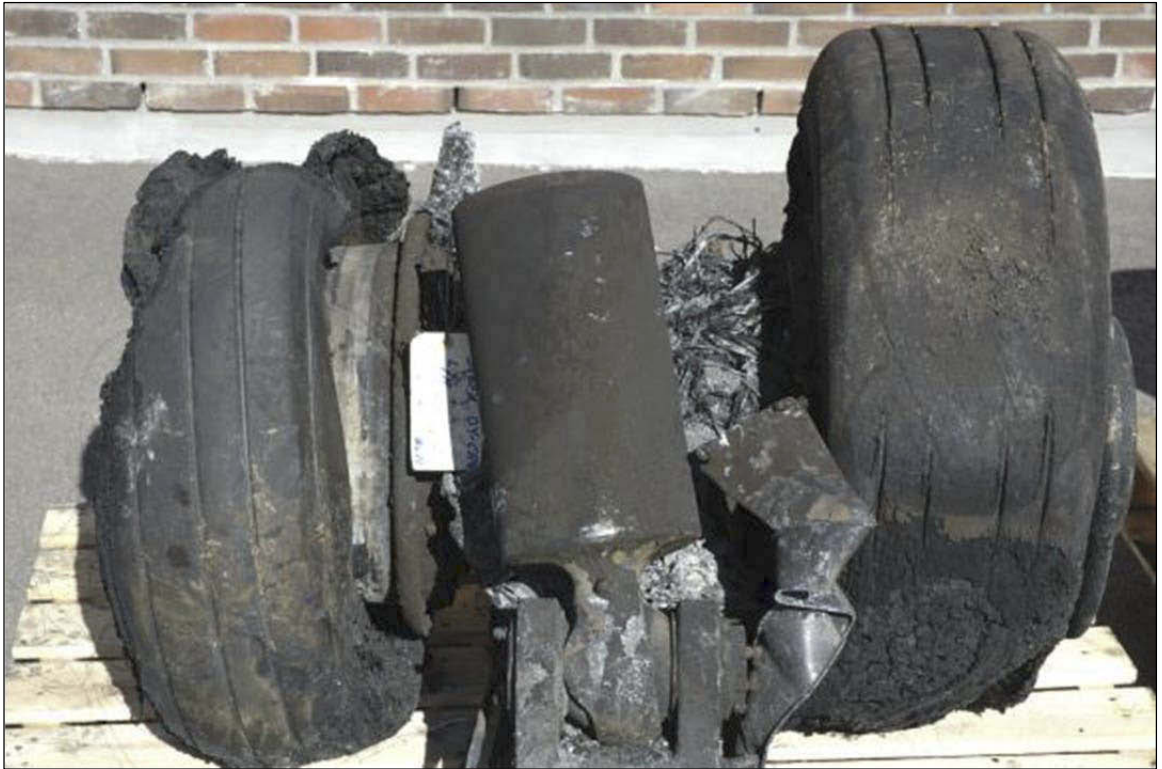
The left main landing gear was found to be partially submerged in a small bog, and this had protected some parts of the tyres (see the photo in Figure 26). That part of the left tyre which had skidded along the runway was completely undamaged by fire (see Figure 27). Corresponding wear marks were not found on the right tyre, but more than half the surface of that tyre had been burnt up.

*Figure 26: The wheels on the left main landing gear. The left wheel is on the right in the photo.*

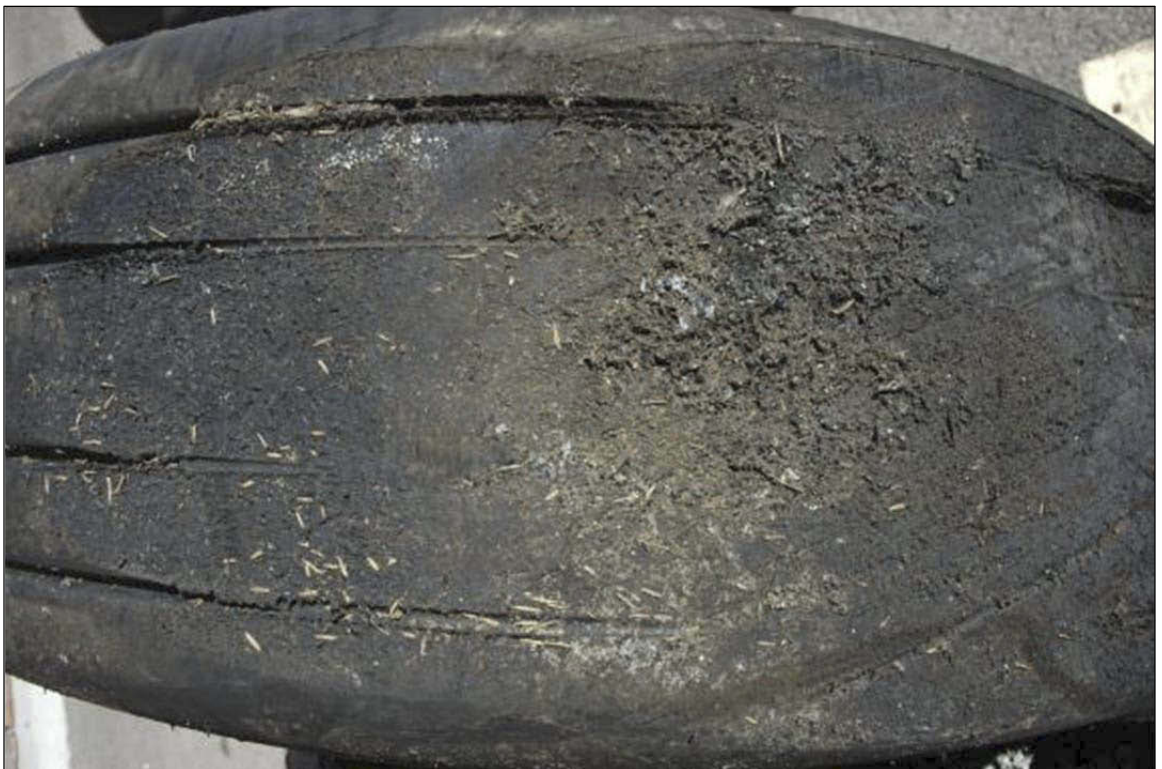
*Figure 27: Wear marks on the left tyre of the left main landing gear. The tyre had moved from left to right at an angle of 27° in relation to the asphalt, for an unspecified period. Clumps of decomposed rubber on the right in the photo.*

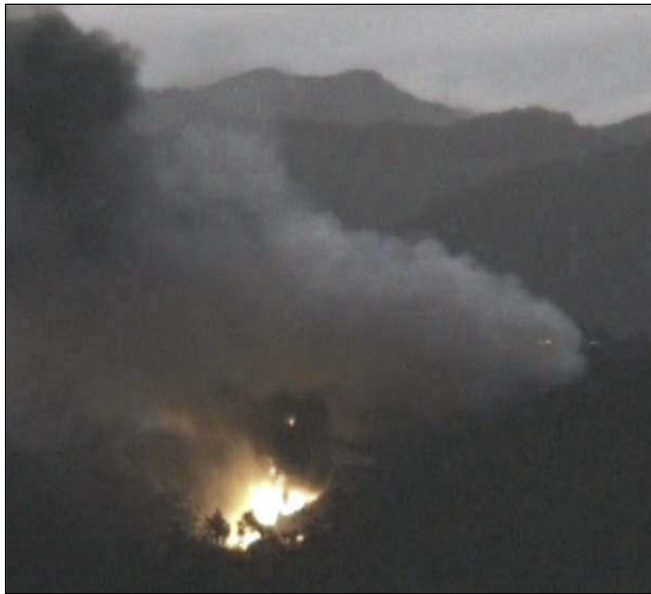
*Figure 30: Fire development 1 minute and 45 seconds after the aircraft left the runway and when the fire crew had been trying to extinguish the fire for 1 minute.*

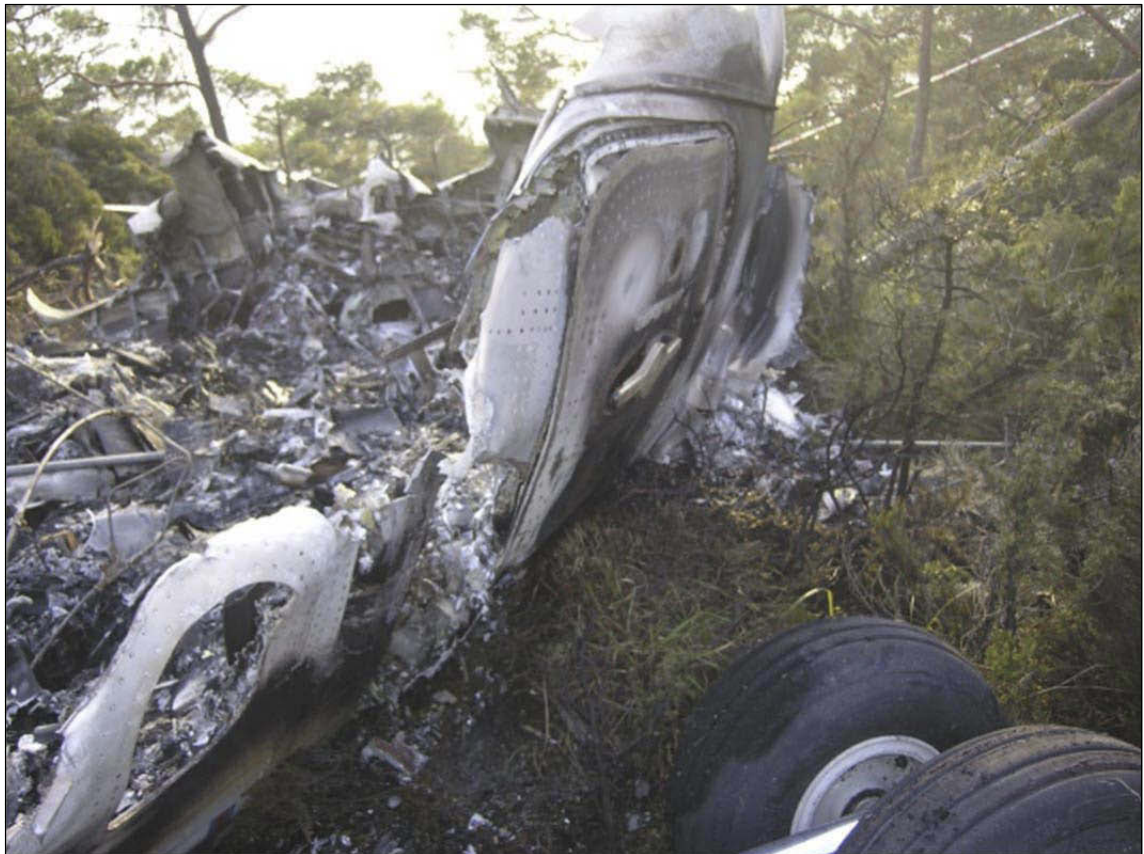
*Figure 33: The cockpit and the blocked front right emergency exit. The door handle has been pushed out (partially opened). The nose wheels can be seen in the foreground on the right.*

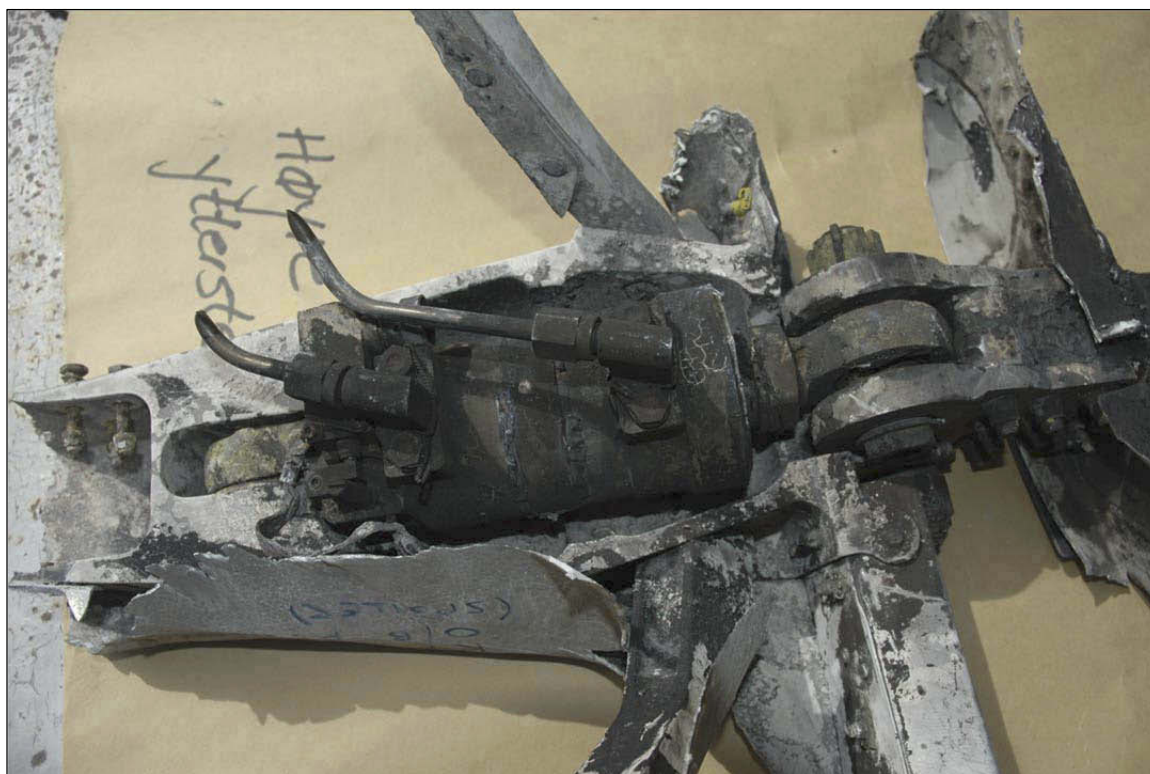
All lift spoiler actuators were found in a much burnt condition inside the aircraft wreck. They were sent to the Royal Norwegian Air Force's main maintenance depot at Kjeller (LHK) for radiographic examination. The radiographic images showed that all six actuators were in the closed and locked position. This was subsequently verified by the AIBN at the manufacturer Smiths Aerospace's facilities in Wolverhampton in the UK.

Figure 34: One of the six lift spoiler actuators.
