# Report

Serious incident on **22 July 2011**  
**in cruise at FL350, north Atlantic Ocean**  
to the **Airbus A340-313**  
registered **F-GLZU**  
operated by **Air France**

**BEA**

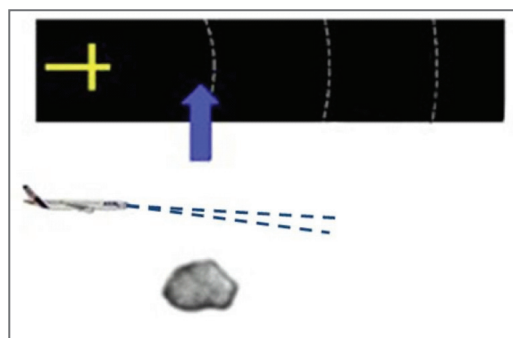
Figure 3 - Example of radar image

The tilt adjustment determines the zone scanned by the radar beam and consequently the echoes that are detected and displayed on the ND. Adjustment of the gain then enables the reflectivity of the precipitation encountered to be adapted. It should be noted that clouds situated in front of the aeroplane but not swept by the beam are not visible on the radar:

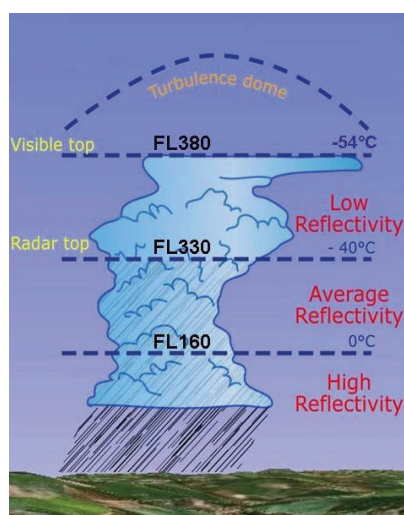
Figure 4 - Cumulonimbus radar reflectivity

The most reflective zones (liquid precipitation) are located under ISO 0°C. The reflectivity is higher there.

Between ISO 0° and ISO -40°C (called "radar top"), reflectivity is average, and depends on the liquid water/ice crystals ratio.

When the temperature is below -40°C, the reflectivity is very low (ice crystals).

On the day of the event, the Météo France data indicated that the visible top of the clouds corresponded to FL380, ISO -40°C at FL 330 and ISO 0°C at FL160.

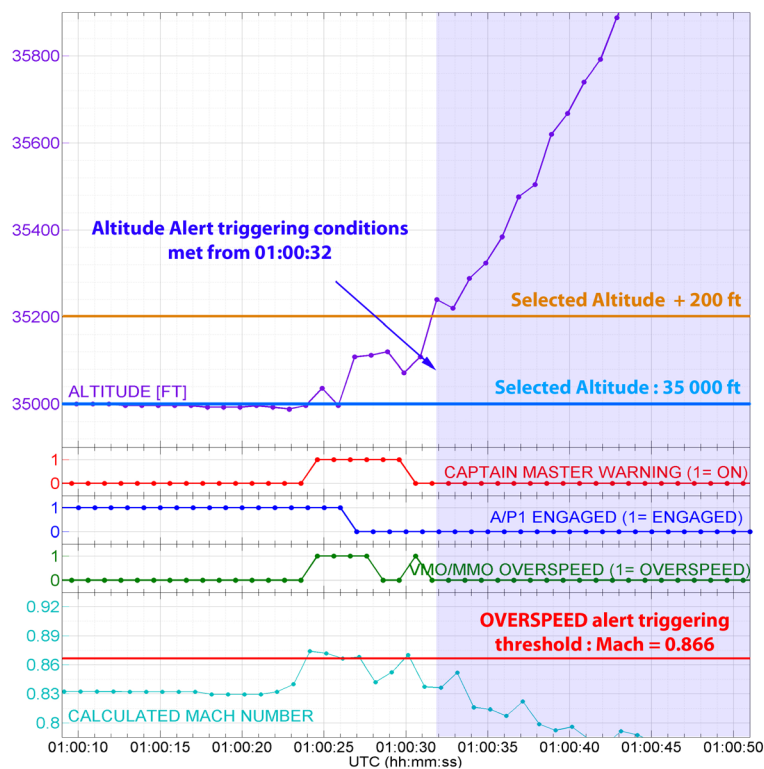
Figure 5 - Warnings recorded

The recorded data showed that there was initially an OVERSPEED warning, which generated a CRC aural warning. This warning was active as long as the Mach was greater than 0.866.

Three seconds later, the AP was disengaged, but as the CRC was still active, the “Cavalry Charge” aural warning was not generated, as it was masked by the CRC. While it was not generated, it could not be cancelled by a possible 2nd press on the sidestick takeover pushbutton.

The moment the 1st OVERSPEED stopped corresponded to the end of the 1.5 second maximum sounding of the “Cavalry Charge”, which was therefore not activated. The “Master Warning” continued to be active between the 1st and the 2nd OVERSPEED as the disengagement of the AP generates a “Master Warning” of 3 seconds if it is not cut off.

The moment of theoretical triggering of the “C-chord” warning, at 35,200 ft, was one second after the end of the 2nd OVERSPEED. Pressing the “Master Warning” warning light, at 36,900 ft, the PNF cancelled the “Altitude alert” about 20 seconds after it appeared. In the absence of a CVR recording, it was not possible to confirm what the real duration of the “C-chord” warning was.

- **EASA evaluate the possibility of requiring that the autopilot disengagement aural warning for all aeroplanes of a maximum mass on take-off of more than 5.7 t be triggered in compliance with paragraphs AMC 25.1322 and AMC 25.1329(j) of the CS-25. [Recommendation FRAN-2012-022]**
