SERIOUS INCIDENT

Aircraft Type and Registration:	DHC-8-402 Dash 8, G-JECF	
No & Type of Engines:	2 Pratt & Whitney Canada PW150A turboprop engines	
Year of Manufacture:	2004	
Date & Time (UTC):	11 September 2010 at 1845 hrs	
Location:	On approach to Exeter Airport, Devon	
Type of Flight:	Commercial Air Transport (Passenger)	
Persons on Board:	Crew - 4	Passengers - 49
Injuries:	Crew - None	Passengers - None
Nature of Damage:	None	
Commander's Licence:	Airline Transport Pilot's Licence	
Commander's Age:	44 years	
Commander's Flying Experience:	3,050 hours (of which 1,560 were on type) Last 90 days - 77 hours Last 28 days - 20 hours	
Information Source:	AAIB Field Investigation

Synopsis

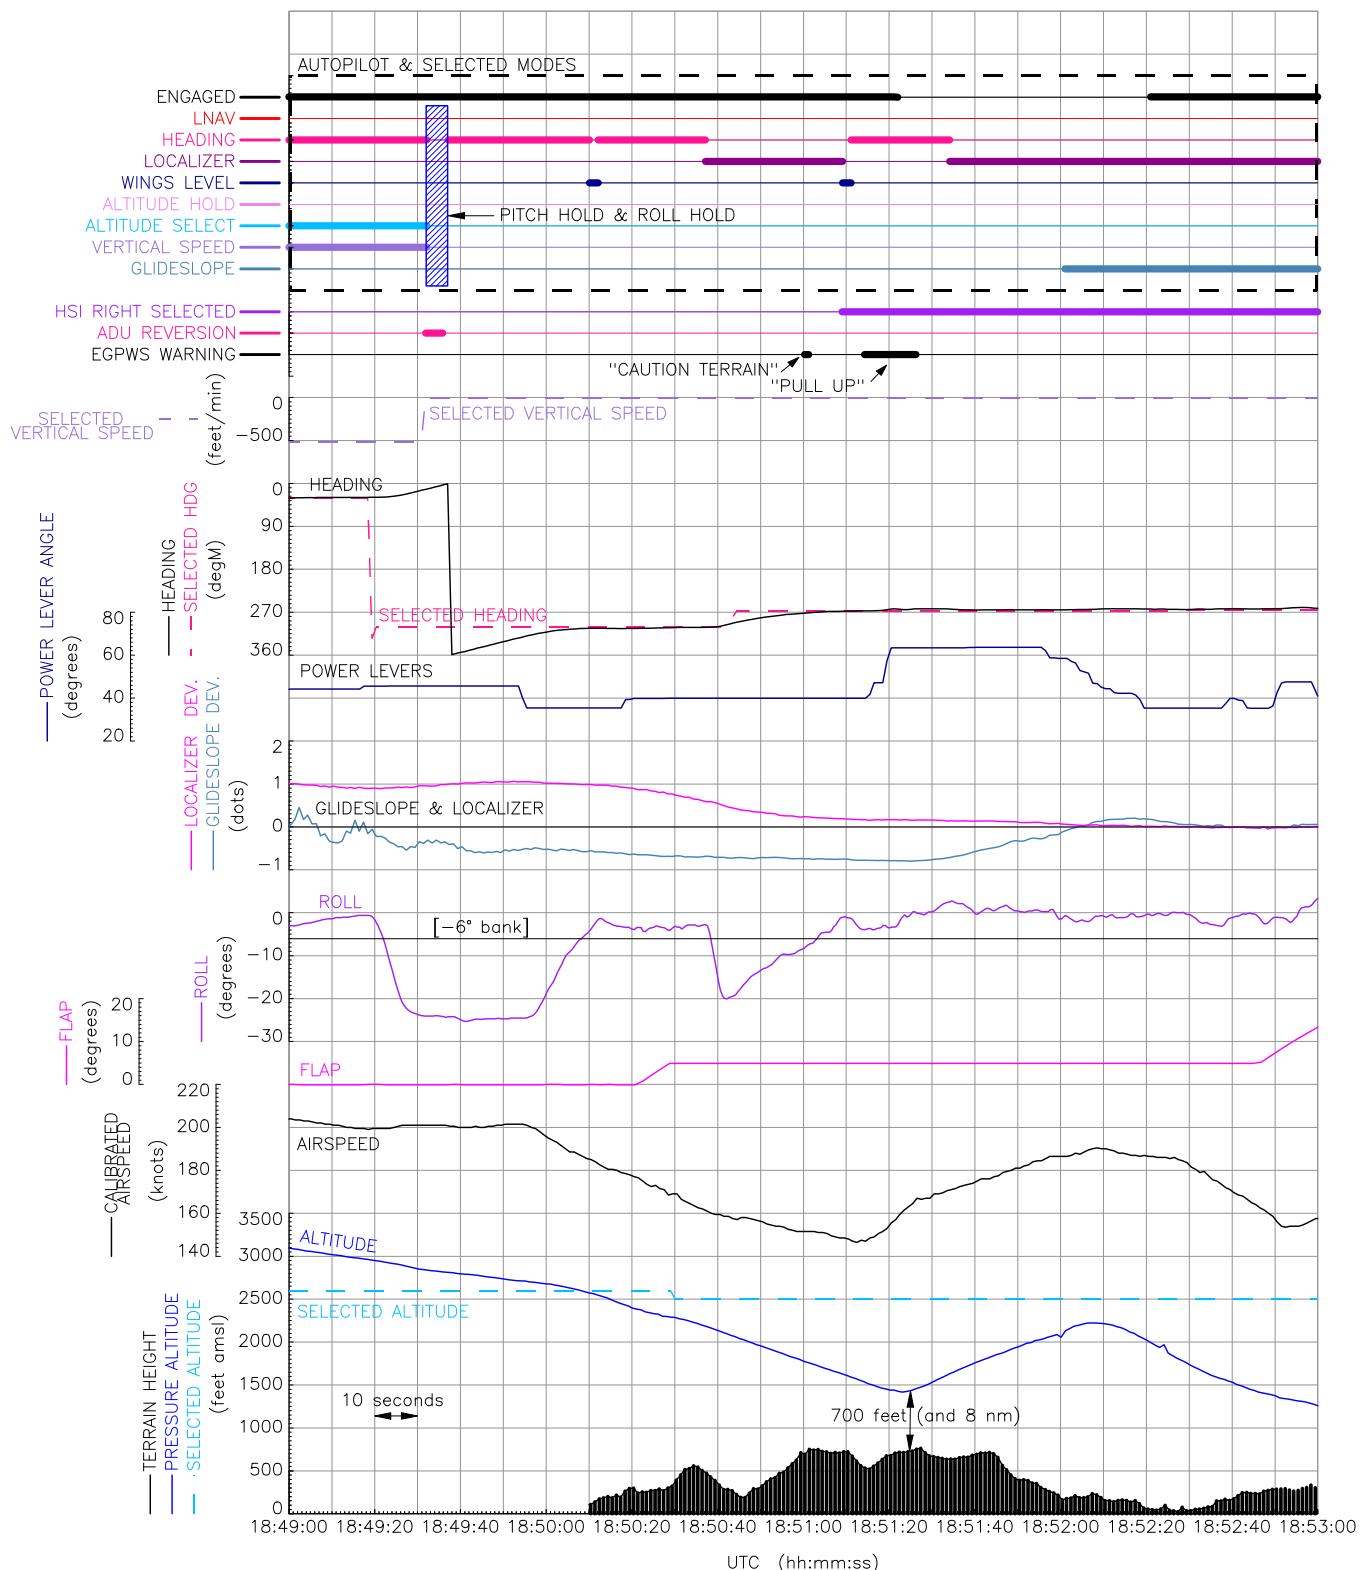
Figure 1
Salient FDR parameters

Figure 1 shows the salient parameters recorded on the FDR during the incident flight. The figure starts at 1849 hrs with the aircraft descending and the autopilot

engaged with HEADING, ALTITUDE SELECT and VERTICAL SPEED modes of the FD selected. The selected altitude was 2,600 ft and the selected vertical speed was -500 ft/min.

At 1849:31 hrs the FDR recorded an ADC reversion in which all the selected FD modes disengaged and the FD reverted to PITCH HOLD AND ROLL HOLD¹; the selected vertical speed also reset to zero. Five seconds later HEADING mode was reselected.

The aircraft was descending to a selected altitude of 2,600 ft at a selected vertical speed of -500 ft/min, with the APPROACH mode armed, when the IOP failure occurred. From the FDR data presented in Figure 1, the loss of the ALTITUDE SELECT armed, VERTICAL SPEED and HEADING SELECT modes are evident, coincident with the ADC reversion. While the commander was aware that the ADC reversion would cause the APPROACH mode to become disarmed, and duly reselected the latter, the effect, as per design, was the loss of *all* selected FD modes, which subsequently reverted to basic modes.
