Final report RL 2012: 07e

**Serious incident on 5 February 2011 with
the aircraft D-ABGQ at Arlanda airport,
Stockholm County.**

Case L-08/11
2012-03-05

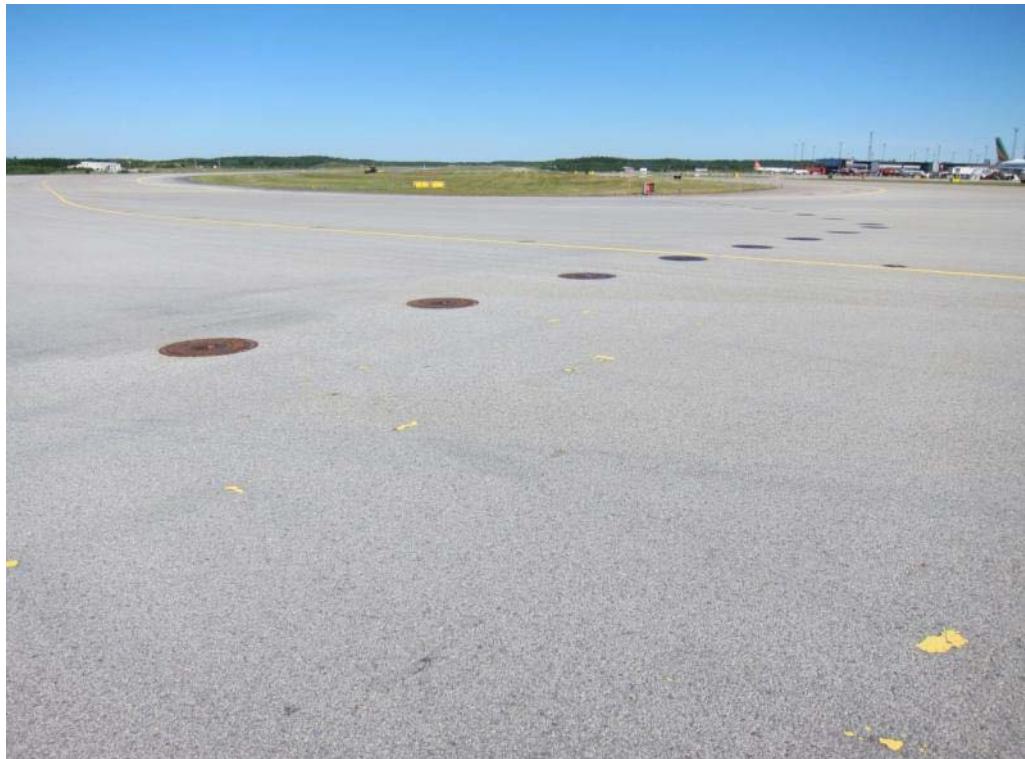
In this case there were no holding position markings at holding position Y3. Taxiway Y3 is an intersection to runway 01L/19R and is part of an area where five possible taxiways meet. In addition to Y3, pilots may also choose Y2 to enter runway 01L/19R from the same area. Taxiway Y goes north and south from the intersection and taxiway D connects from the manoeuvre area where the aircraft in question was parked.

Fig. 4 Remains of previous holding position markings at Y3, 29 June 2011

According to AIP Sweden, neither Y2 nor Y3 has holding position markings, see fig. 8. In this case, there has been holding position markings at Y3, but Swedavia, which is responsible for the operation of the airport, has stated that these were probably worn off by snow removal etc. when runways and taxiways were being brushed clear from precipitation, see fig. 4 and fig. 5. However, there was a marking at level with the RGL, approximately 80 metres further out on Y3, where the painted marks were clear, see fig. 6. This line has been repainted later than the normal holding position marking by Y3.

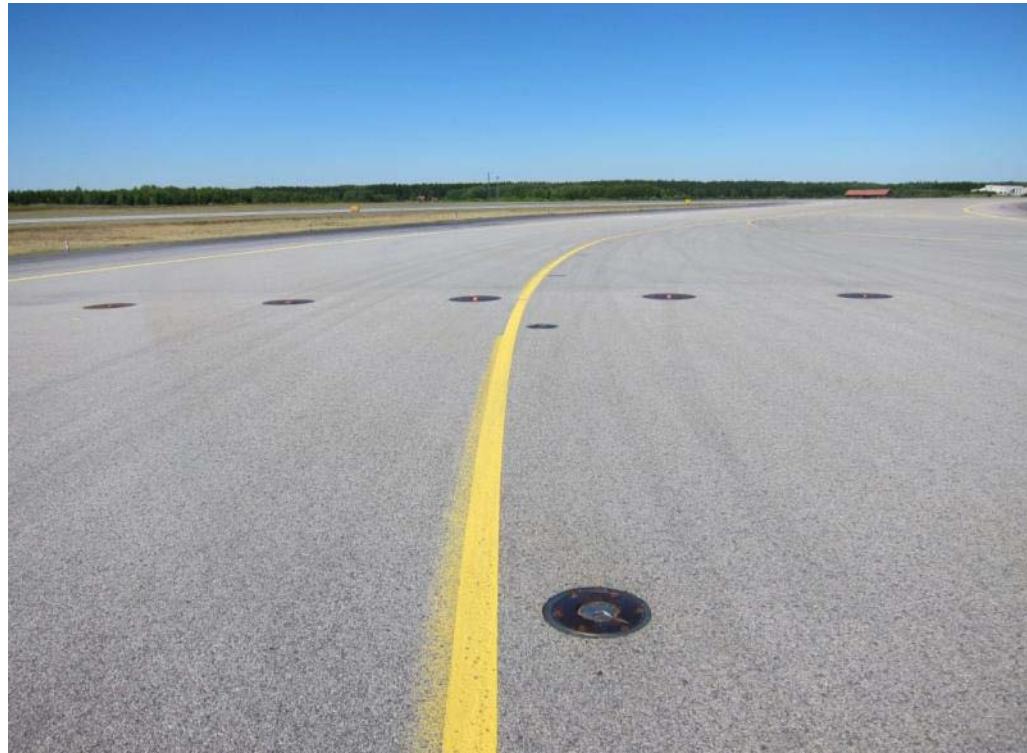
Fig. 5 Taxi line that the pilots followed. The row of five lamps from left to right is part of a stop bar, 29 June 2011.

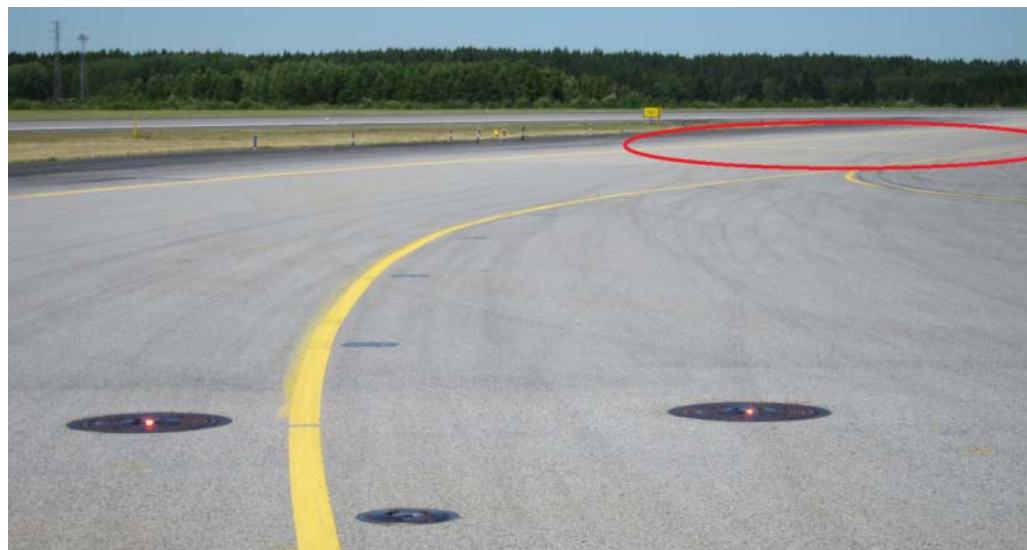
Normally the painting of daylight markings is carried out annually, but there were no daylight markings by Y3 at the holding position. However, there was a daylight marking at the level of the RGL. During an interview one of the pilots said the aircraft had not passed the holding position since the aircraft stopped before the marking on the ground.

Fig. 6 Photograph taken from the holding position at Y3 in level with the stop bar, with the yellow holding position markings at the RGL circled in red, 29 June 2011.

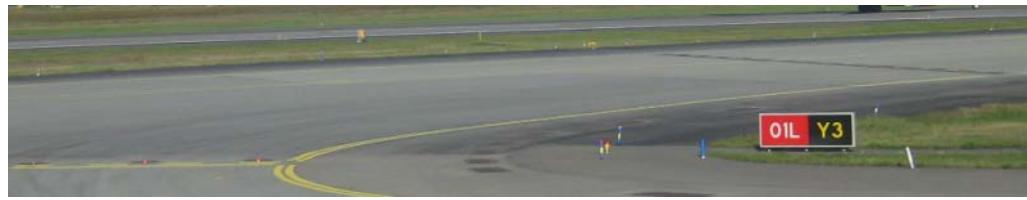
Fig. 7 Photo at Y3 on 23/08/2011. Photo: Bo Säbb

In the summer of 2011 the holding position markings were painted correctly at the holding position at the level of the sign and stop bar at Y3. It has not been possible to present the work order for the painting of Y3 in the summer of 2011

to SHK since it was given orally. At the same time as the holding position markings were painted at Y3, the remaining daylight marking by the RGL was blacked out, see fig. 7.

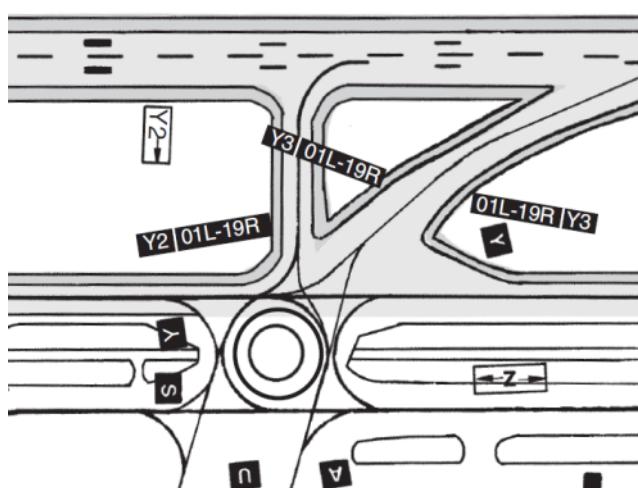
An airline rarely uses AIP directly for taxiing, but purchases a service from a company that produces a so-called route manual. It is important that the AIP is correct for the information in the route manual to be accurate in turn. Page AD 2-ESSA-2-5, Markings, in AIP Sweden with taxi markings for runway 01L/19R is expected to contain all markings, but no markings were presented at Y3 (or Y2), see fig. 8.

Fig. 8 Part of the AIP Sweden ESSA RWY 01L/19R Markings, received on 29/06/2011. Source: AIP Sverige/Sweden

The investigation has not been able to explain the lack of holding position markings in the AIP. It has been found that neither the older holding position markings nor the more recent markings appeared in the AIP that was valid in the summer of 2011. Changes to the daytime markings at Y3 have probably not been communicated to those who are responsible for updating the AIP for Arlanda.

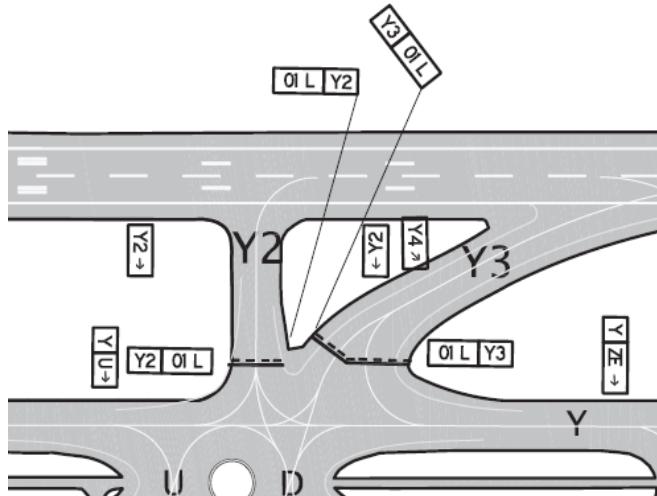
Fig. 9 Part of the AIP Sweden ESSA RWY 01L/19R Markings, received in November 2011. Source: AIP Sverige/Sweden

In connection with the paint job during the summer of 2011, the AIP was updated with the correct holding position markings at Y3 (and Y2), see fig. 9.

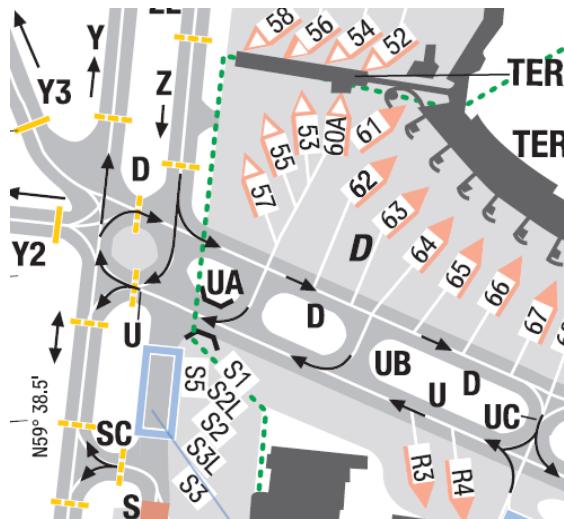
Fig. 10 Excerpt from the pilots' taxiway chart, Lufthansa LIDO, published 01/04/2010

The taxiway chart shows the older holding position (CAT I) at Y3, see fig. 10. However, the stop bar at Y3 is not marked.

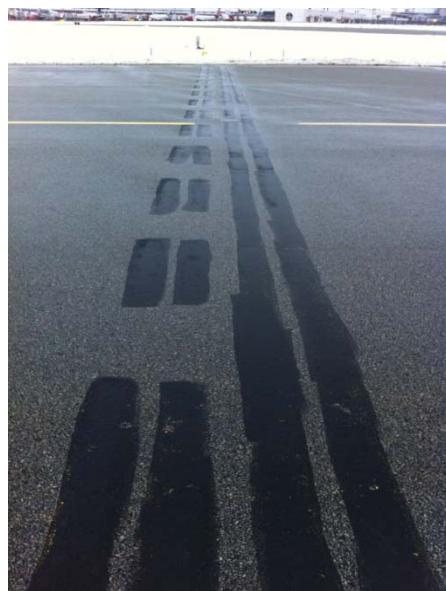
Fig. 11 Blacked out lines at the old CAT I holding position.

The occurrence which was the incentive for this investigation occurred on 5 February 2011 and in April 2011 a verbal directive was issued to paint the holding position markings at Y3 and to blacken the line at the old CAT I holding position.

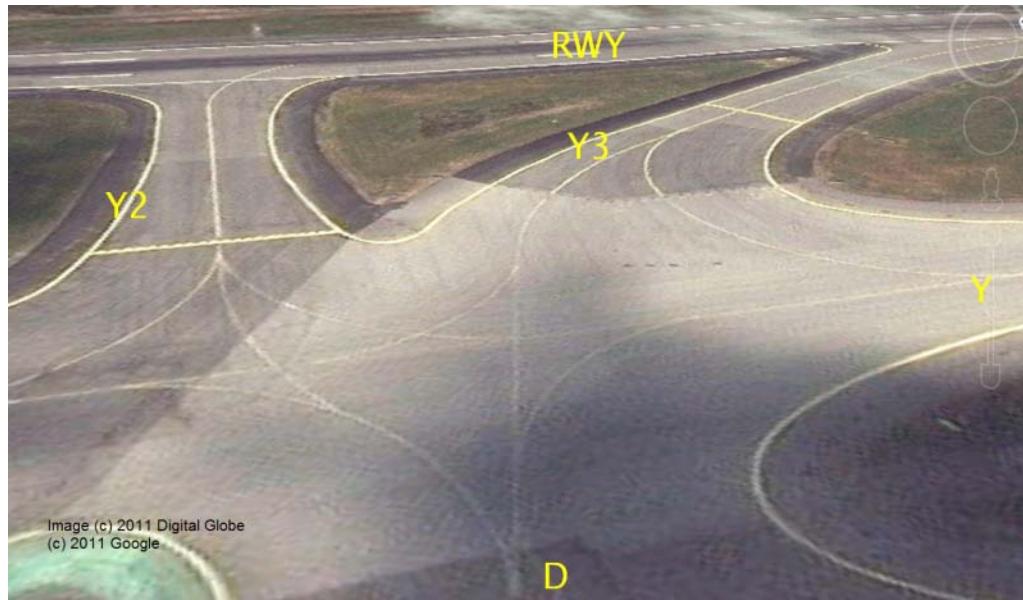
At the crossing between Y and D where the aircraft was going to turn right, the taxiway line D continues straight ahead. The pilots were expected to turn nearly 90 degrees to the right onto taxiway Y, but continued along the extension of taxiway D onto Y3, which turns about 45 degrees to the right before it connects to runway 01L (see fig. 12).

Fig. 12 Side view of the taxiway intersection. Note that this is a satellite image taken from above but viewed from the side, which means that signs and lights are not visible in the picture.

The snow and ice present on the runway cannot be considered to have significantly affected the visibility of the stop bar or the holding position markings. The lack of daylight markings at the holding position at Y3 probably influenced the ability to detect it during the day, particularly as the pilots said that they observed and stopped at the holding position marking further ahead. The lack of daylight marking at the holding position may also have caused the pilot to believe that they were still on taxiway D.
