Transportation Safety Board
of Canada

AVIATION INVESTIGATION REPORT
A10A0032

RUNWAY EXCURSION

**CARGOJET AIRWAYS LTD.
BOEING 727-225, C-GCJZ
MONCTON, NEW BRUNSWICK
24 MARCH 2010**

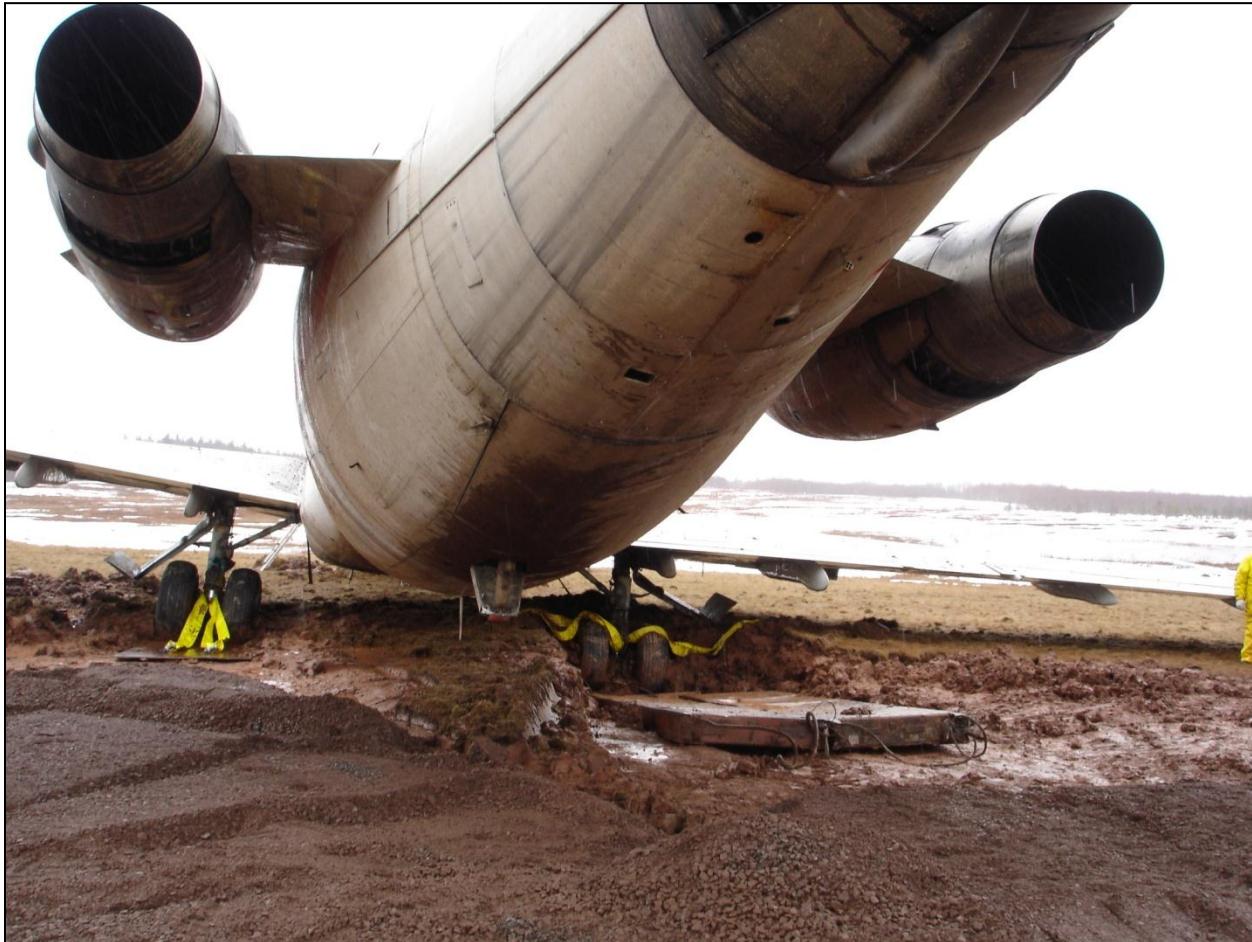
paved surface with an indicated airspeed of approximately 50 knots. The aircraft came to a stop in deep mud approximately 27 seconds after touching down on Runway 06 (see Photo 1). Maximum manual wheel braking was applied shortly after touchdown, and maintained by the flight crew throughout the entire landing roll.

Photo 1. Occurrence Aircraft Stuck in Mud (Photo taken during recovery)

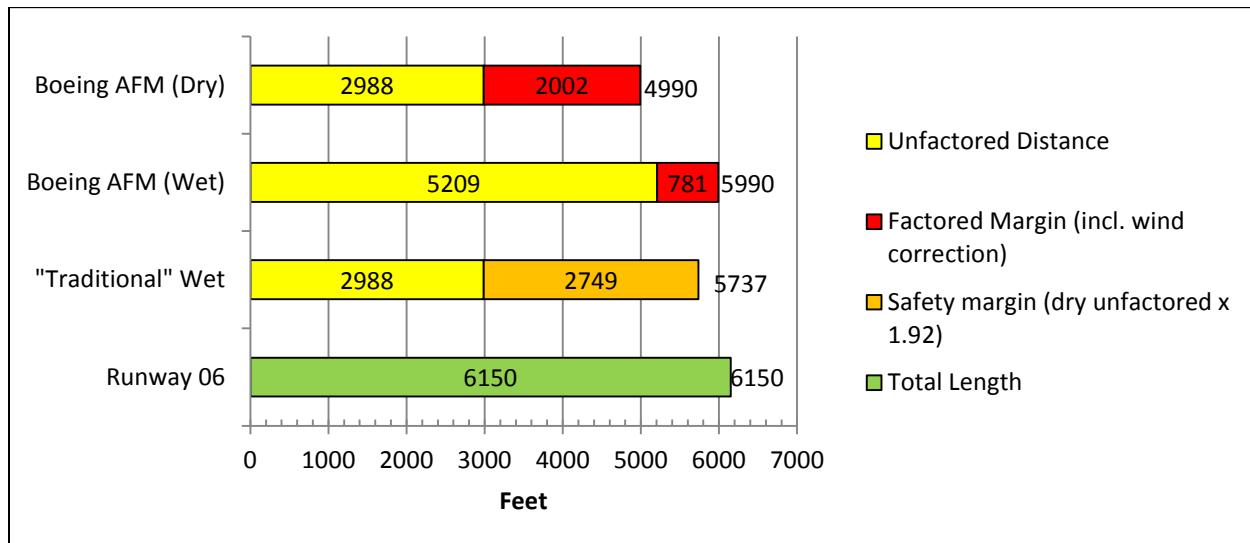
Figure 1. Comparison of AFM Dry/Wet Landing Distances versus Usable Runway (LDA)

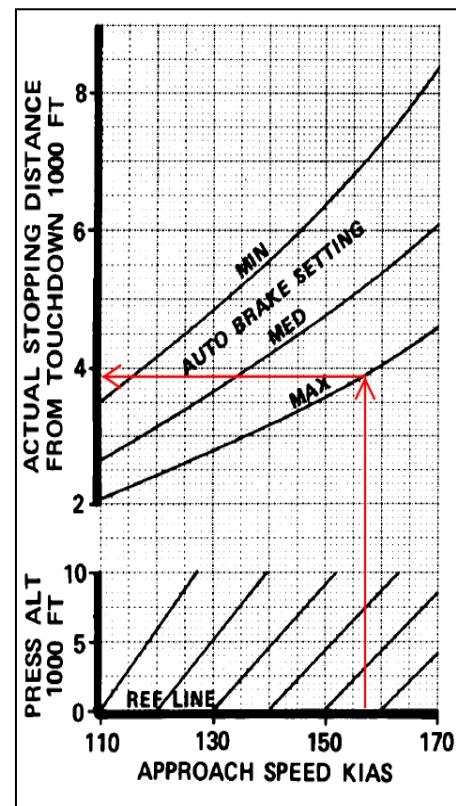
While the FCOM does not provide an actual value for stopping on a wet runway, that information is located in the AFM. According to the AFM, actual stopping distance on a wet runway, for the conditions listed above, would be approximately 500 feet greater than the value determined for a dry runway. Maximum manual braking would produce slightly shorter stopping distances if applied immediately upon touchdown. However, the benefits of

Figure 2. Boeing Actual Stopping Distance Chart

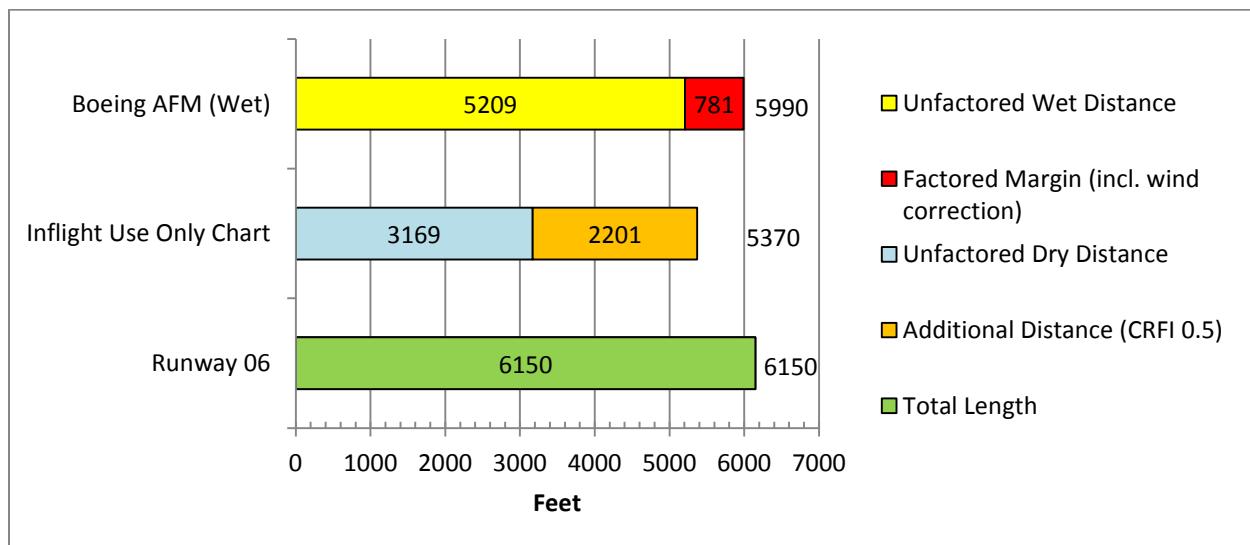
Using the surface wind information broadcast in ATIS information Bravo, the crew calculated the approach speed to be 157 KIAS. This was based on a V_{REF} speed of 139 knots³⁵ plus 18 knots to compensate for the wind, as per the *Cargojet Operations Manual*.^{36,37} The wind correction applied to the approach speed is to be decreased as the aircraft nears the ground. If both wind and gust corrections have been applied, the gust correction is retained until touchdown while the steady wind correction should be bled off as the aircraft approaches touchdown.³⁸ In this case, the gust correction was 10 knots, which would make the target touchdown airspeed 149 KIAS.

Figure 3. Comparison of AFM versus Cargojet “Landing Distance - Inflight Use Only” chart

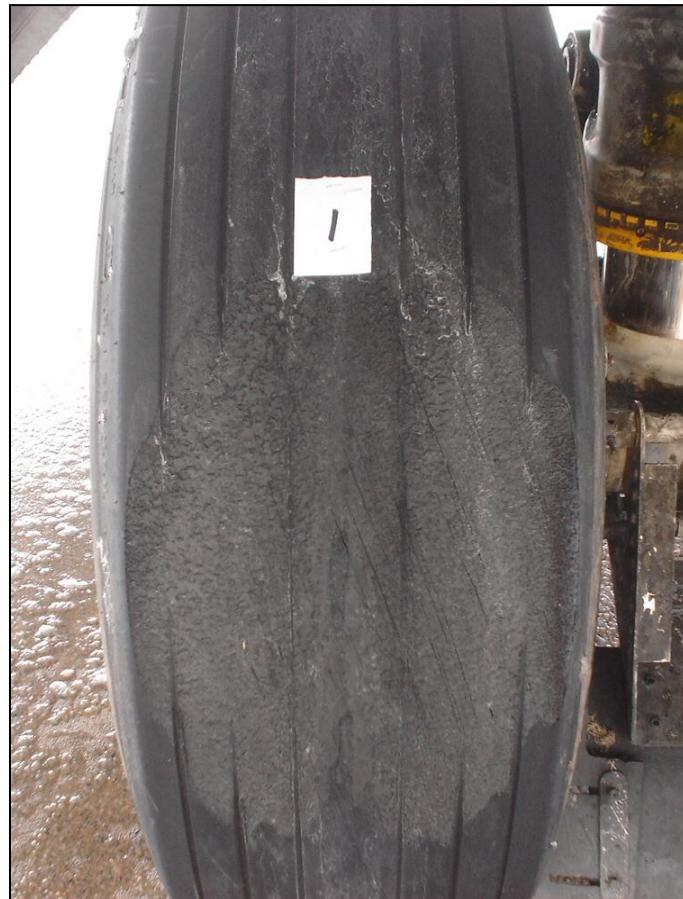
One type of hydroplaning is called reverted rubber hydroplaning, which occurs with a non-rotating or skidding tire on a surface covered with a thin water layer up to and including standing water. The heat generated by this type of hydroplaning can leave steam-cleaned marks on the runway surface and can cause rubber to revert to its original uncured state.

In this occurrence, steam cleaned marks were not detected on the runway after the incident. However, all four of the B727's main landing gear tires exhibited damage consistent with reverted rubber hydroplaning (see Photo 3).

Photo 3. Reverted Rubber Occurrence Aircraft Tire

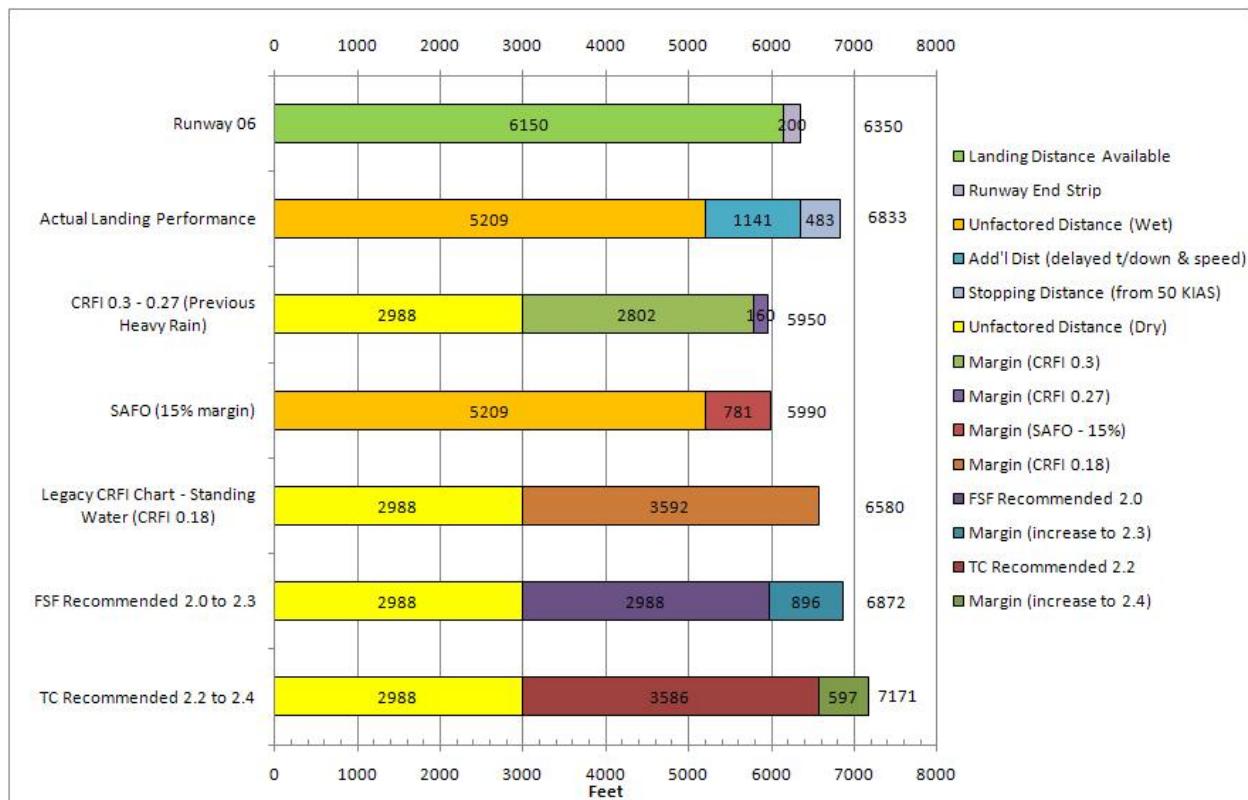
Figure 4 below provides a comparison of the actual landing performance⁶² of the aircraft in this occurrence compared to the calculated landing distances based on the various recommended safety margins suggested by SAFO 06012, the Flight Safety Foundation, Transport Canada, and previous CRFI equivalent values for heavy rain and standing water.

Figure 4. Comparison of Recommended Wet Adjustments to Landing Distance
