**AVIATION INVESTIGATION REPORT**  
**A10O0089**

**RISK OF COLLISION**

**NAV CANADA - TORONTO AREA CONTROL CENTRE  
TORONTO / BILLY BISHOP TORONTO CITY AIRPORT  
TORONTO, ONTARIO, 6 NM SE  
11 MAY 2010**

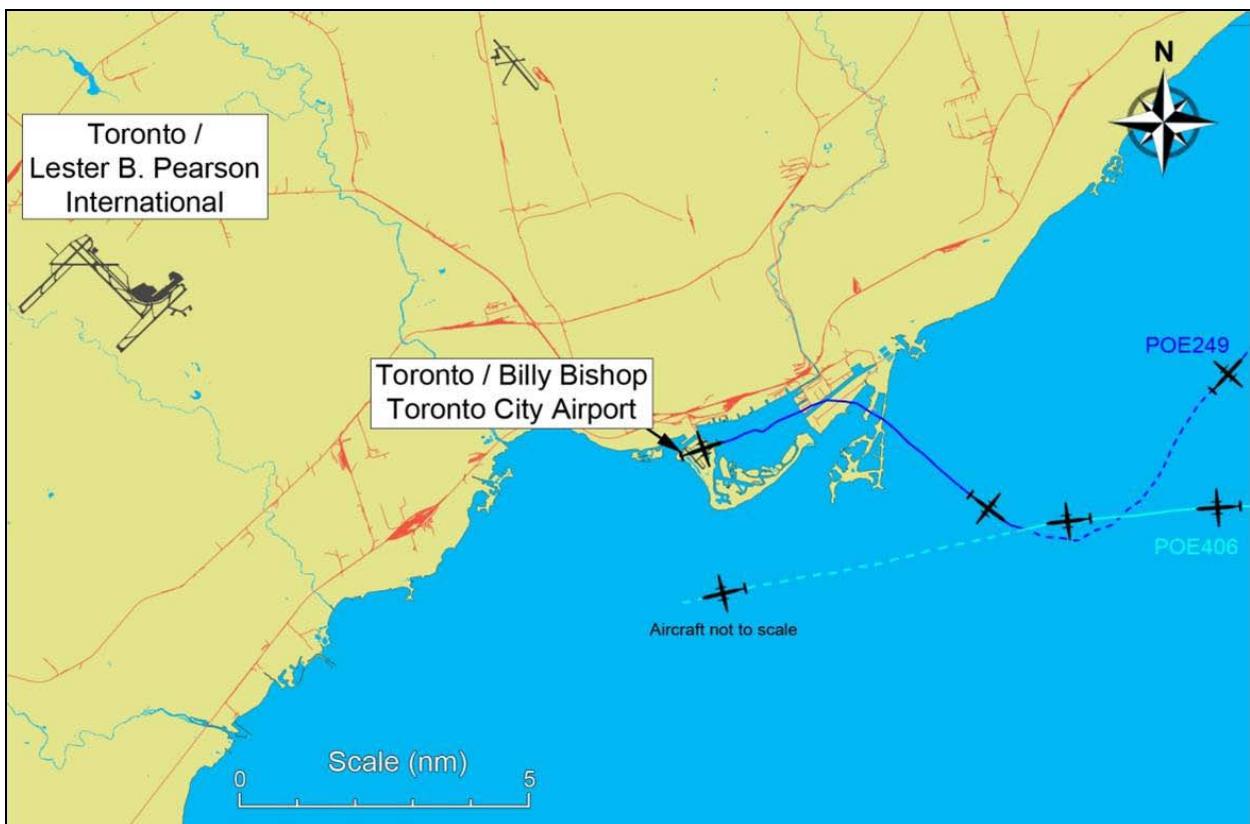
**Figure 1.** Flight Paths

For 10 seconds, another aircraft transmitted on the frequency. During this time, both POE249 and POE406 received and responded to their respective traffic collision avoidance system (TCAS) resolution advisories. Seconds later, POE249 and POE406 crossed paths 300 feet vertically apart, 6 nm east southeast of Billy Bishop Airport (see Figure 1).
