Aviation inquiry 10-007:  
Boeing 737-800, ZK-PBF and Boeing 737-800, VH-VXU, airspace incident,  
near Queenstown Aerodrome, 20 June 2010

# Final Report

10-007  
Boeing 737-800, ZK-PBF and  
Boeing 737-800, VH-VXU  
airspace incident  
near Queenstown Aerodrome  
20 June 2010

Approved for publication: 13 March 2012

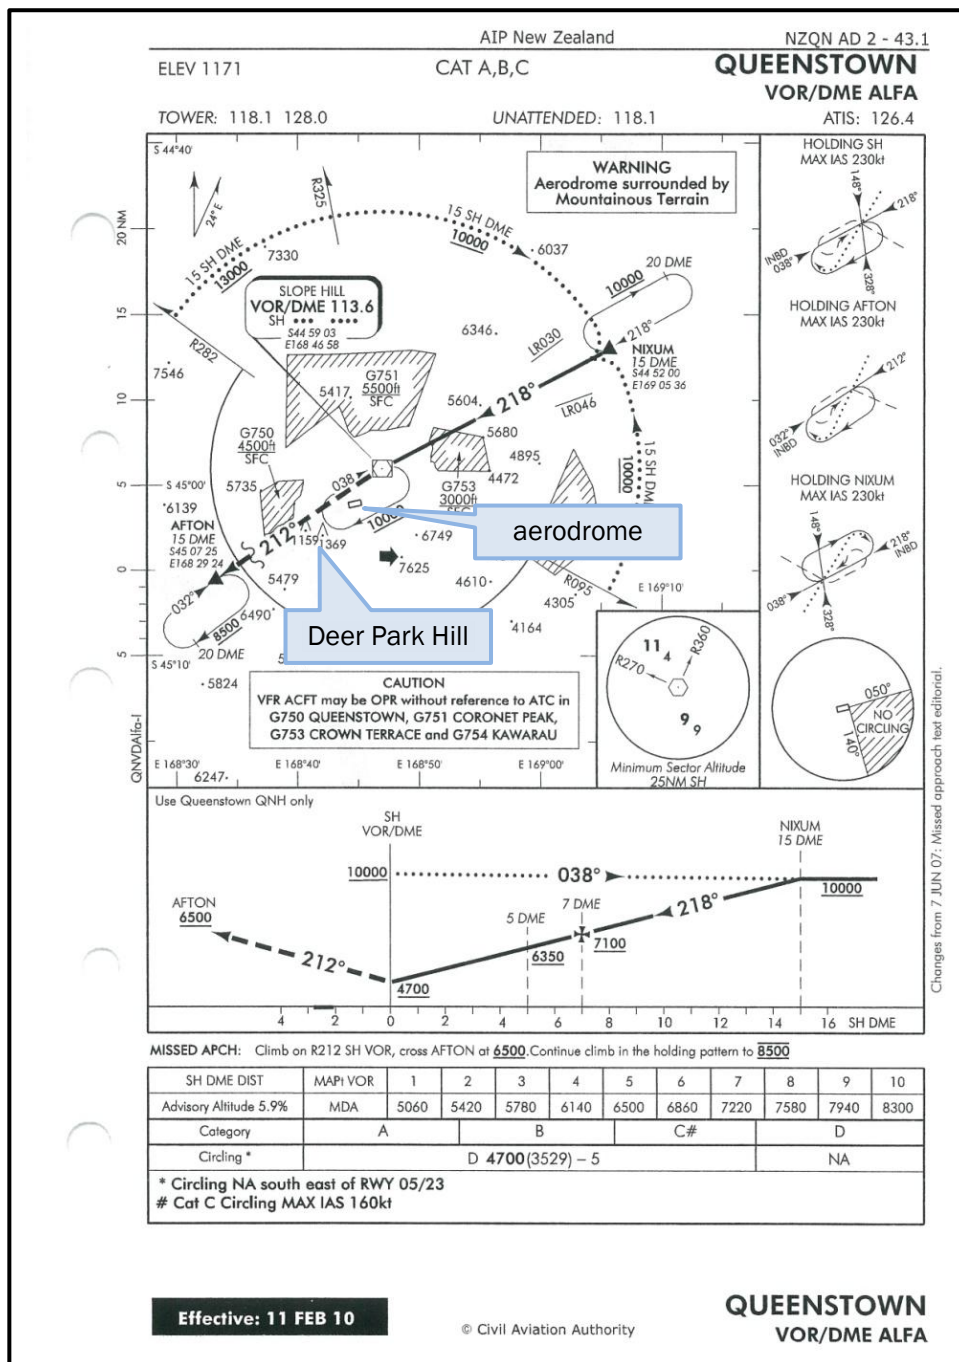
**Figure 3**  
**Approach flown by Pacific Blue**

- 3.2.8. Twenty seconds later, Pacific Blue advised it would now track overhead the aerodrome and 'try' an approach to runway 05. It did not request a revised clearance to the different runway, as it should have done, and ATC did not explicitly re-clear it. The pilots then asked ATC about the cloud to the south and over the Frankton Arm, because they found it difficult to discern the height of the cloud tops, and were told the cloud was quite thick to the south but the Frankton Arm looked clear.

- 3.2.11. 'Deer Park Hill' was a hill immediately south of the aerodrome. After Pacific Blue had flown overhead the aerodrome and turned to go behind Deer Park Hill, the pilots saw that they would likely lose visual contact with the runway because of low cloud. At 1345 they advised ATC that they had commenced a missed approach and were tracking to position AFTON, the missed approach holding point 15 miles from the VOR/DME.

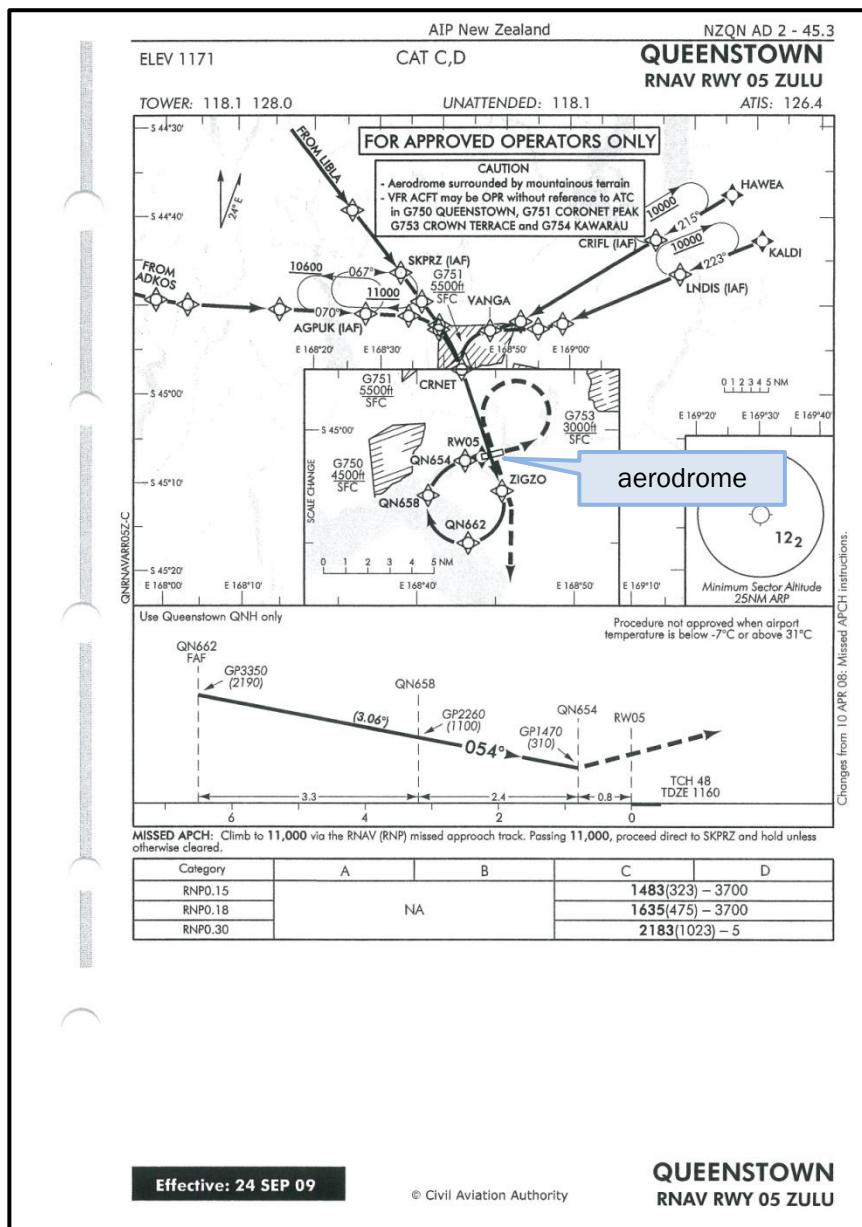
**Figure 5**  
**Approach flown by Qantas**

- 3.2.14. Pacific Blue was not authorised for the same high-precision approaches as Qantas, so its pilots did not know all of the positions referred to by ATC and Qantas, and were concerned initially that Qantas might be on an approach that came over the lake in the opposite direction to the missed approach track they were flying.<sup>7</sup> At one point the Pacific Blue pilots observed a target on their traffic display, a couple of miles behind and 800 ft or 900 ft above them.<sup>8</sup> The collision avoidance systems fitted to the aeroplanes did not generate any traffic advisories or warnings.

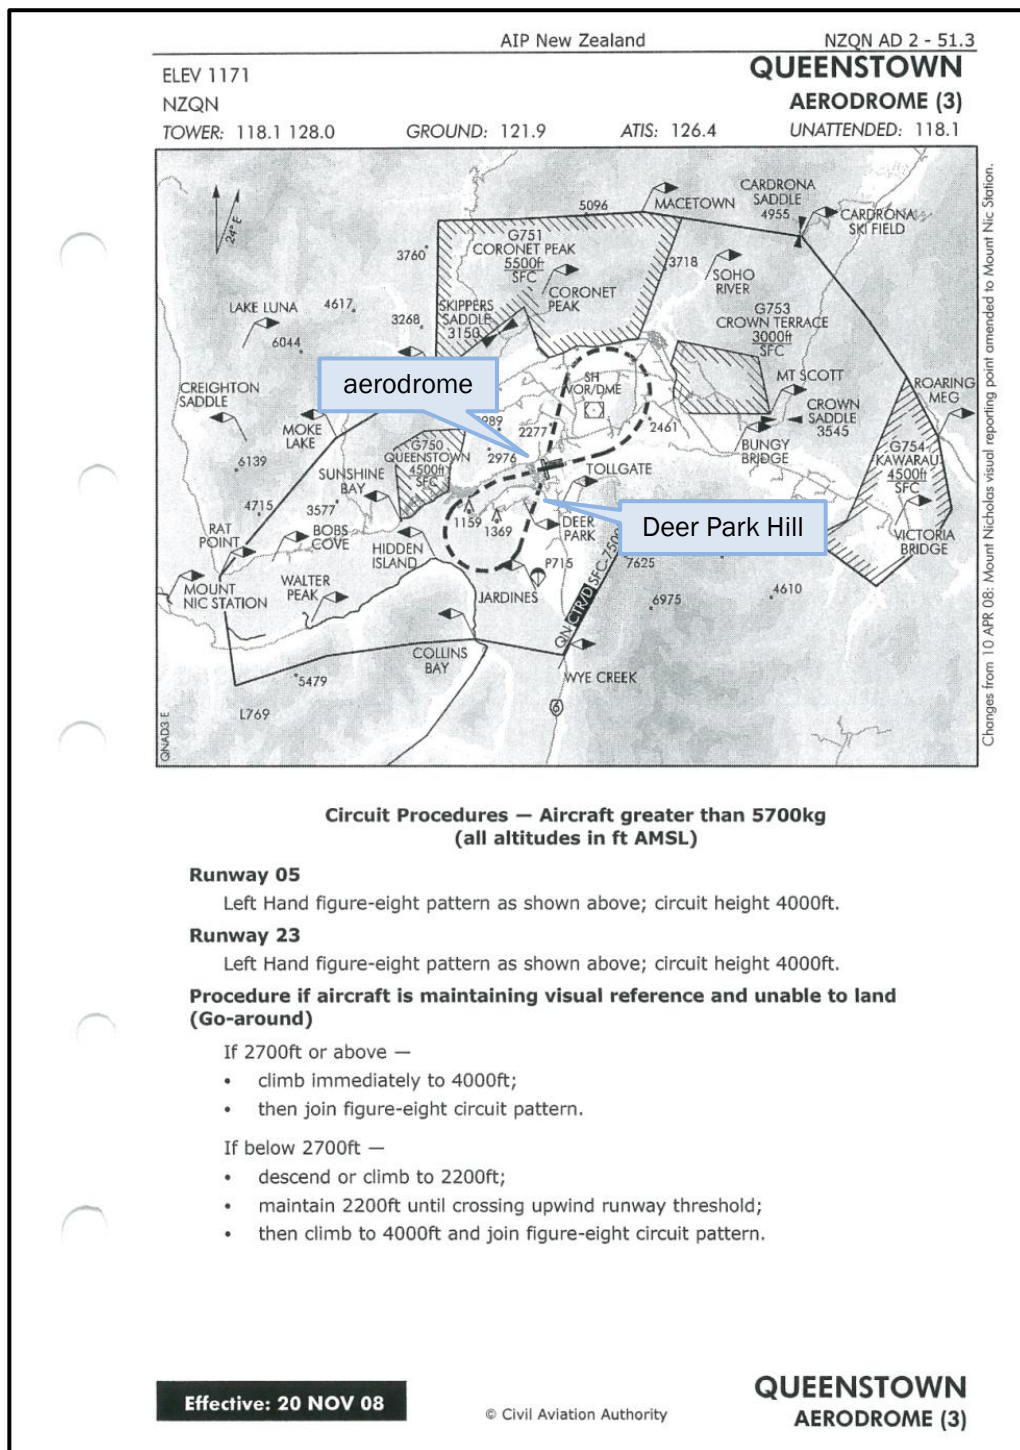
**Figure 6**  
**Visual circuit for large aircraft**

- 3.5.4. The different circuit for larger aircraft arose from airline concerns that a jet aeroplane going around from its final approach to the main runway 05/23 could conflict with an aircraft on the downwind leg of the circuit for the crossing grass runway. The internal 'Request for Change' submitted by the aerodrome chief controller noted there was a right-hand circuit for runway 23 promulgated under Civil Aviation Rules<sup>19</sup>, but added 'terrain prohibits large aircraft carrying out [the published] circuits, so the airlines have adopted a figure-8 type circuit pattern.'

- 3.5.9. In response to observations made during this investigation, the chief controller initiated an AIP change to correct the description of the figure-8 circuit and clarify its purpose. On 10 February 2011, the chart sub-title was amended to read, 'Procedure if aircraft is maintaining visual reference or circling from an instrument approach and unable to land.' The supporting documentation for the change request noted that, if the change were not implemented, there was 'a high risk of misinterpretation by pilots unfamiliar with the procedure'. The request also stated that 'no one has been asked to consult on this [change]', and the potential for the procedure to be misinterpreted had not been identified earlier due to the procedure's 'very rare use.'

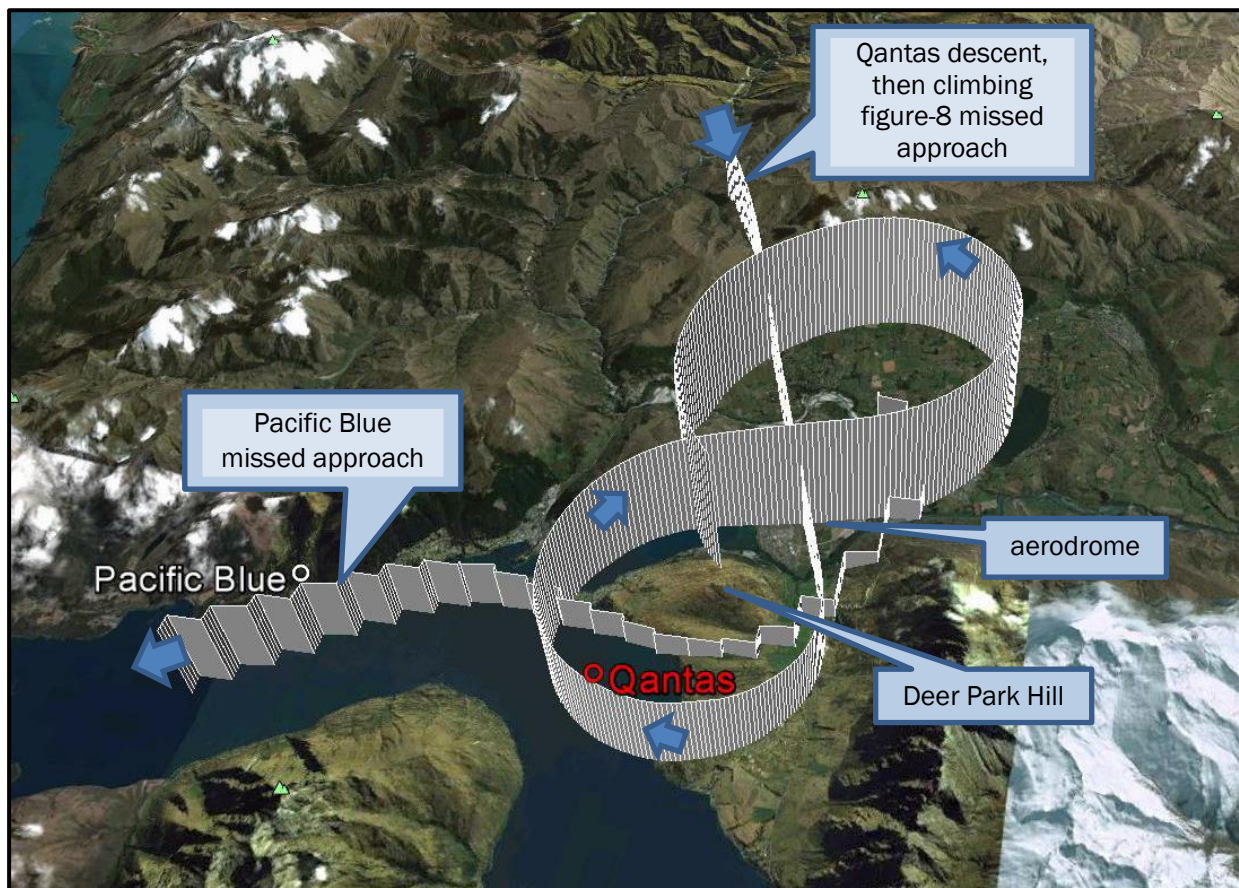
**Figure 7**  
**Flight paths of both aeroplanes**  
 (Image courtesy of the Australian Transport Safety Bureau)

- 3.3.6. Pacific Blue was climbing through about 6300 ft when the aeroplane intercepted the prescribed missed approach track approximately 7 miles from the VOR/DME, which was the start point for the missed approach procedure. The procedure design minimum altitude at 7 miles was 5528 ft.<sup>13</sup>
