DATA SUMMARY

Date and time	Thursday, 14 April 2011; 08:30 UTC¹
Site	Barcelona Airport

Registration	EI-EKB	N366AA
Type and model	BOEING 737-800	BOEING 767-300
Operator	Ryanair	American Airlines

Operation	Commercial Air Transport – Scheduled – International – Passenger	Commercial Air Transport – Scheduled – International – Passenger
Phase of flight	Taxiing	Taxiing

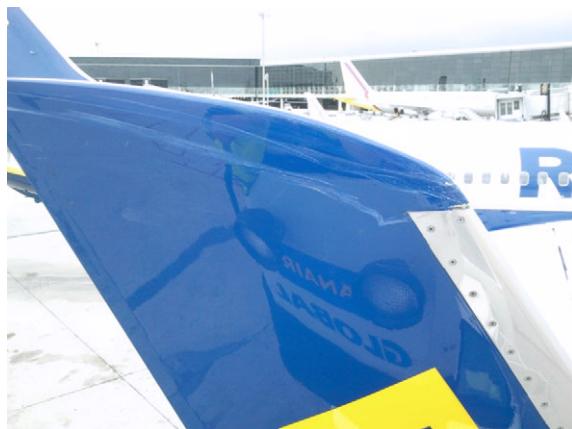
During the walk-around before the B737's next flight, the crew noticed damage to the winglet on the right wing (Fig. 1), which made them suspect that they had in fact made contact with the other aircraft.

Figure 1. Damage to the B737 winglet

Though they stated being certain that there had been no contact, the captain decided to do the pre-flight walk around personally once they were parked at the Ibiza airport. During the inspection she noticed that the paint on the right winglet was scratched. She regarded the defect as minor, one that did not justify any actions by maintenance personnel, especially as they would have had to fly from Barcelona, since the airline does not have mechanics in Ibiza. She also did not make an entry of the defect in the aircraft logbook.

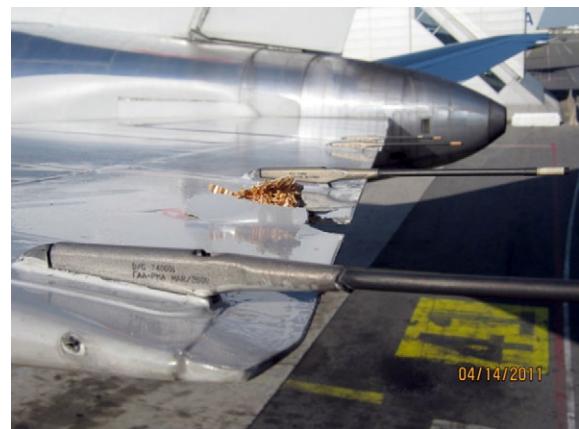
Figure 2. Damage to the B767 stabilizer

Ryanair contacted American Airlines to inform it of the incident. After the arrival of the flight, American Airlines personnel verified the existence of damage to the outboard section of the left horizontal stabilizer (Fig. 2). This damage required that the aircraft be removed from service for repairs.

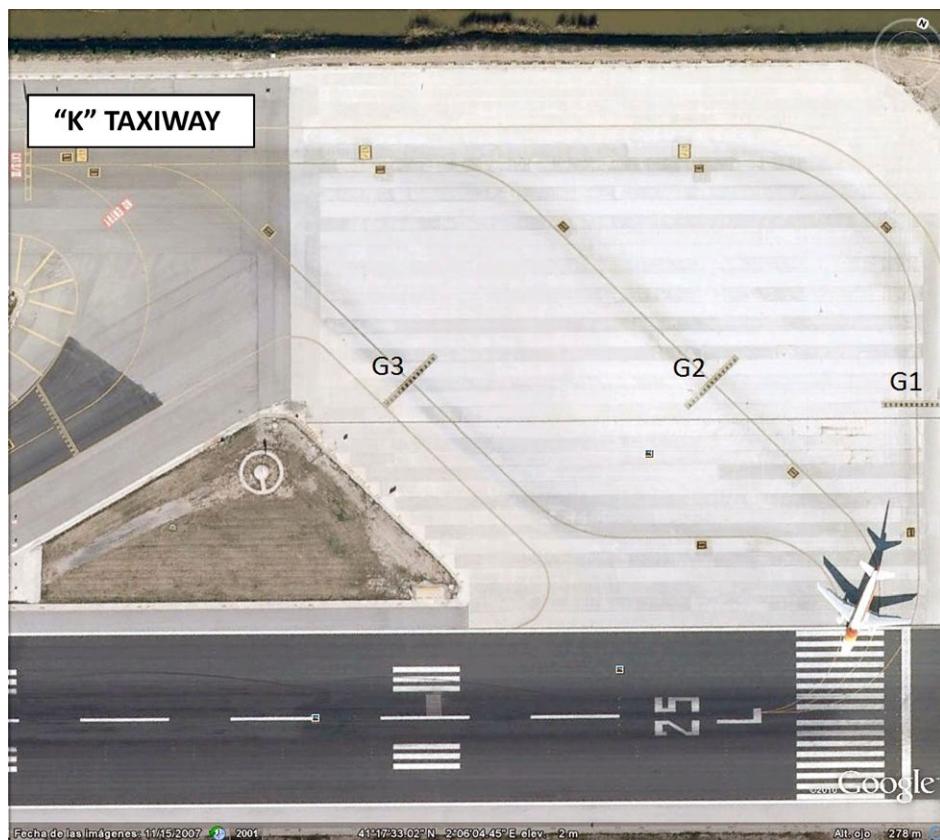
The layout of the runway 25L threshold allows three aircraft to hold simultaneously at three holding positions labeled G1, G2 and G3 (Fig. 3). These points are accessed via a single taxiway, K, whose centerline branches into three to provide access to each point. The ability to use three points at the same time gives controllers flexibility when organizing takeoff sequences and allows for smoother operations.

So as to maintain separation between aircraft, only certain aircraft categories are allowed to access the most remote points (G1 or G2) via taxiway K when G3 and/or G2 are already occupied.

Figure 3. Triple holding point at runway 25L

REC 06/12. It is recommended that AENA reassess the taxi limitations applicable to taxiway K and holding points G at both the runway 25L (points G2 and G3) and runway 07R (points G10 and G11) thresholds at the Barcelona Airport. Specifically, AENA is to take into account the effect that the length and position of aircraft situated at the holding points has on taxiing limitations and include these limitations, if any, in ATC procedures.

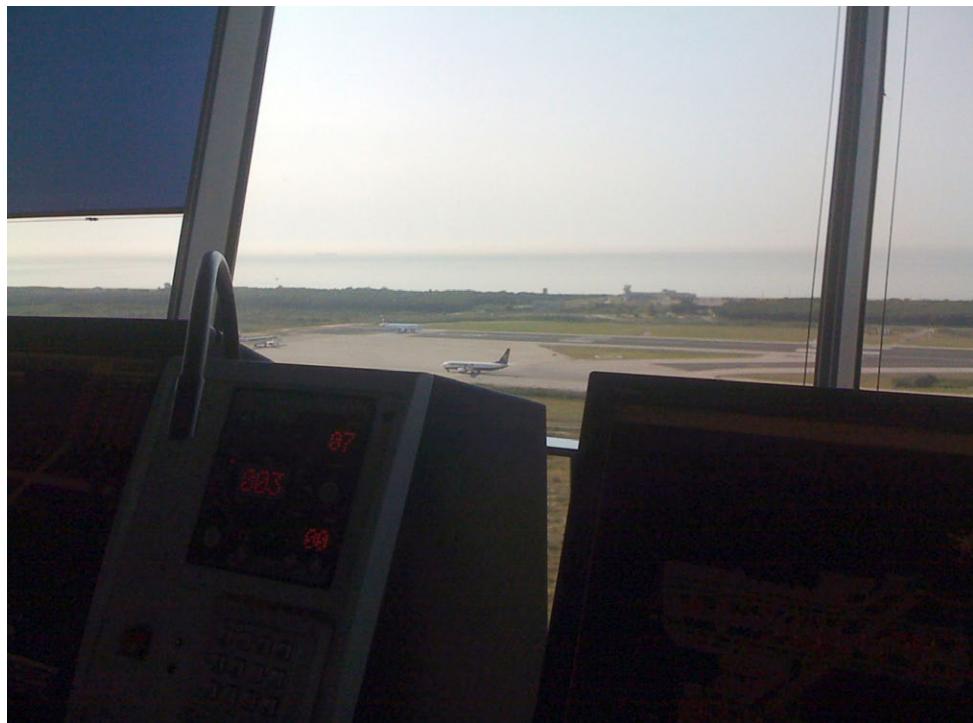
The GMC controllers are located in the control tower. The tower at the Barcelona Airport is some 600 m NW of the runway 25L holding point. The visibility of the area from the tower is ideal, though the distance and the relative geometry do not allow controllers to evaluate the separation between an aircraft at the G3 holding point and those moving into holding points G1 or G2 (Fig. 4).

Figure 4. View of the runway 25L holding point from the tower control room

Controllers in the tower have a direct line of sight to any aircraft movements in this area, but they cannot discern the separation that exists between aircraft. ATC handles access to the holding points and the subsequent entries into the runway in accordance with procedures. It is the crews who are responsible for avoiding collisions and for requesting assistance from ATC if necessary.

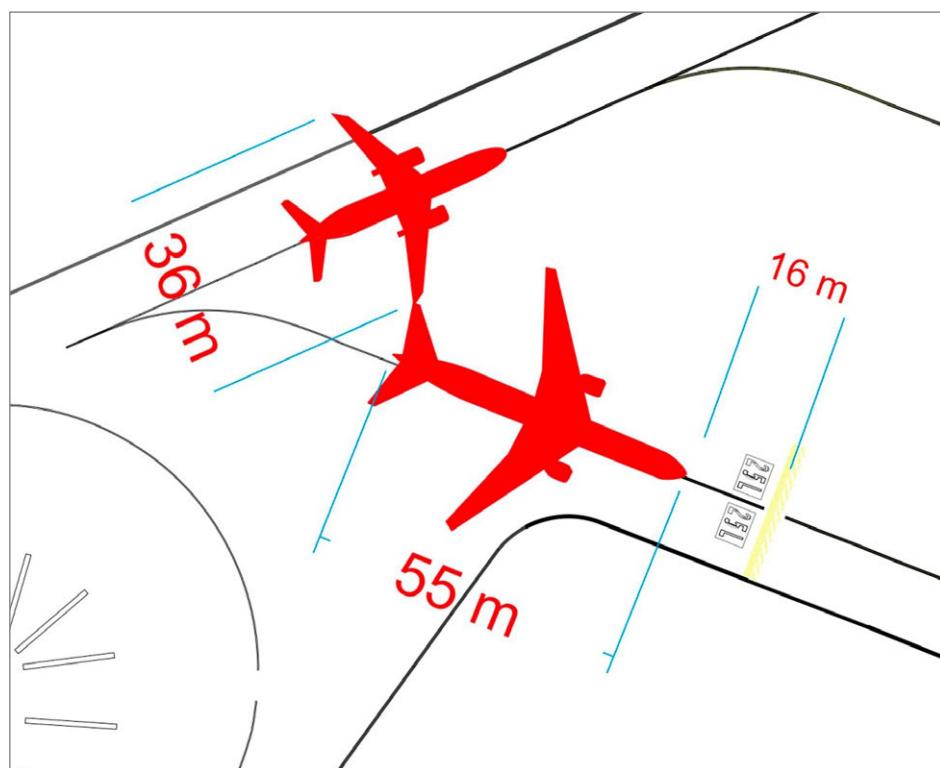
Figure 5 depicts the geometry of a hypothetical contact scenario between two aircraft of the type involved in this incident.

Assuming that both aircraft are perfectly aligned with their respective centerlines, a collision would take place if the B767 were a little over 16 m (54 ft) away from the holding point marking. This scenario would be even more restrictive if the airplane waiting at G3 were, for example, a B767-400, which is also a category D airplane but 6.4 m longer than the B767-300.

Figure 5. Collision geometry in the vicinity of G3

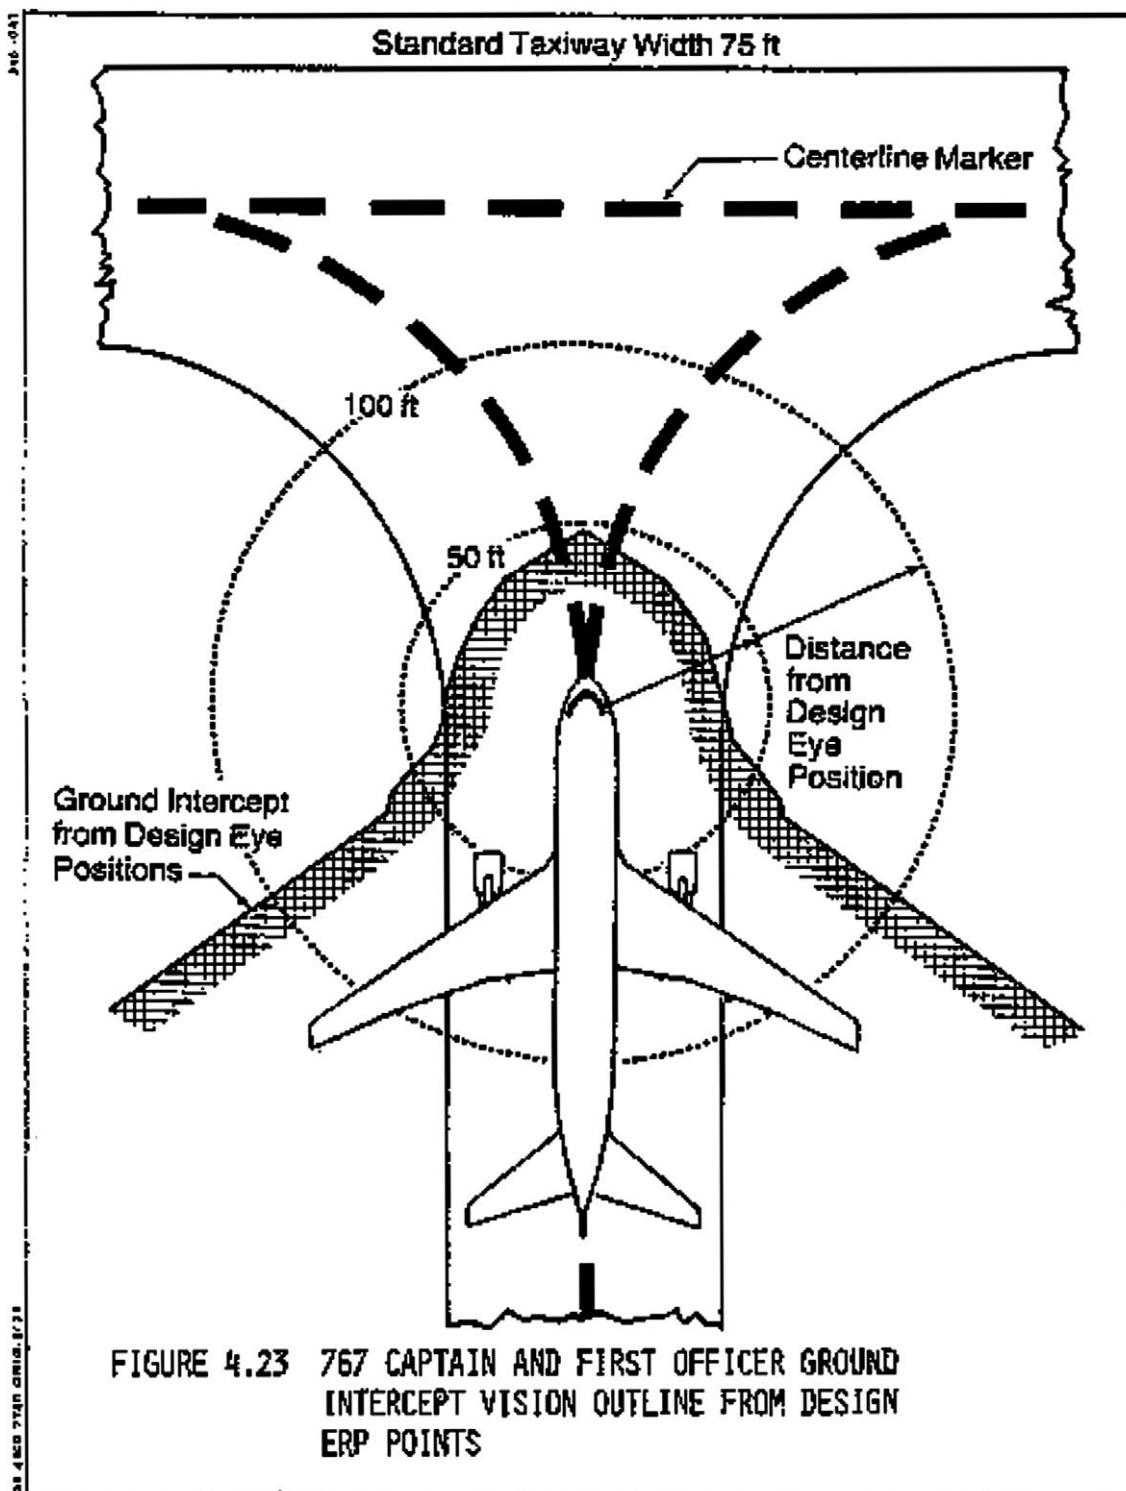
Visibility from the B767 flight deck

The distance will depend on the field of view that the crew has from the cockpit. For the B767 (Appendix I), the nearest point on the ground that can be seen from the pilot's seat is 50 ft away. The typical stopping distance, then, will be along the same order of magnitude so that the marking remains within the crew's field of vision. In this case, this figure also matches that expressed by the pilots in their statement and is consistent with the result of the integration of the speed recorded by the B767's FDR as it traveled over the taxiway en route to the holding point, and with the returns from the surface radar (SMR) (Appendix III).

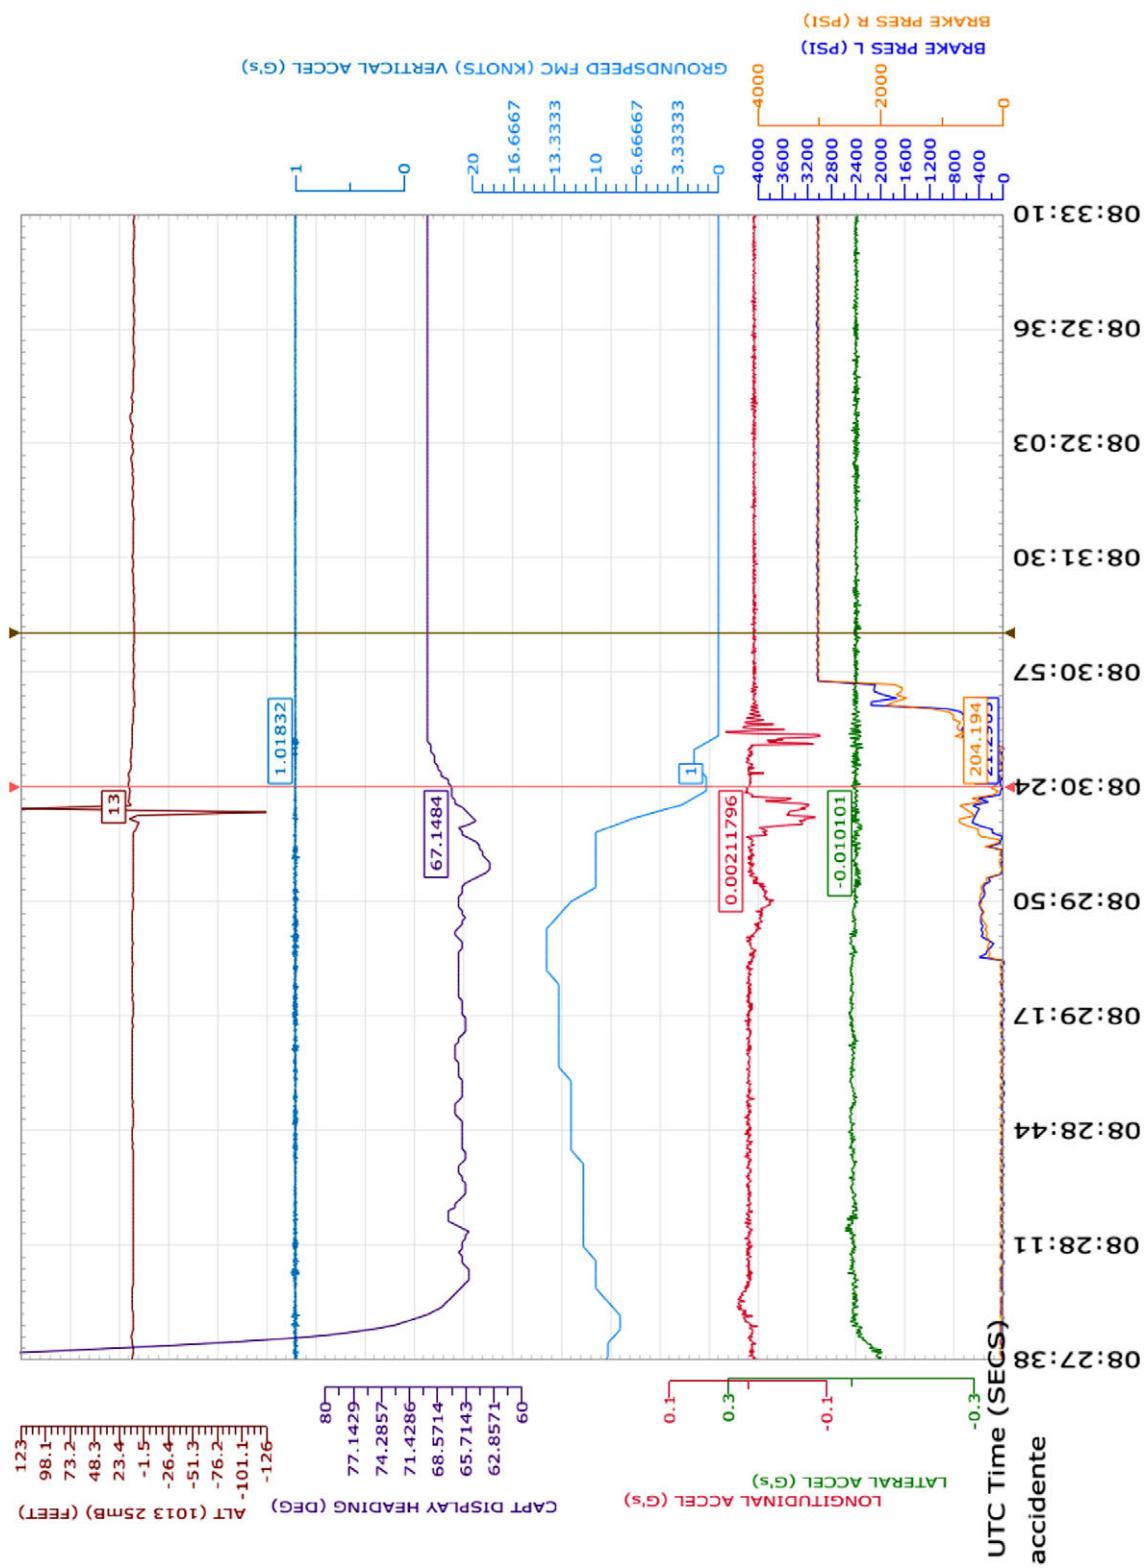
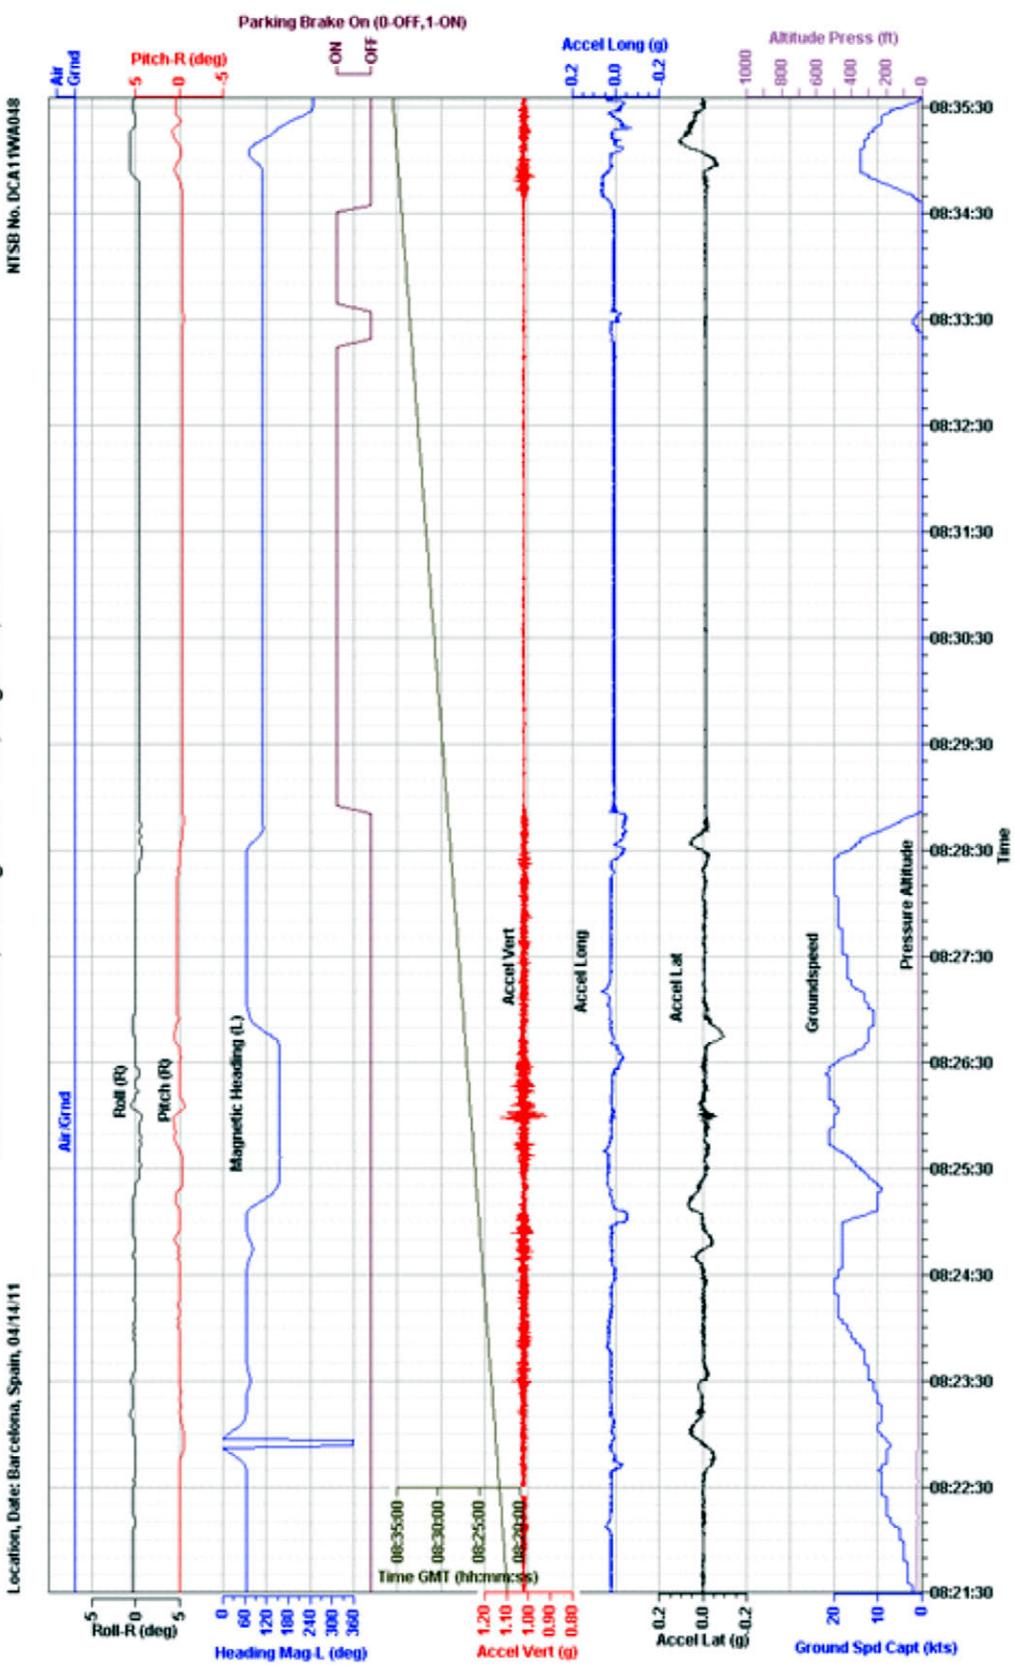
APPENDIX II
Graphs of flight parameters
recorded by the FDR

For the B737, the graphs show an increase in brake pressure until 08:29:30 and a subsequent reduction in ground speed from 14 kt to a full stop at 08:30:45. Also shown

is the change in heading associated with the deviation from the taxiway centerline in an effort to maintain separation between the two aircraft.

As for the B767, the ground speed graph shows that it stopped in front of the bar at point G1 at 08:28:50, where it stayed until 08:33:20, at which time it moved forward a few meters and stopped again before finally entering the runway at around 08:34:35.

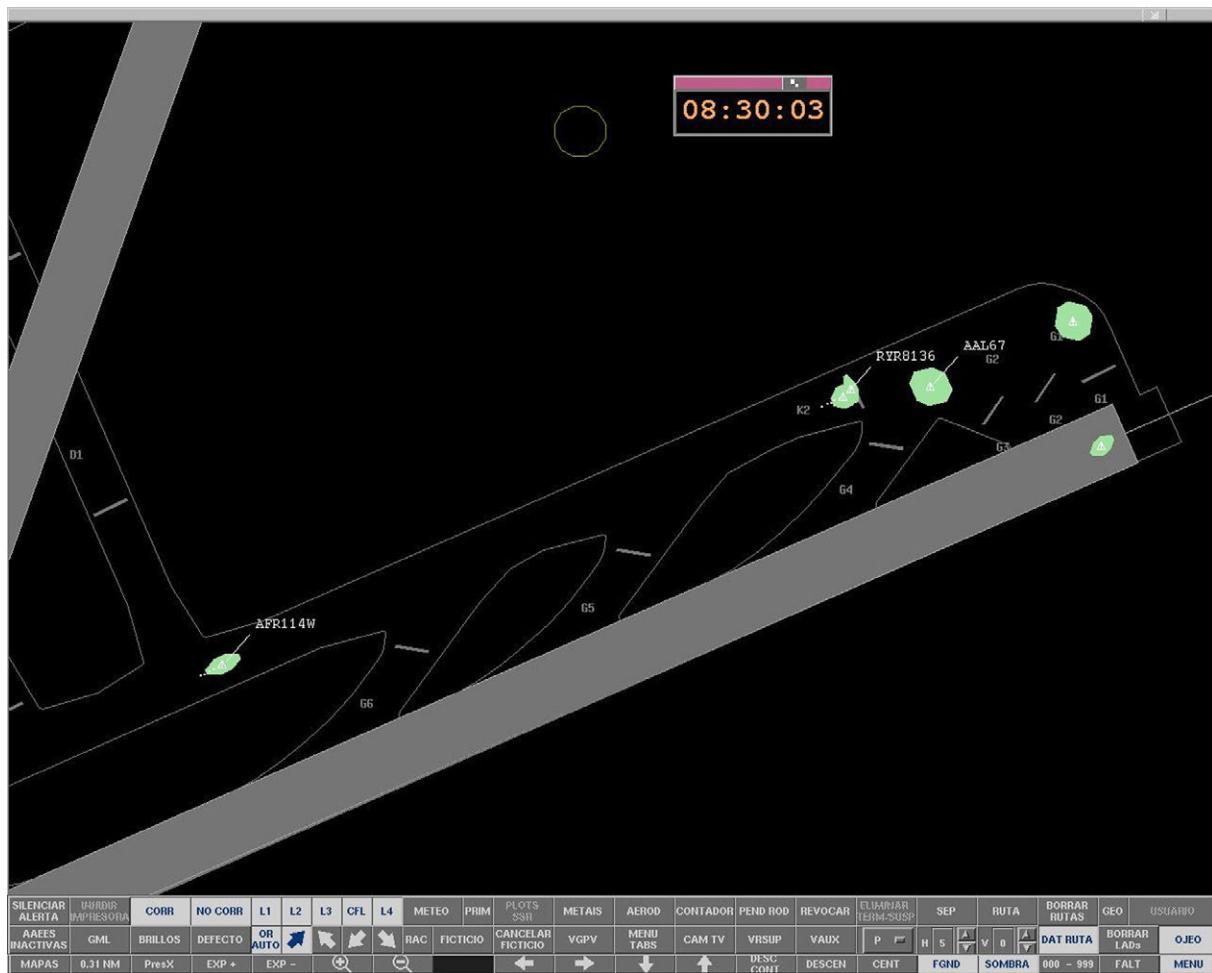
The B767's speed through the taxi line branch towards the holding point, as recorded by its FDR, was integrated to yield an estimate of the aircraft's position at its initial stopping point and of the distance covered during its subsequent displacement forward before stopping again. These calculations indicated that the B767 stopped some 50-60 ft before the marking and then moved forward about 15 ft. These figures are consistent with the crew's statements and with the information obtained from the ground radar (Appendix III).

APPENDIX III
**Echoes from the SMR (Surface
Movement Radar) around the 25L runway
holding point, moments before the collision**
