AIRCRAFT INCIDENT REPORT AND EXECUTIVE SUMMARY

Reference:	CA18/3/2/0799		
Aircraft Registration	ZS-SJS & ZS-OAO	Date of Incident	27 July 2010		Time of Incident
Type of Aircraft	B737 - 800 & B737 - 400		Type of Operation		Air Transport
Pilot-in-command Licence Type (ZS-SJS)	ATPL		Age	53	Licence Valid
Pilot-in-command Licence Type (ZS-OAO)	ATPL		Age	42	Licence Valid
Pilot-in-command Flying Experience (ZS-SJS)	Total Flying Hours		17746.0		Hours on Type 4530.0
Pilot-in-command Flying Experience (ZS-OAO)	Total Flying Hours		unknown		Hours on Type unknown
Last point of departure	ZS-SJS - OR Tambo International Airport (FAJS) ZS-OAO - Cape Town International Airport (FACT)				
Next point of intended landing	ZS-SJS - Cape Town International Airport (FACT) ZS-OAO - OR Tambo International Airport (FAJS)				
Location of the incident site with reference to easily defined geographical points (GPS readings if possible)					
Runway 21R at O R Tambo International Airport (FAJS)

AIRCRAFT INCIDENT REPORT

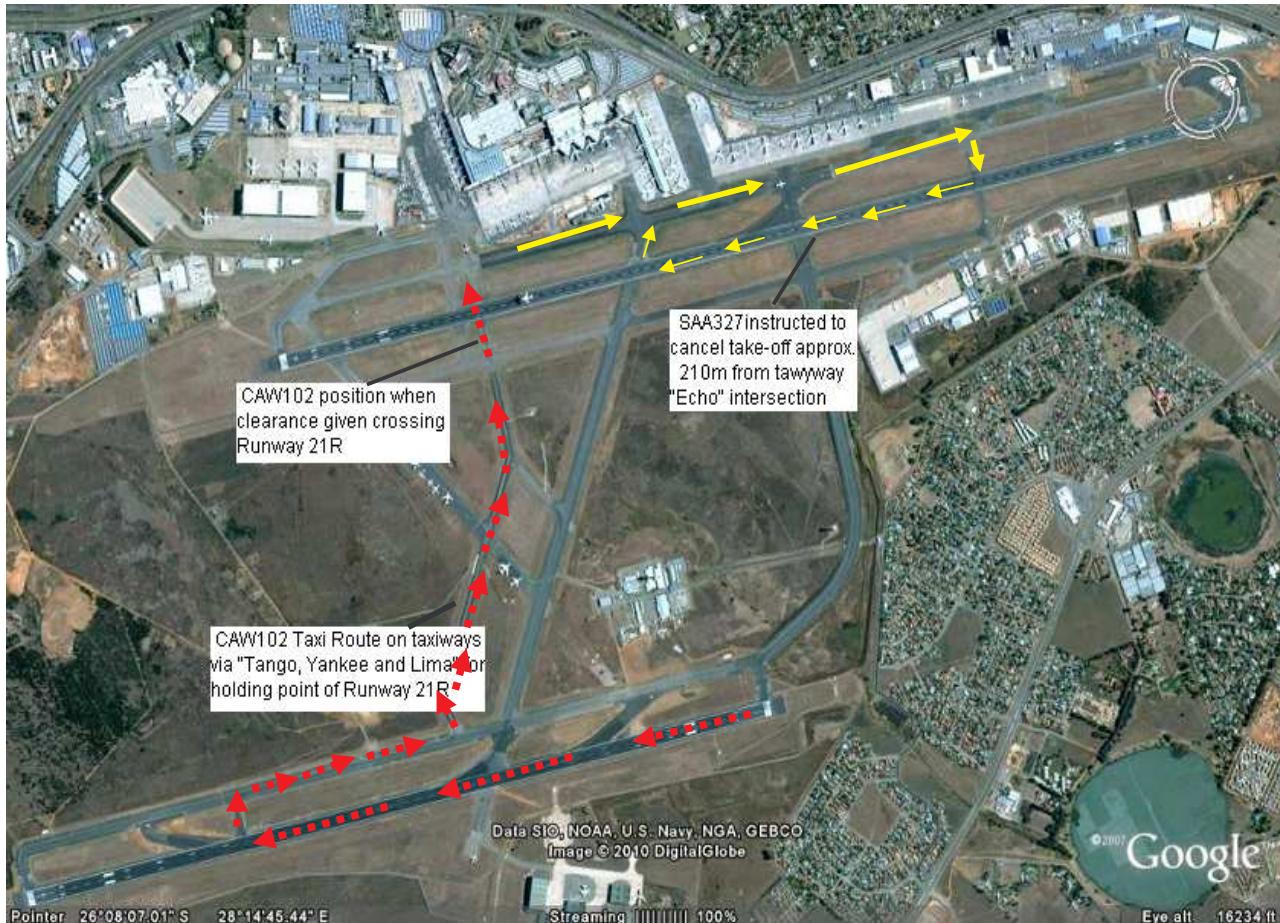
1.1.1 The aircraft SAA327 was scheduled for a domestic flight, departing from O R Tambo International Airport (FAJS) to Cape Town International Airport (FACT) on 27 July 2010. The aircraft was pushed back from the “Charlie #3” parking bay at approximately 0855Z. The flight crew were given clearance by Tower West controller to use “November” intersection and enter Runway 21R for takeoff. FAJS ATC - Tower West transmitted on VHF frequency 118.1 MHz, giving takeoff clearance to the aircraft. The flight crew then entered the runway and started the takeoff roll. When the aircraft reached approximately 80 knots indicated airspeed (IAS), the flight crew were given urgent instructions by Tower West controller to cancel the takeoff due to other aircraft crossing Runway 21R on taxiway “Lima”. There was the threat of a collision between the two aircraft. The flight crew acted immediately and reported to ATC that they were stopping. ATC apologised and instructed the flight crew to vacate the runway right into taxiway “Echo”, “Alpha” and hold short at “November” to take off again from Runway 21R. The flight crew complied with Tower West controller’s instructions and taxied back to Runway 21R. The aircraft lined up on the runway centre line and cleared for takeoff. However, the flight crew was requested to be given time (approximately 30 sec), stating that “We just want to make sure we’ve got everything sorted”. SAA327 then finally took off during the second attempt from Runway 21R and flew to FACT.

1.1.2 The aircraft CAW102 was flown from Cape Town International Airport (FACT) on a scheduled domestic flight to O R Tambo International Airport (FAJS) on 27 July 2010. On arrival the aircraft was cleared by Tower East controller to land on Runway 21L. After the landing the aircraft was taxied to the holding point of RWY 21R at Lima and handed over to Tower West. The flight crew were then cleared to taxi via taxiway "Lima" to cross Runway 21R. At the holding point of Runway 21R, at Lima the flight crew found that the stop bars were switched on. The flight crew reported to Tower West that the stop bars were still switched on. Once the stop bars were switched off, the aircraft started to cross the runway at Lima. This was also the time when the flight crew heard over the radio that SAA327 should cancel the takeoff. SAA327 and CAW102 sustained no damage during the incident and no occupants were injured.

Figure 1, shows the path that SAA327 and CAW102 travelled, leading up to the incident.

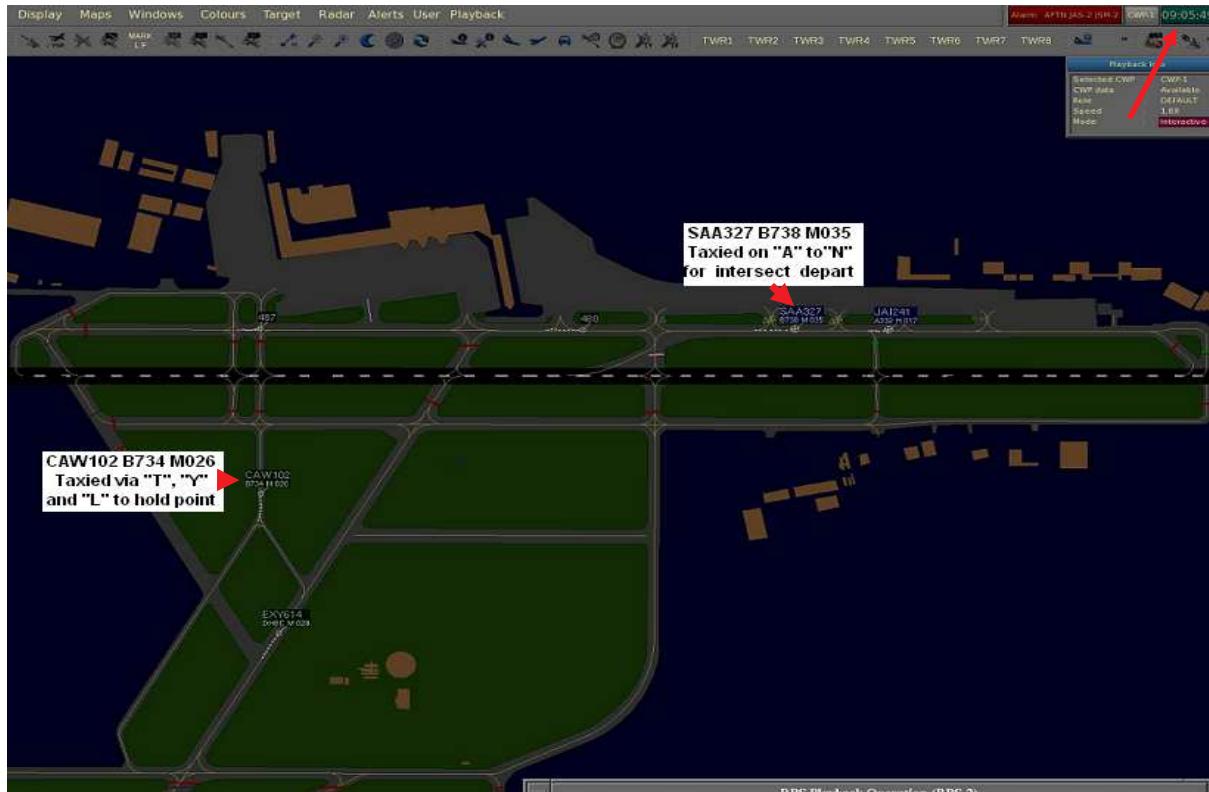
- (i) When SAA327 first made contact with ATC - Tower West; the flight crew were cleared for takeoff even though the aircraft still had to taxi approximately 1400 m before entering Runway 21R.

- (ii) CAW102 was handed over to ATC - Tower West approximately 44 sec after SAA327 was cleared for the takeoff. Tower West instructed the flight crew of CAW102 to stand by approximately 22 sec later. Approximately 1.06 sec after the SAA327 aircraft had been cleared for takeoff, the CAW102 aircraft was then cleared to cross RWY 21R. 23 Seconds after the crossing instruction was given, CAW102 transmitted to ATC – Tower West about the stopbars not being switched off. The ASMGCS system recording also showed that the stopbar was still selected and was indicating a red light. After the CAW102 transmitted, the ATC – Tower West deselected the stopbar showing green. At the time when the stopbar was deselected, SAA327 entered taxiway “November” and crossed the holding point (see figure).

Figure 7, shows ASMGCS image of SAA327 and CAW102.

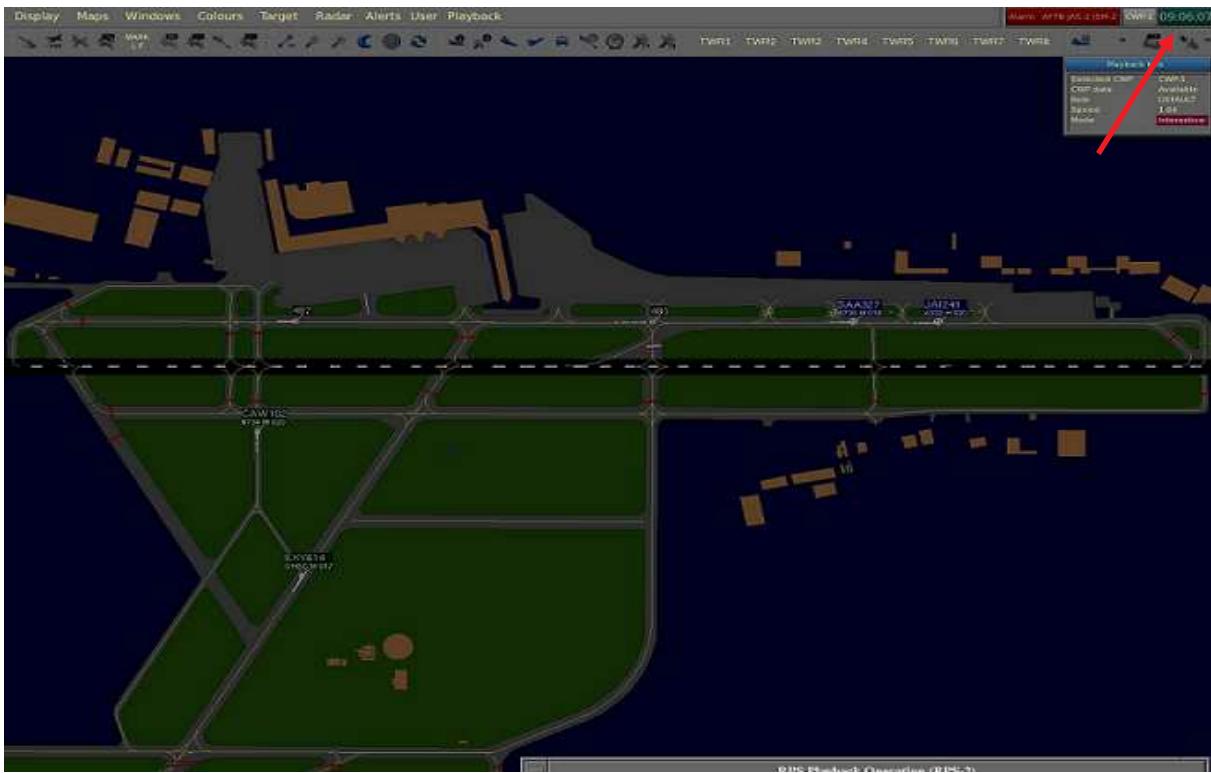
Figure 8, shows ASMGCS image of SAA327 and CAW102.

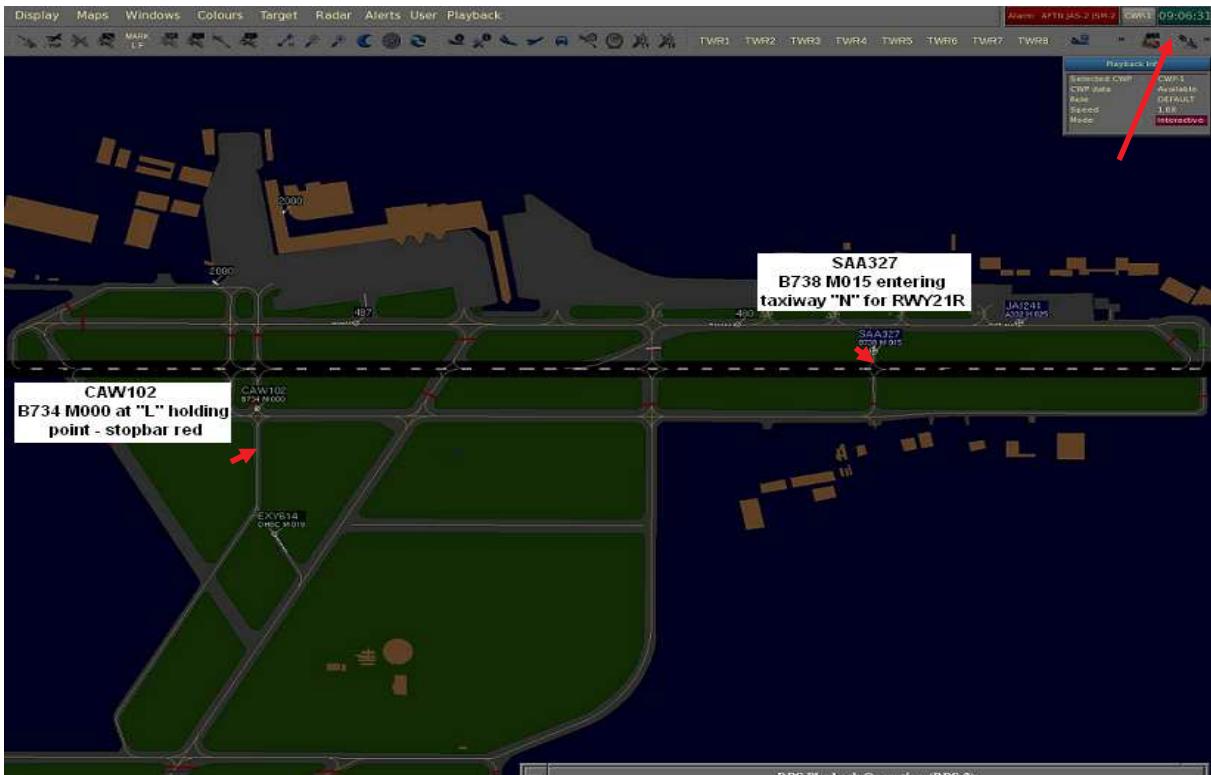
Figure 9, shows ASMGCS image of SAA327 and CAW102.

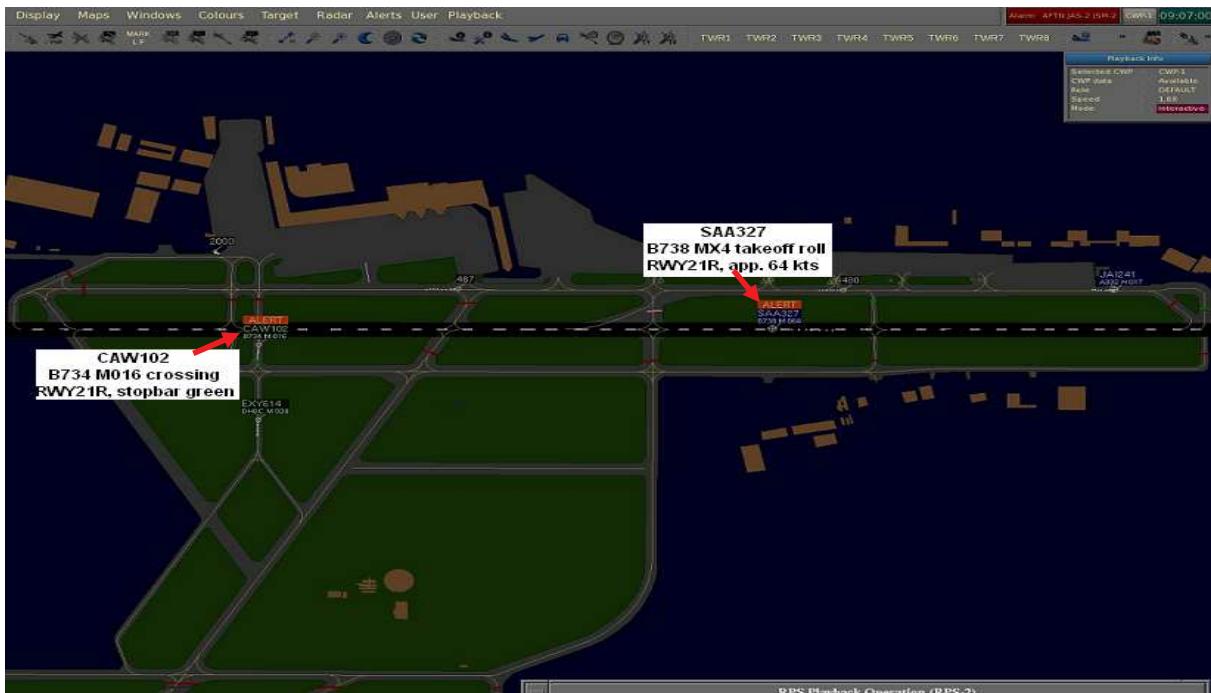
Figure 10, shows ASMGCS image of SAA 327 and CAW 102.

- (iii) There were two aircraft (JAI 241 and SAA547) that taxied in front of SAA 327. The crew of JAI 241 transmitted to ATC at 09:05:27. The Tower West controller instructed the crew to hold short of RWY21R. The aircraft taxied to the end of the runway and held short at the holding point. The crew transmitted again to ATC at 09:06:49, indicating that they were ready for departure. Immediately after ATC had received the transmission of JAI 241, they were reminded that SAA 327 was already on the runway and taking off.
