Investigation Report

Type of Occurrence:	Serious incident
Date:	5 January 2009
Location:	Stuttgart Airport
Aircraft:	Transport aircraft
Manufacturer / Model:	Embraer EMB-145
Injuries to Persons:	No injuries
Damage to Aircraft:	Minor damage to airplane
Other Damage:	Minor damage to the airfield lighting
Source of Information:	Investigation by BFU staff
State File Number:	BFU EX001-09

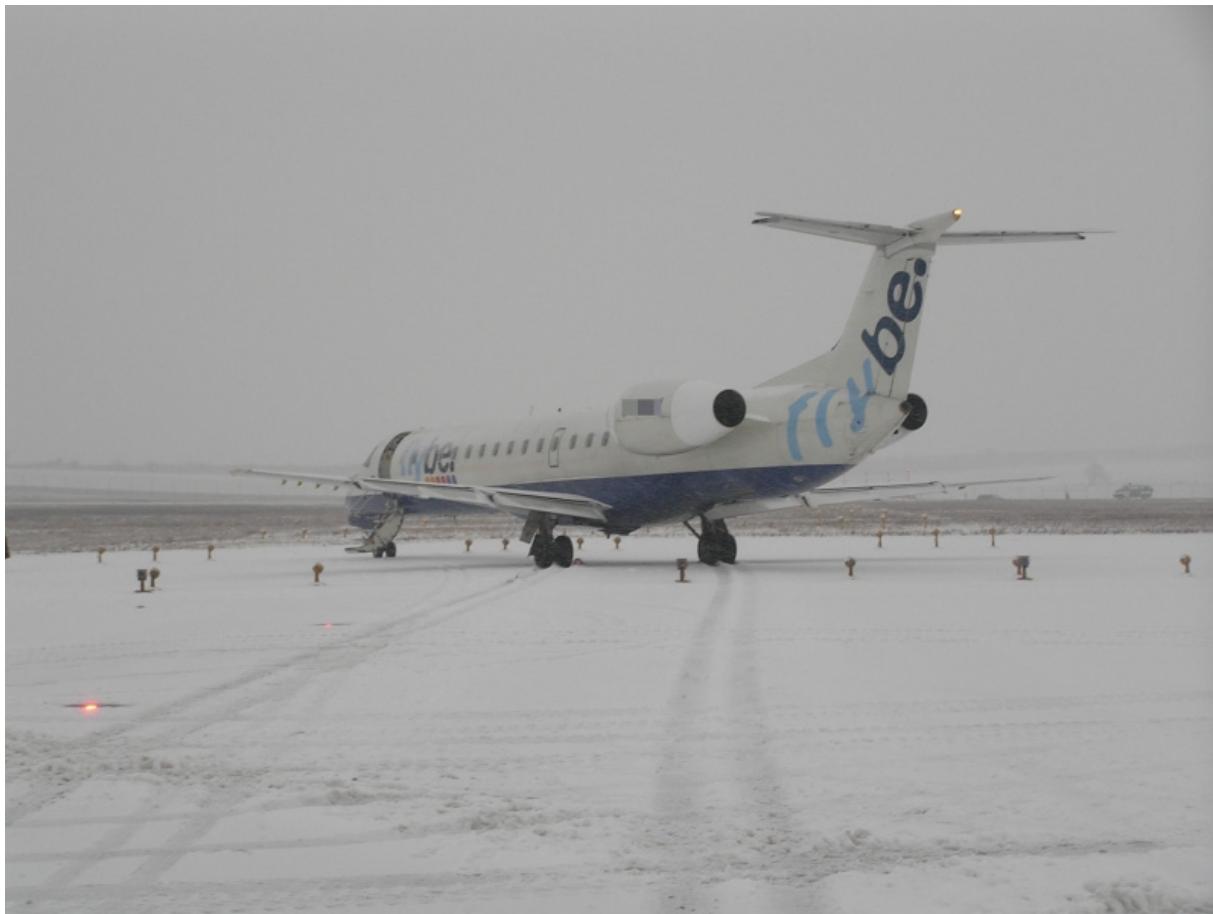
Overview photo towards the end of runway 07

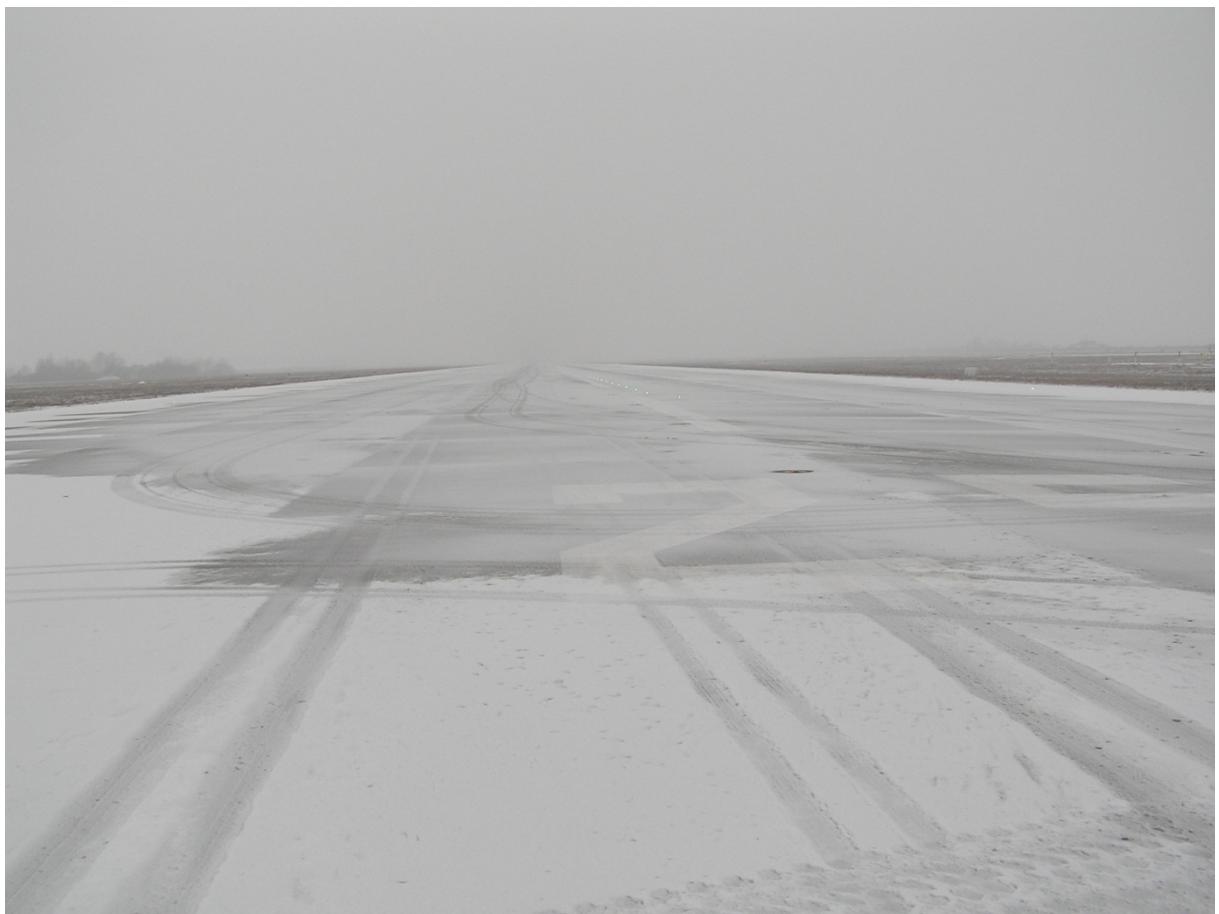
Overview photo towards end of runway 25 at 1612 hrs

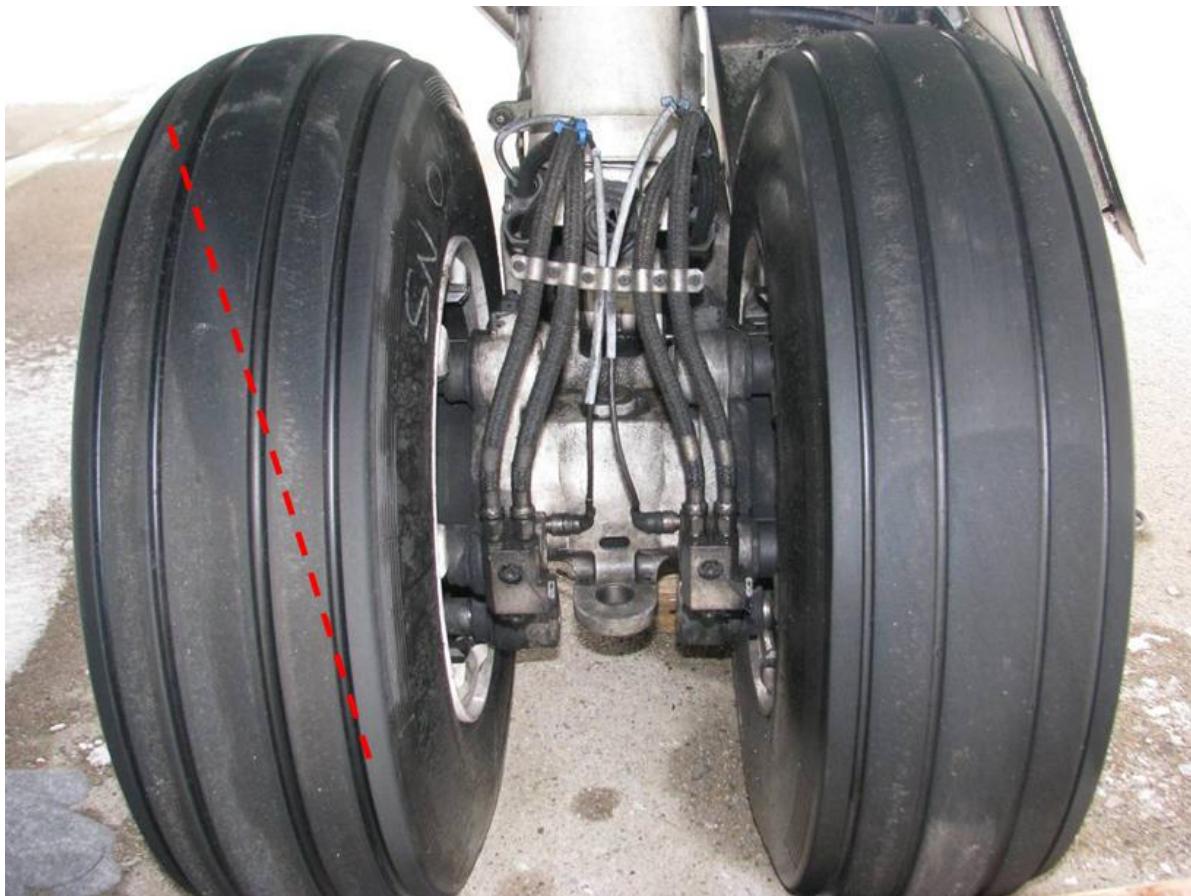
The outer tire of the left main landing gear showed a crack with a length of approx. 30 cm and a depth of 10 mm. All tires of the main landing gear showed skid marks. The marks showed a skidding direction of approximately 25° relative to the longitudinal axis of the aircraft.

Skid marks on the right main landing gear

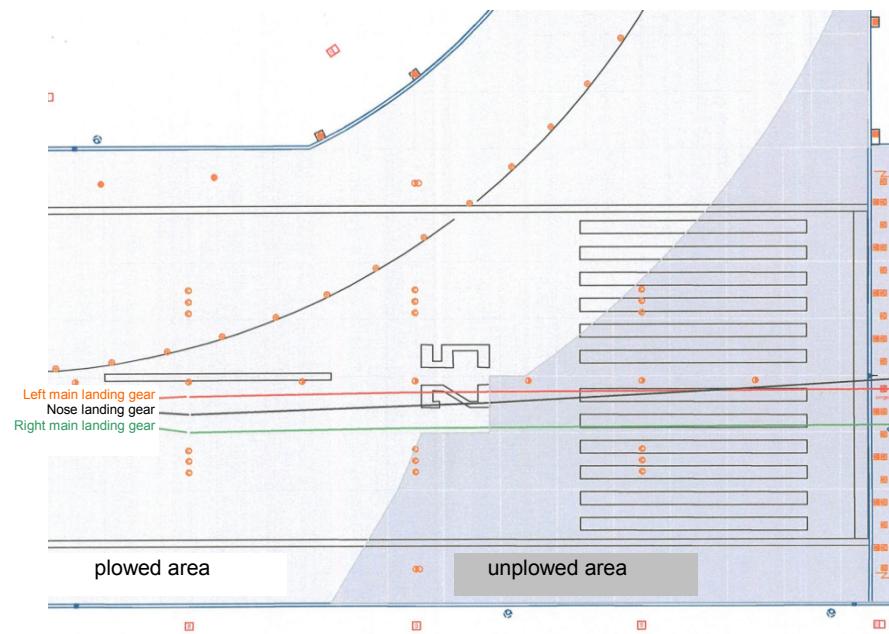
In the rear area of the runway around taxiway A, a semi-circular area of approximately 40 meters had not been completely cleared of snow.

Illustration of the unplowed area at the end of the runway

The Flughafen Stuttgart GmbH should modify the Service Instruction D No. 43 so that the prevailing weather conditions are taken into account when decisions regarding measurement runs are made.

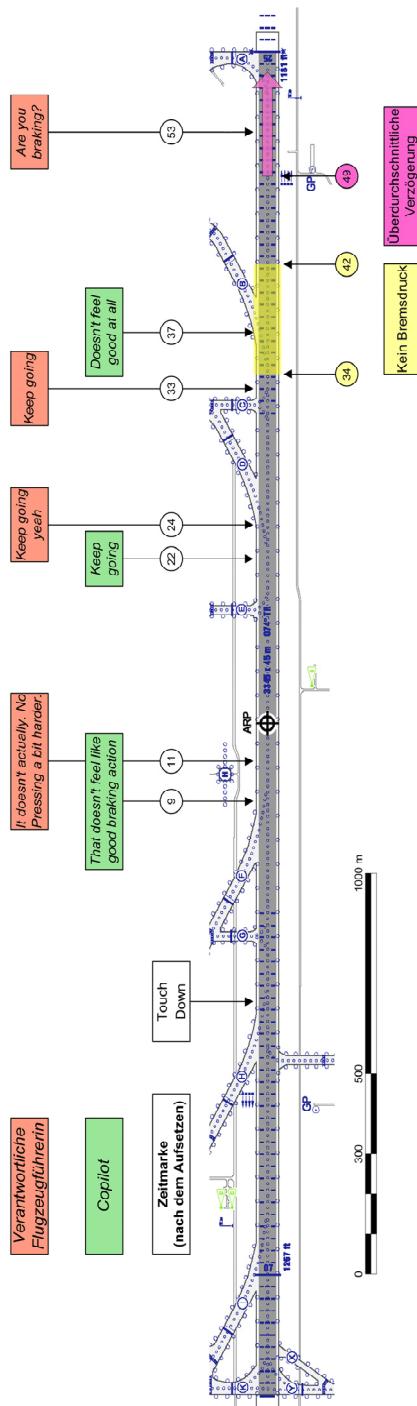
The FDR data showed that the deceleration was approx. -0.1 g in the first section of the landing distance, and later approx. -0.05 g. Approximately 1,600 m behind the touchdown point, brake pressure dropped to zero and the deceleration values decreased accordingly. The brake pressure returned after approx. eight seconds, and

The FDR shows movements of approx. 6° around the vertical axis and opposing inputs to the rudder pedals after the touchdown. This yawing shows that the crew experienced directional control difficulties during landing. An effective use of the brakes was impaired under these conditions. The data show that the oscillations around the vertical axis were minimized initially with reduced and later complete interruption of braking pressure.

Illustration of the crew's comments and selected parameters from the FDR in relation to the position on the runway
(Map: AIP-DFS)
