AO-2010-011: PK-GMG, Runway incursion

Date and time:	24 February 2010, 1609 WST
Location:	Perth aerodrome, Western Australia
Occurrence category:	Incident
Occurrence type:	Runway incursion
Aircraft registration:	PK-GMG
Aircraft manufacturer and model:	Boeing Company 737-800
Type of operation:	Air transport - high capacity
Persons on board:	Crew – 8 Passengers – 119
Injuries:	Crew – Nil Passengers – Nil
Damage to aircraft:	Nil

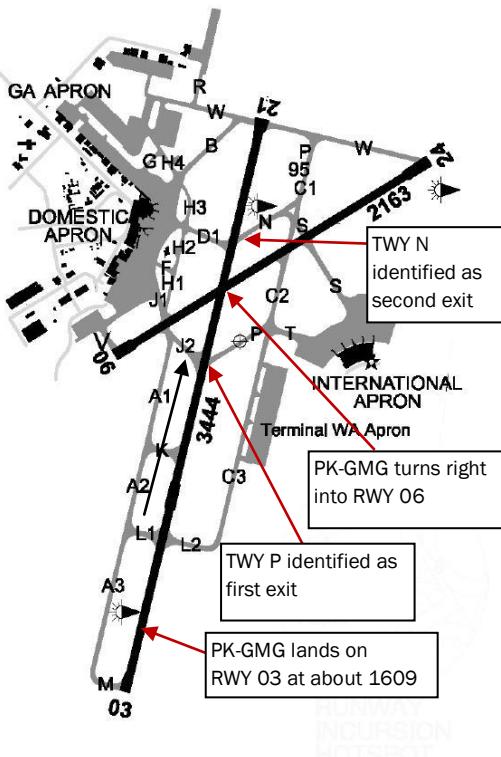
Figure 1: Perth aerodrome

The crew stated that they had discussed the probable taxi route during their approach to landing briefing. They had determined that taxiway P was the first exit and taxiway N as the second exit off runway 03 (Figure 1).

The crew reported that they had confirmed these instructions. A few moments later, the aircraft was turned right onto runway 06, which lies between taxiways P and N. The crew were then given instructions by Perth ATC to expedite their exit from runway 06 via taxiway S. The crew confirmed and complied, taxiing the aircraft without further incident to its parking stand.
