Investigation Report

Type of Occurrence:	Serious incident
Date:	13 December 2011
Location:	Frankfurt/Main
Type of aircraft:	<ul style="list-style-type: none">1) Airplane2) Airplane
Manufacturer / Model:	<ul style="list-style-type: none">1) Airbus / A380-8002) Airbus / A320-214
Injuries to Persons:	None
Damage:	None
Other Damage:	None
Information Source:	Investigation by BFU
State File Number:	BFU 5X013-11

One day after the occurrence, the German Federal Bureau of Aircraft Accident Investigation (BFU) was advised by the air traffic service provider that at 1426 hrs¹ on 13 December 2011 an Airbus A320-214 (A320) taking-off from runway 25C of Frankfurt/Main Airport suffered an air proximity with an Airbus A380-800 (A380) which had aborted the landing on runway 25L and conducted a missed approach. According to the radar data the closest proximity was 0.97 Nautical Miles (NM) horizontally and approximately 200 ft vertically, respectively. The minima for the separation of aircraft were 7 NM horizontally and 1,000 ft vertically. The BFU classified the occurrence as a serious incident and initiated an investigation.

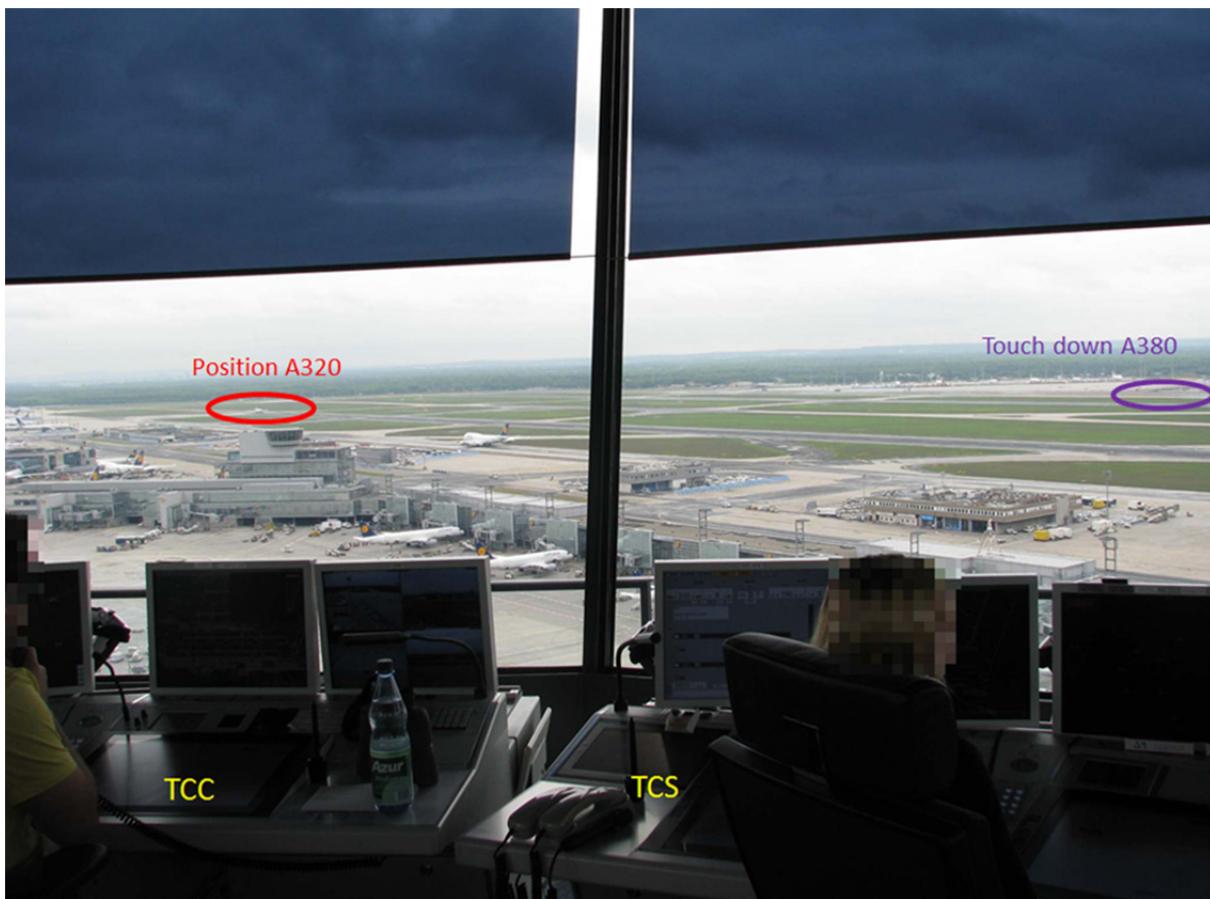
Substantial changes, also concerning air traffic control services, became effective once the north-west runway (07L/25R) was put into operation. Up to four controllers were working in the Tower Frankfurt. The flight operations on runways 07C/25C and 07R/25L were handled by one controller each on different frequencies.

Controllers' working positions TCC (left) and TCS (right)

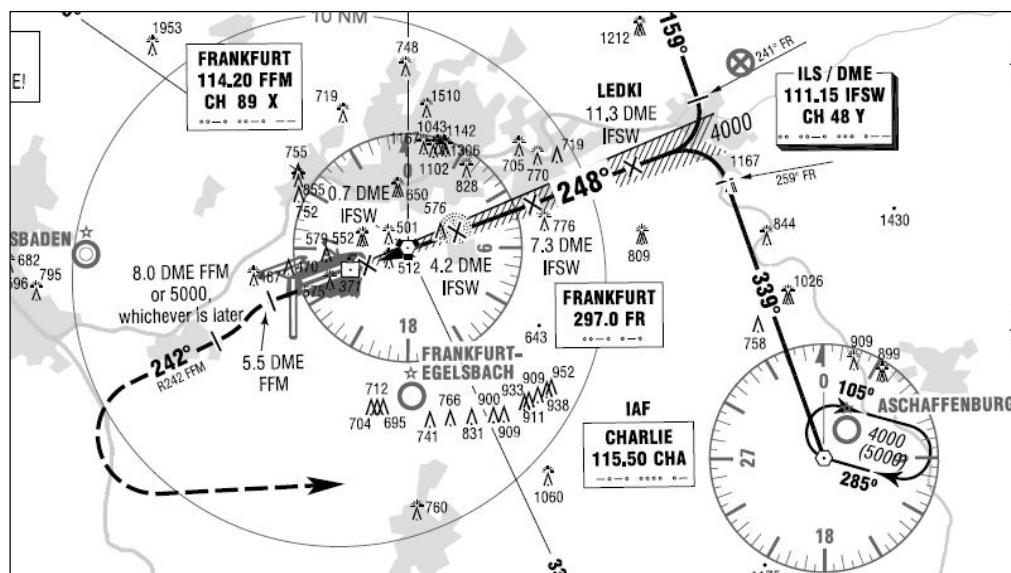
The standard missed approach procedure for the ILS approach to runway 25L stipulated: climb straight ahead to 5.5 NM to DVORTAC FFM; left-hand turn, intercept radial 242 FFM to 8.0 NM DME FFM 5,000 ft AMSL, whichever is later, left-hand turn to CHA VOR, maintain 5,000 ft.

Excerpt standard missed approach procedure runway 25L

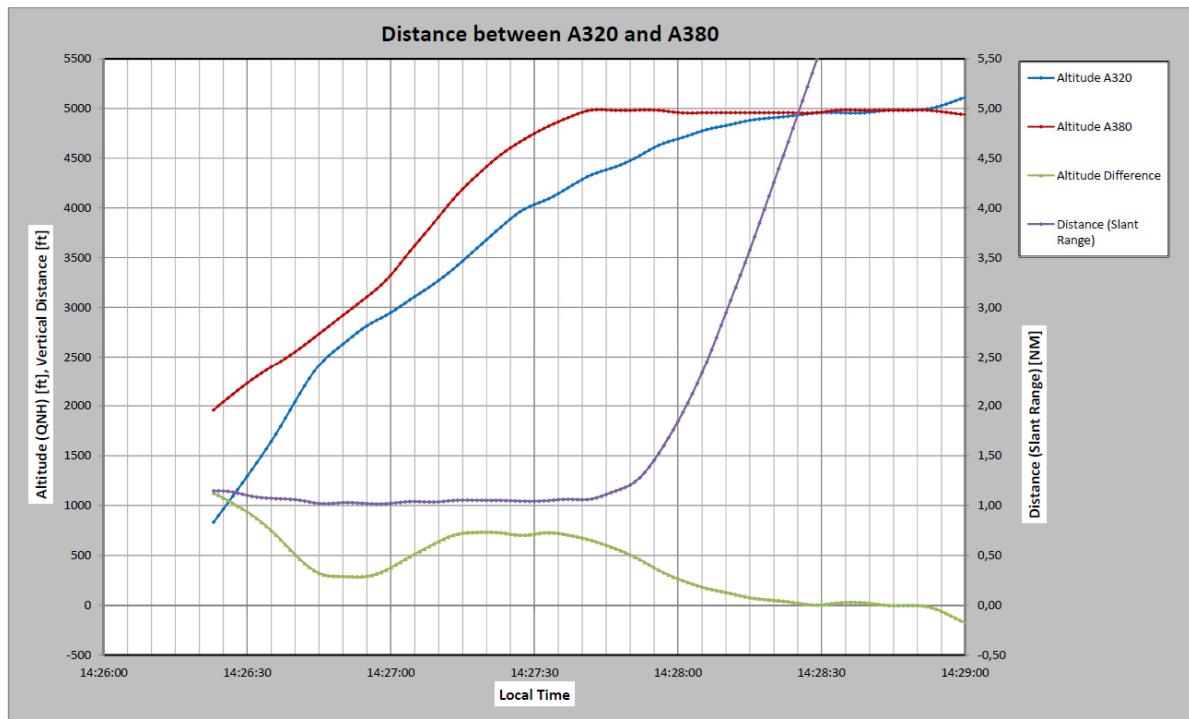
Both airplanes were in climb on almost parallel headings. The radar data showed that the A320 was behind and to the right of the A380 when at 1426:53 hrs the air proximity occurred with a horizontal distance of 0.97 NM and a vertical distance of about 200 ft.

For illustration purposes the vertical and lateral distances resulting from the position and altitude indications of the radar recordings of both aircraft were depicted in a graph.

Distance between aircraft

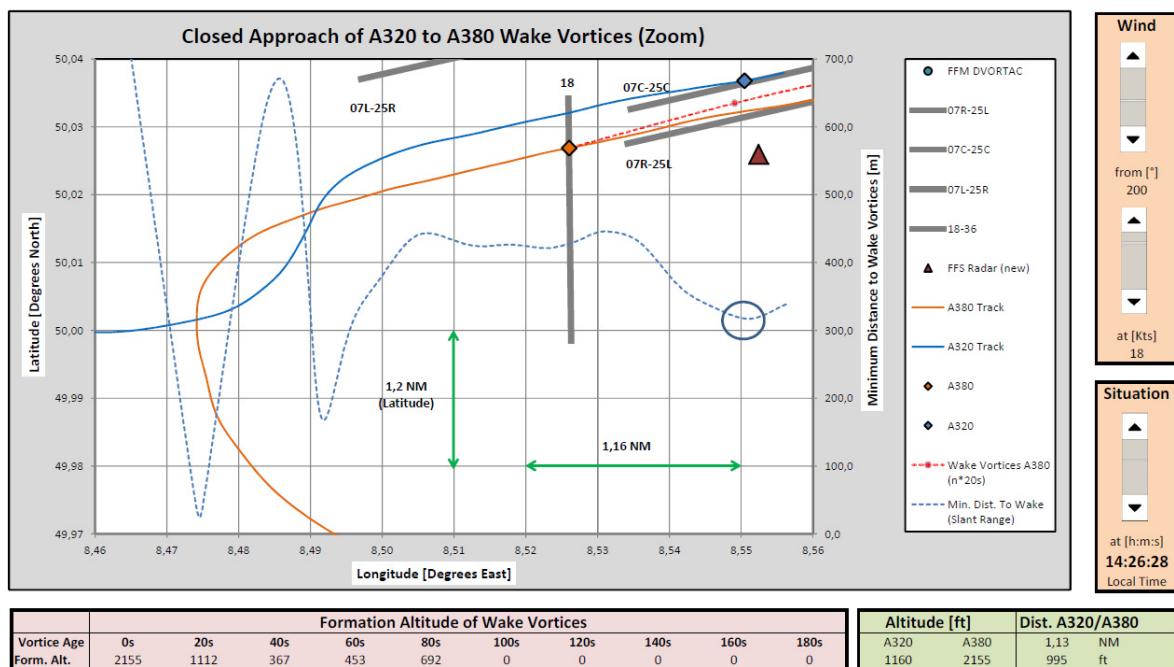
Situation at 1426:28 hrs

As the A380 passed the threshold of runway 18 at 1426:28 hrs the distance between the A380's wake vortices and the A320 was about 320 m.

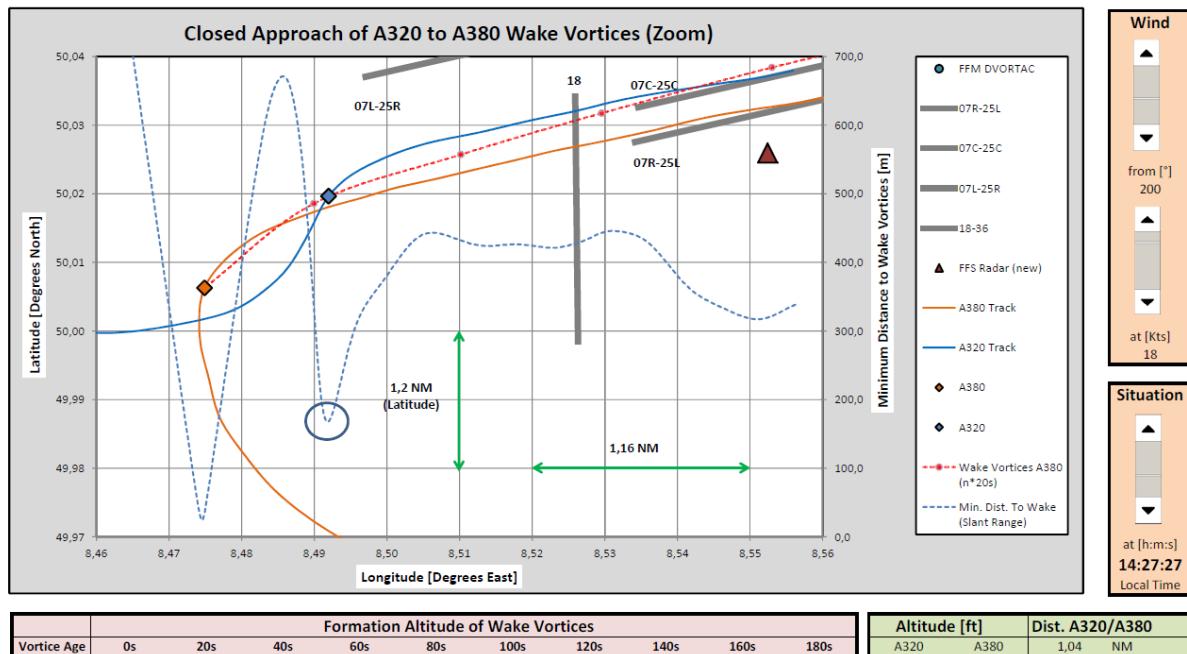
Situation at 1427:27 hrs

At 1427:27 hrs as both airplanes had begun to turn south the distance of the A320 to the wake vortices of the A380 decreased to about 180 m.

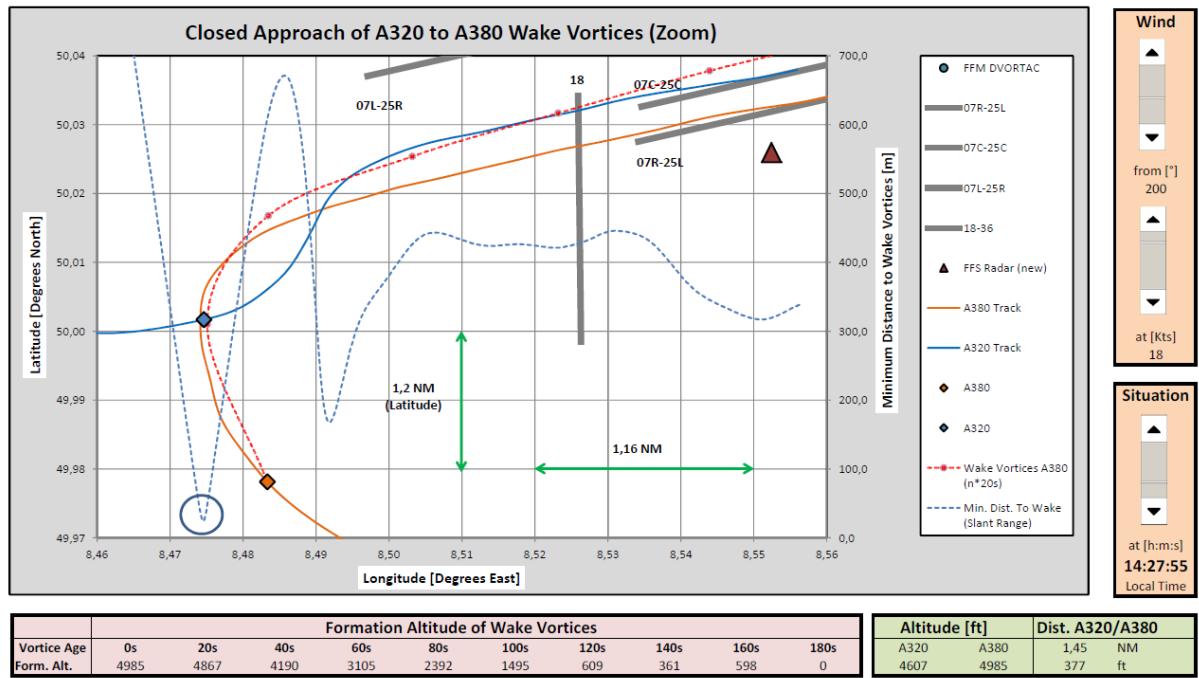
Situation at 1427:55 hrs

At 1427:55 hrs as the A320 was turning right in western direction the distance to the wake vortices was about 30 m.
