AIR ACCIDENT INVESTIGATION SECTOR

SERIOUS INCIDENT INVESTIGATION REPORT

Runway Misalignment

A6-EYE

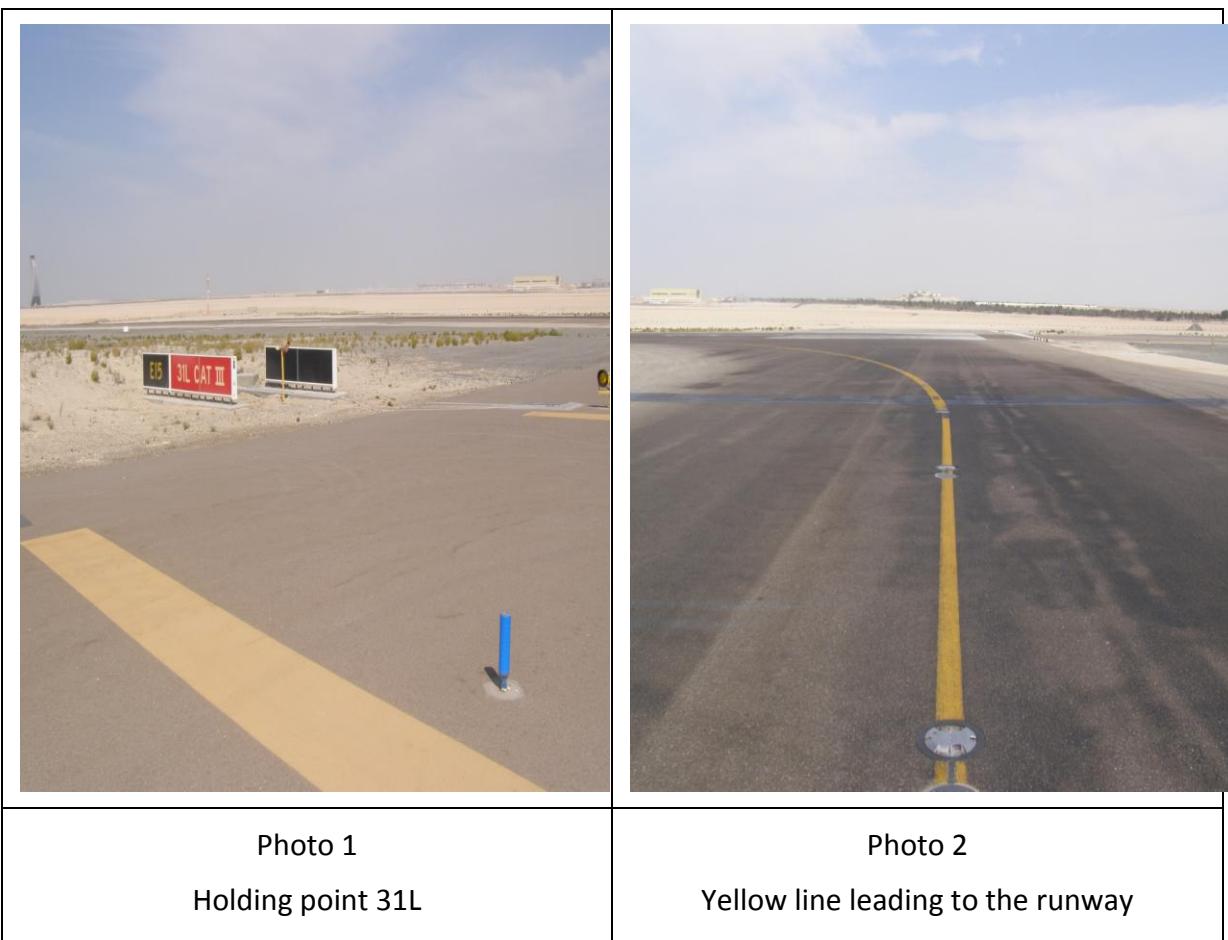
Following an uneventful start of the engines and taxi, the aircraft reached the holding point of runway 31L, which is the southern runway (see photo 1), during which time the crew was informed of the limited visibility but acceptable for the Operator's take off operating minimums. Following a brief communication of the crew with the Air Traffic Control Tower regarding the stop bar, the lights (indicating the runway ahead) were extinguished to allow the aircraft to proceed into the active runway. The crew taxied the aircraft towards the active runway following the yellow line leading towards runway 31L (see photo 2).

This yellow line is normally illuminated by 30 green lights and it was measured to be approximately 222 meters long, leading the aircraft to the centre line of the runway from the red stop bar.

The crew members involved in the event stated, after the occurrence, that shortly after passing the stop bar they could not see the green leading taxi centerline lights located on the yellow line.

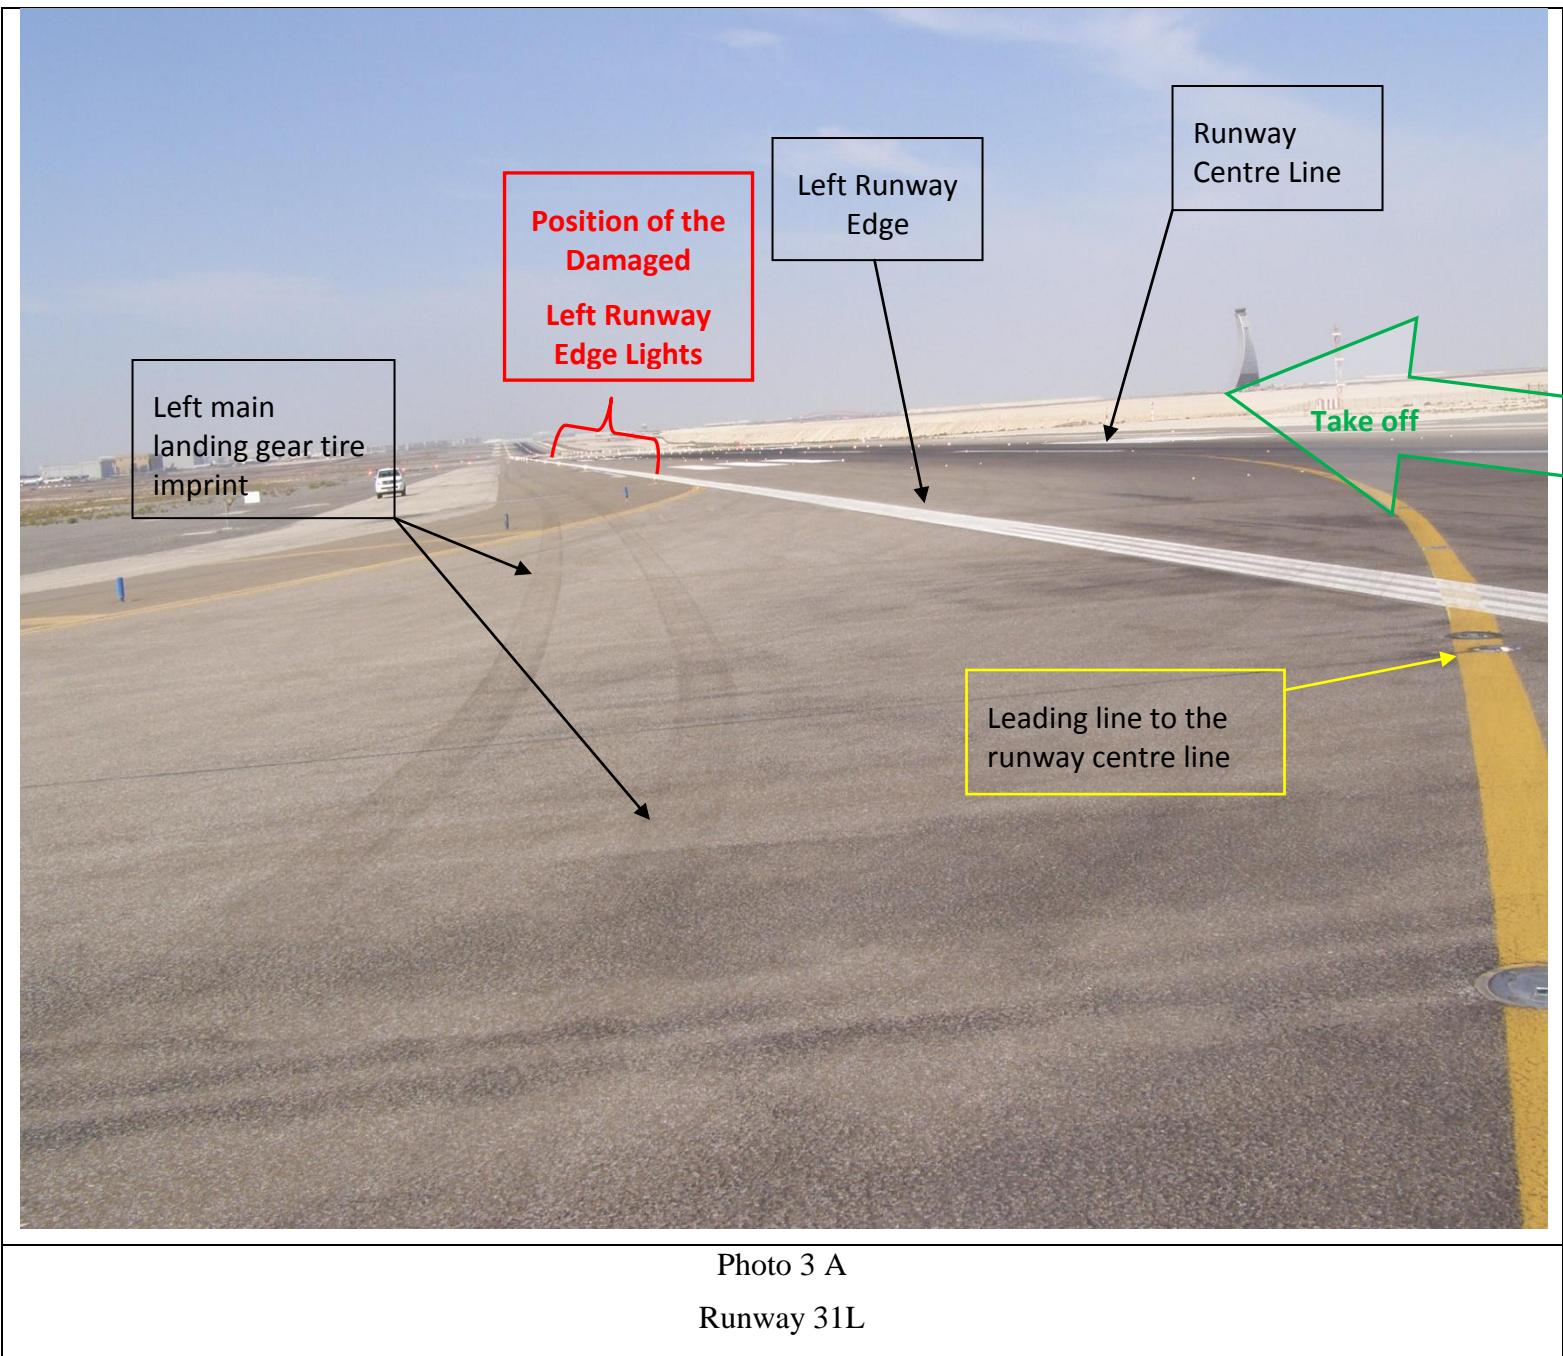
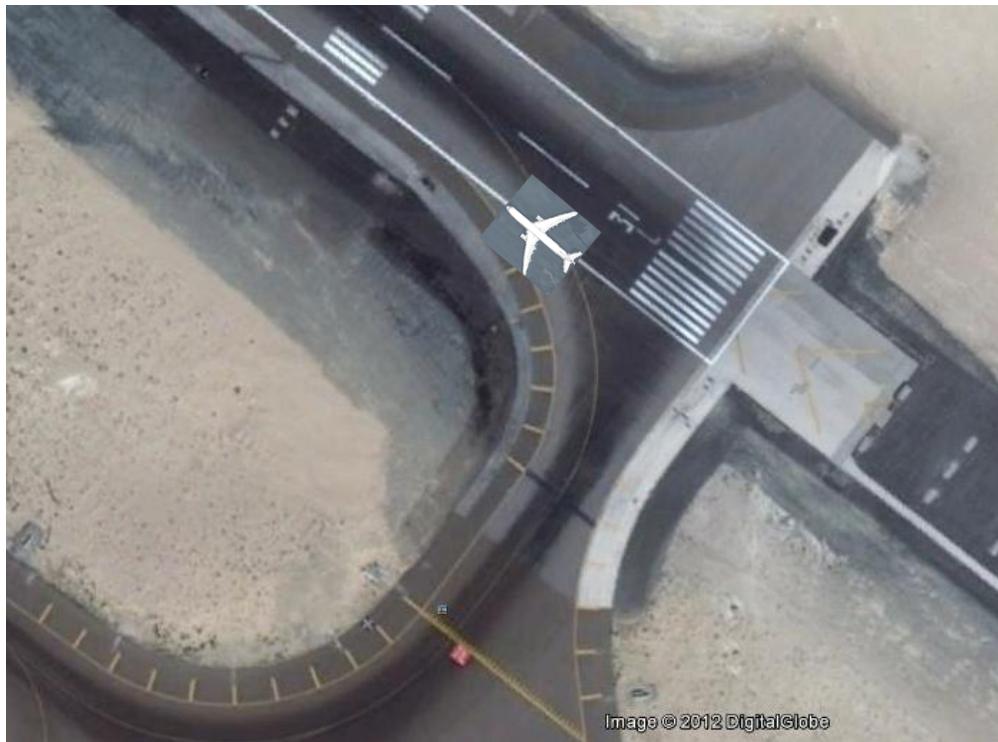
Photo 3B – Aircraft Line-up Position

Then the occurrence aircraft after travelling for approximately 157 meters on this yellow leading line, turned left away from the yellow line and the nose gear was positioned, to be over the left runway edge white line, instead of the runway centre line (see photos 3A and 3B).

Shortly after, the take off run was initiated, with the aircraft's nose gear continued being over the left runway edge, passing over 11 runway edge lights, which were destroyed, while the left main landing gear was approximately 4.9 meters left of the runway edge.

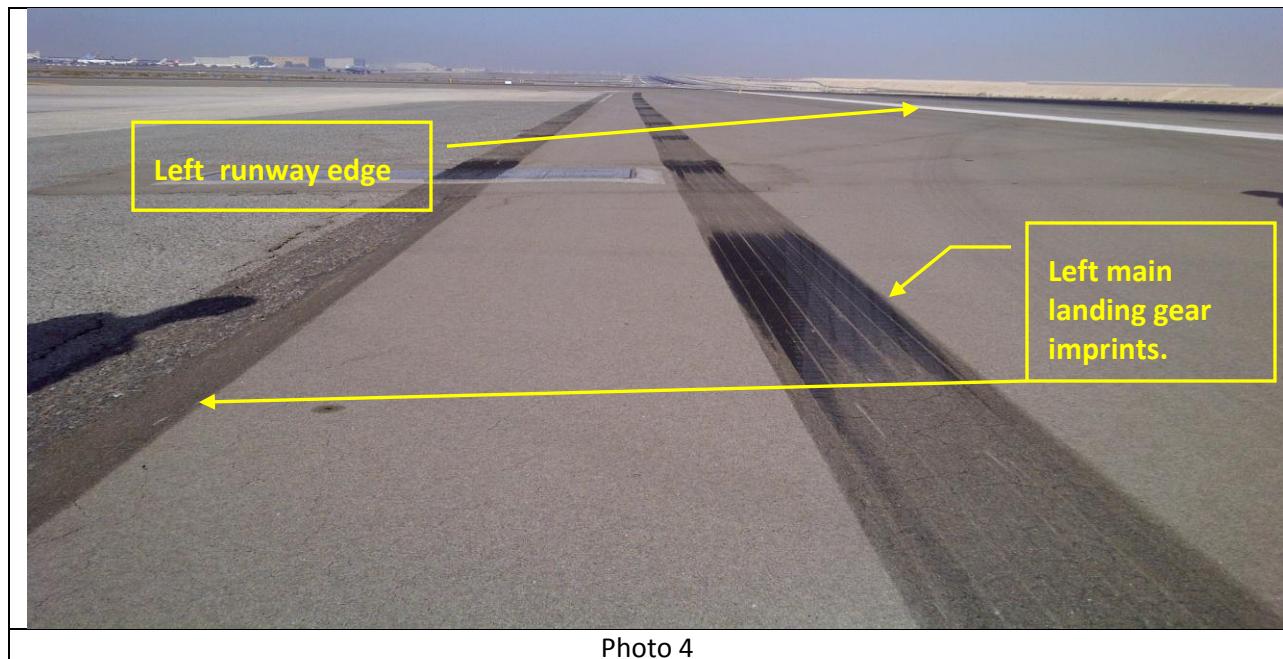
Photo 4

The crew stated that during the takeoff roll the interval of travelling over the lights to be unfamiliar and the intensity of the thumps to be more intense.

Due to this the take-off was rejected, with the maximum indicated airspeed reached 83 knots, as per the flight recorder data (see Appendix 1). After stopping for approximately 2 minutes, the pilots taxied the aircraft back to the runway centerline in order to vacate the runway. While taxiing on the centerline, the crew received the ECAM message, "TIRE LO PR" as the left hand nose wheel had punctured due to the impact with the runway edge lights. The pilots then stopped the aircraft on the centerline, from where they requested towing assistance back to the terminal building.

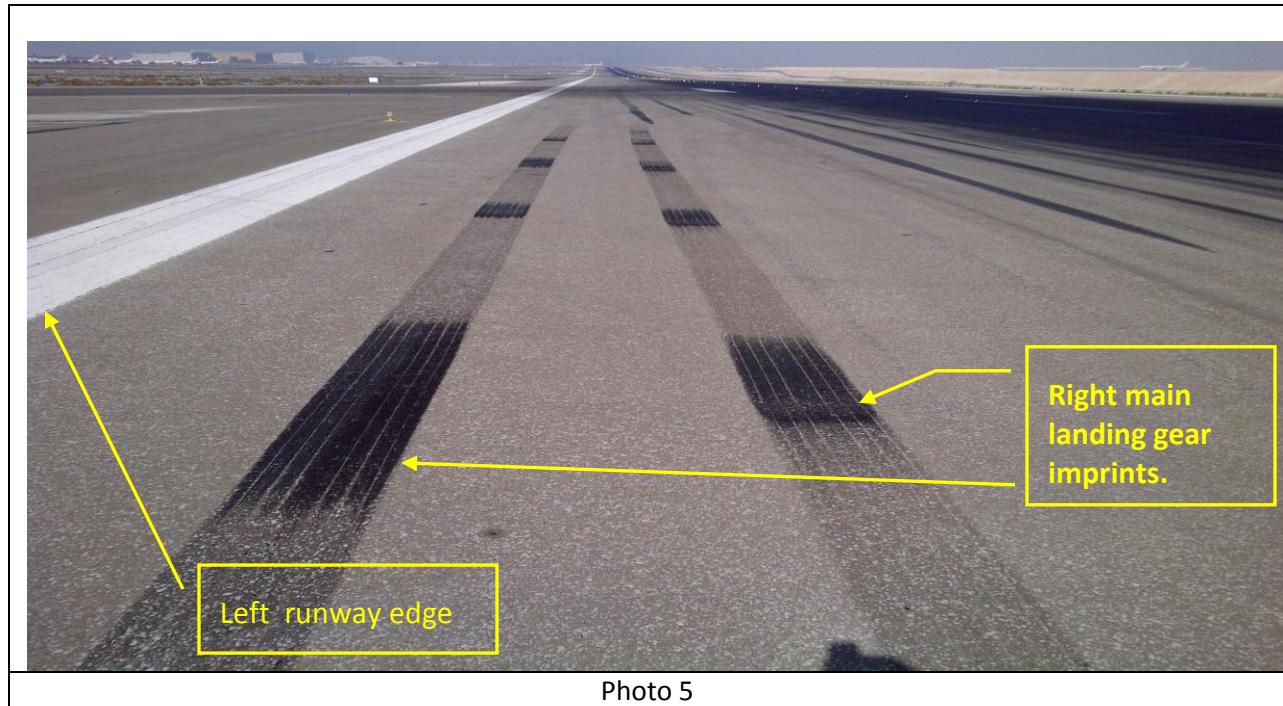
Photo 5

During the event, the left hand nose wheel was punctured and replaced. Seven main wheels were found with glass pieces embedded in the wheels and required replacement. The right hand nose wheel was also replaced due to the load placed on it.

Eleven runway Edge lights were damaged and replaced.

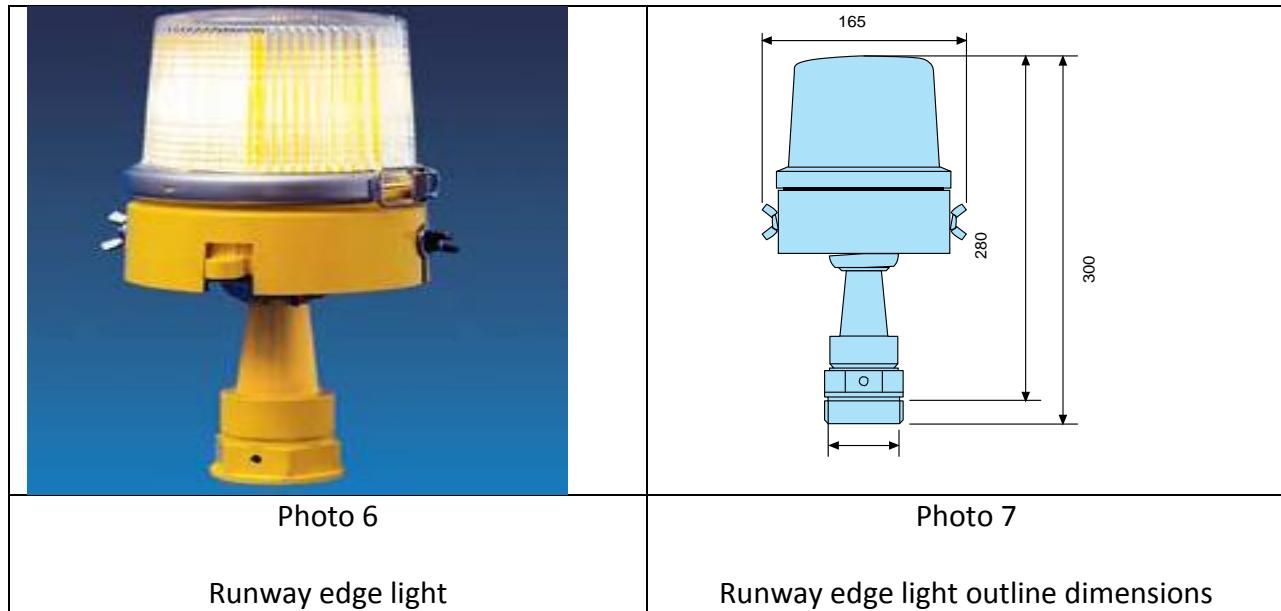
Runway 31L has an ICAO CAT II/III precision approach lighting system 900 M CL strobe and Flashing RTIL. The Runway centre line lighting is bi - directional with 15 meters spacing, Colour coded with first 3200 M white, next 600 M ALTN white / red, last 300 M red LIH. The runway edge lighting is bi - directional with LIL omni - directional component white LIH. The Runway Edge lights are High Intensity Bidirectional Elevated Lights (see photos 6 & 7)
