AAIS Case Reference: 06/2012

SERIOUS INCIDENT INVESTIGATION REPORT

Runway Incursion

Dubai International Airport
United Arab Emirates
20th March 2012

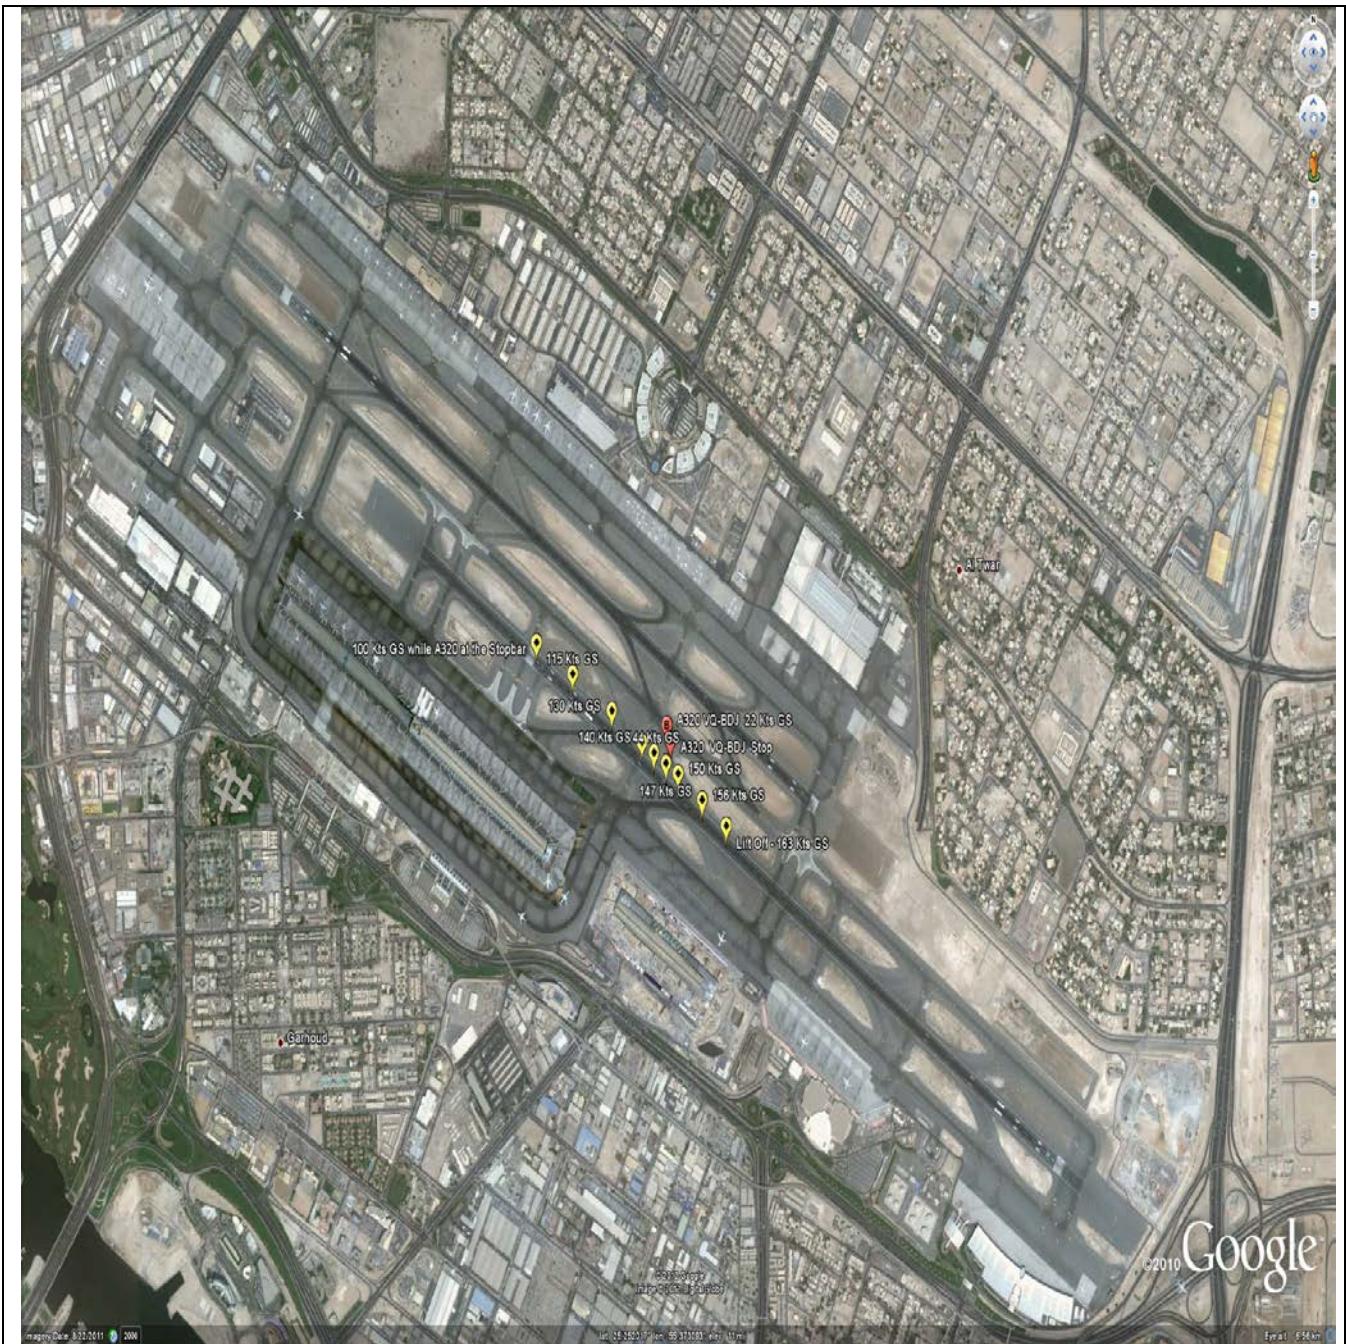
Image 1

Dubai International Airport

Dubai International Airport (see image 1) has two parallel runways and taxiways have respective signs. (see photos 1, 2 and 3 which were taken a day after the occurrence. At the time the photographs were taken the visibility was reported as 3000m).

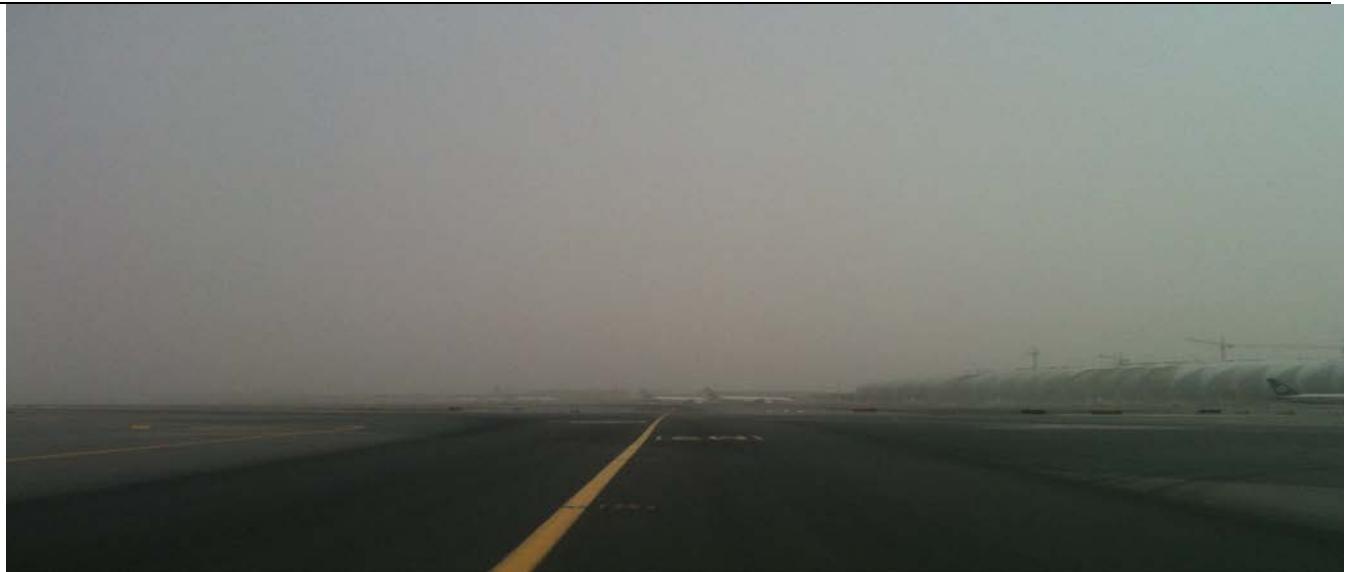
Photo 1

View of taxiway M9 after vacating runway 12L

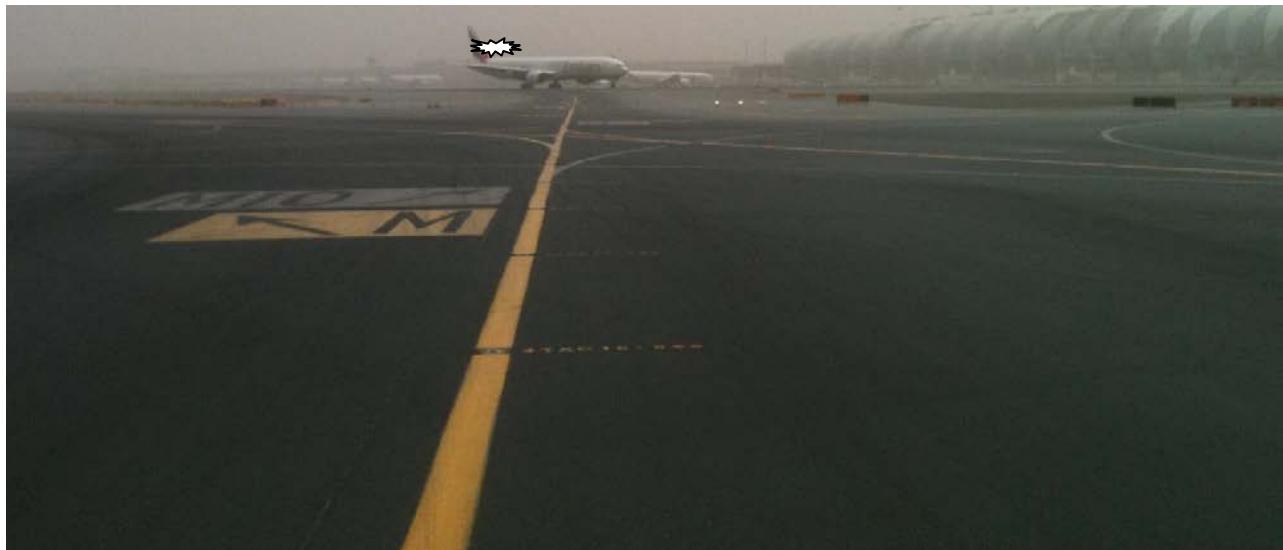
Photo 2

View of taxiway Mike

The red and yellow board on the yellow center line was erected after the occurrence

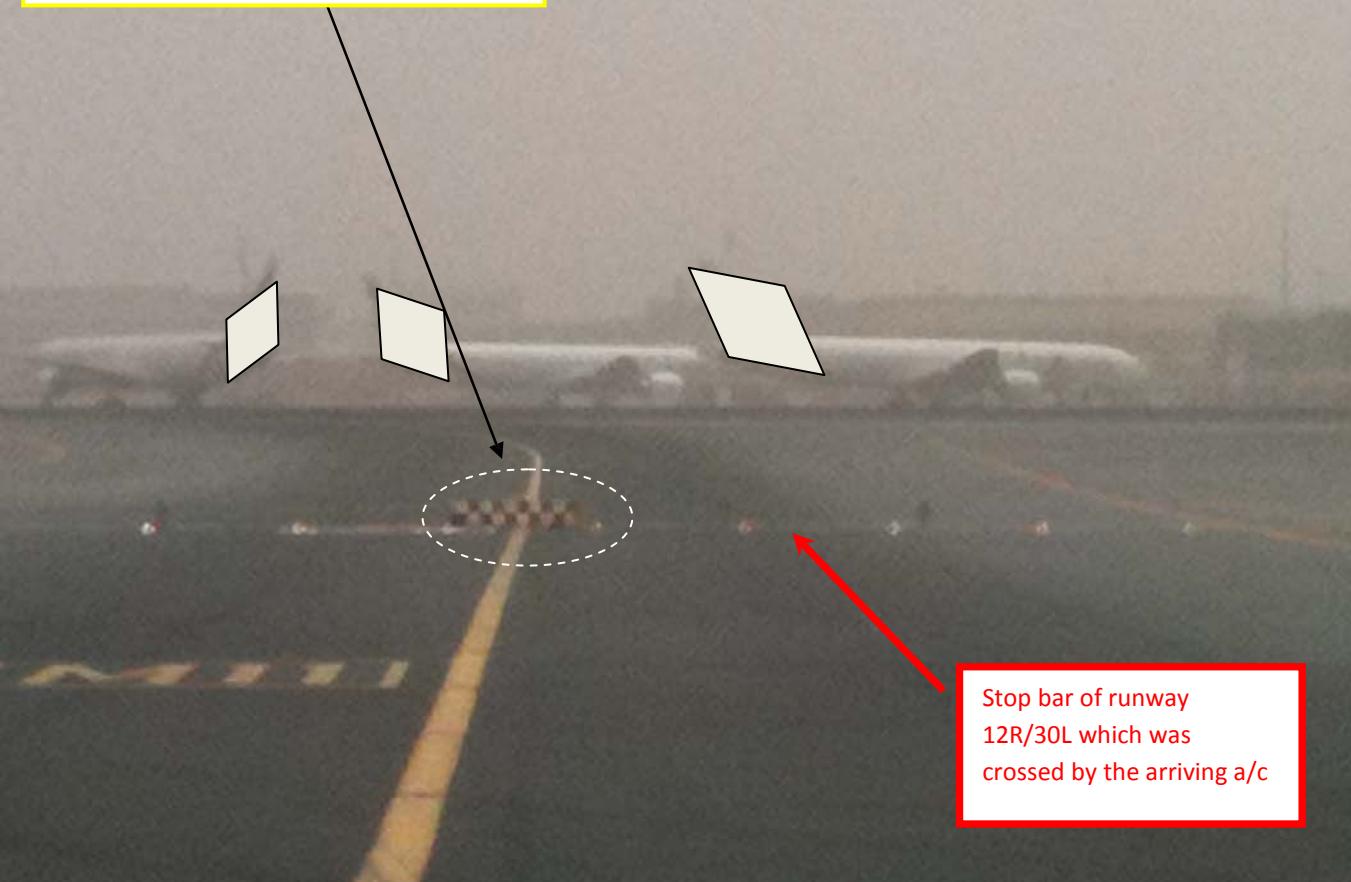
Photo 3

View of taxiway M11

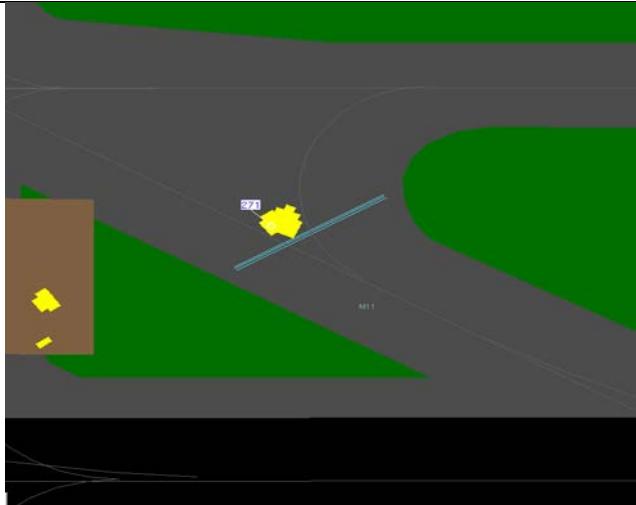
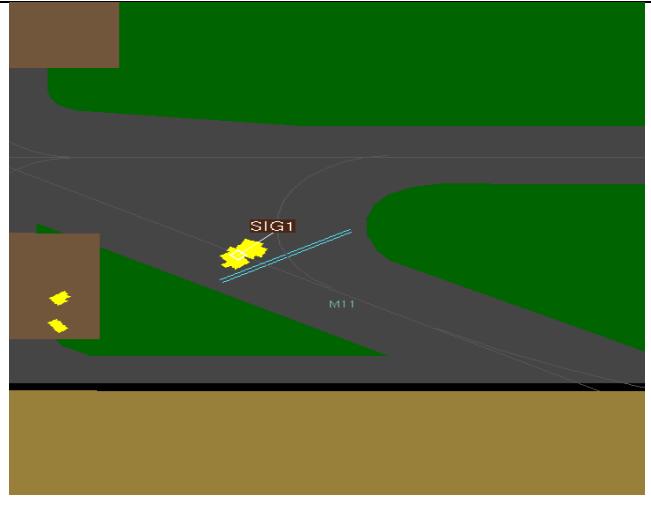
Image 3 Stop Bar accuracy check	Image 4 Stop Bar accuracy check (detail)

Stop bar accuracy checks were carried out on January 18th 2012 (see images 3 &4), following identification of possible inaccuracies with respect to the map displayed on the Ground Movements Radar. Subsequently an additional check was carried out for M11, with identical results, on the 20th March. These checks confirmed that the position of the stop bar on the map was accurate.
