NATIONAL TRANSPORTATION SAFETY BOARD

AIRCRAFT ACCIDENT REPORT

AIR FLORIDA, INC.
BOEING 737-222, N62AF
COLLISION WITH 14TH STREET BRIDGE,
NEAR WASHINGTON NATIONAL AIRPORT
WASHINGTON, D.C.
JANUARY 13, 1982

NTSB-AAR-82-8

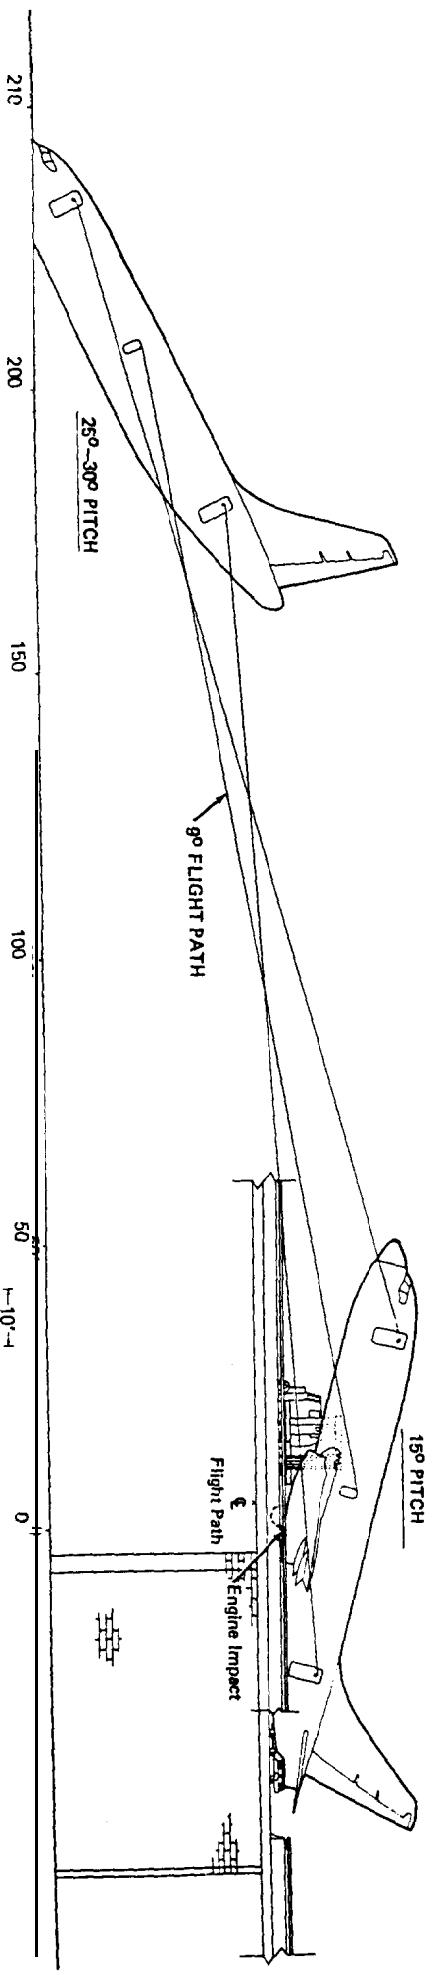
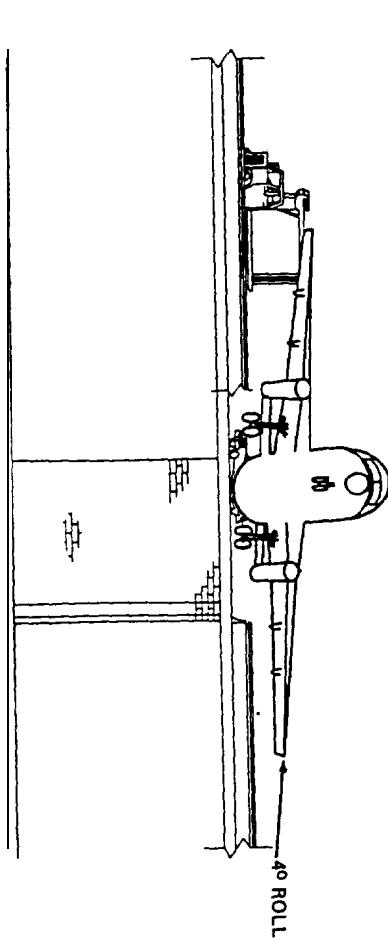
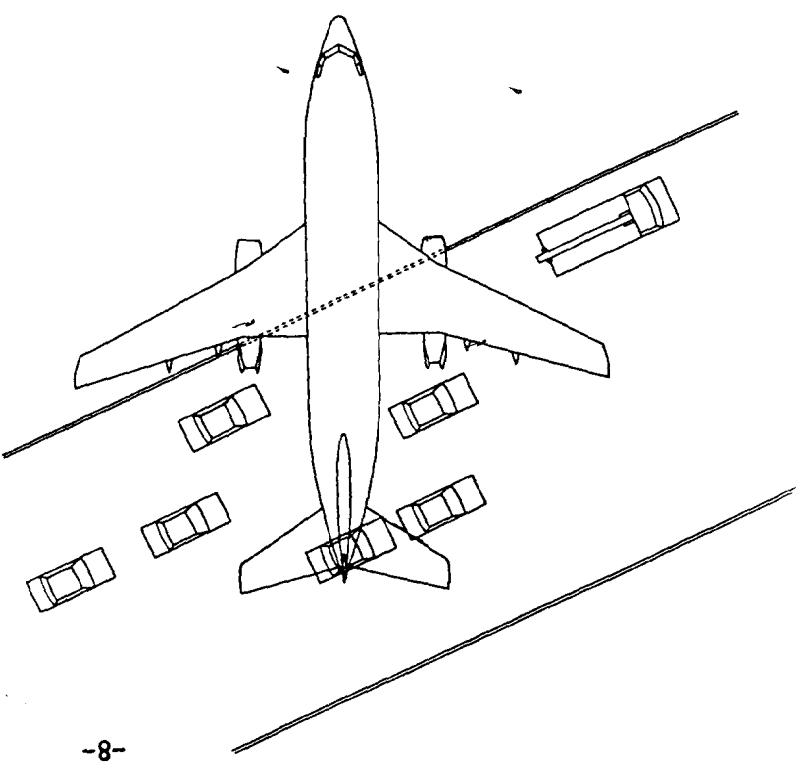
Figure 2. -- Aircraft Impact Attitude.

As the aircraft descended, the right wing was structurally damaged when it hit the boom truck, and shortly thereafter, the aircraft struck the steel barrier and railing on the west side of the 14th Street Bridge at an elevation of about 37 feet mean sea level. Fragments of the right wing remained on the bridge. The remainder of the wreckage sank in the Potomac River in about 25 to 30 feet of water. The wreckage area was confined to the south side of the river between the 14th Street Bridge and the Center Highway Bridge of the George Mason Memorial Bridge. (See figure 4.)

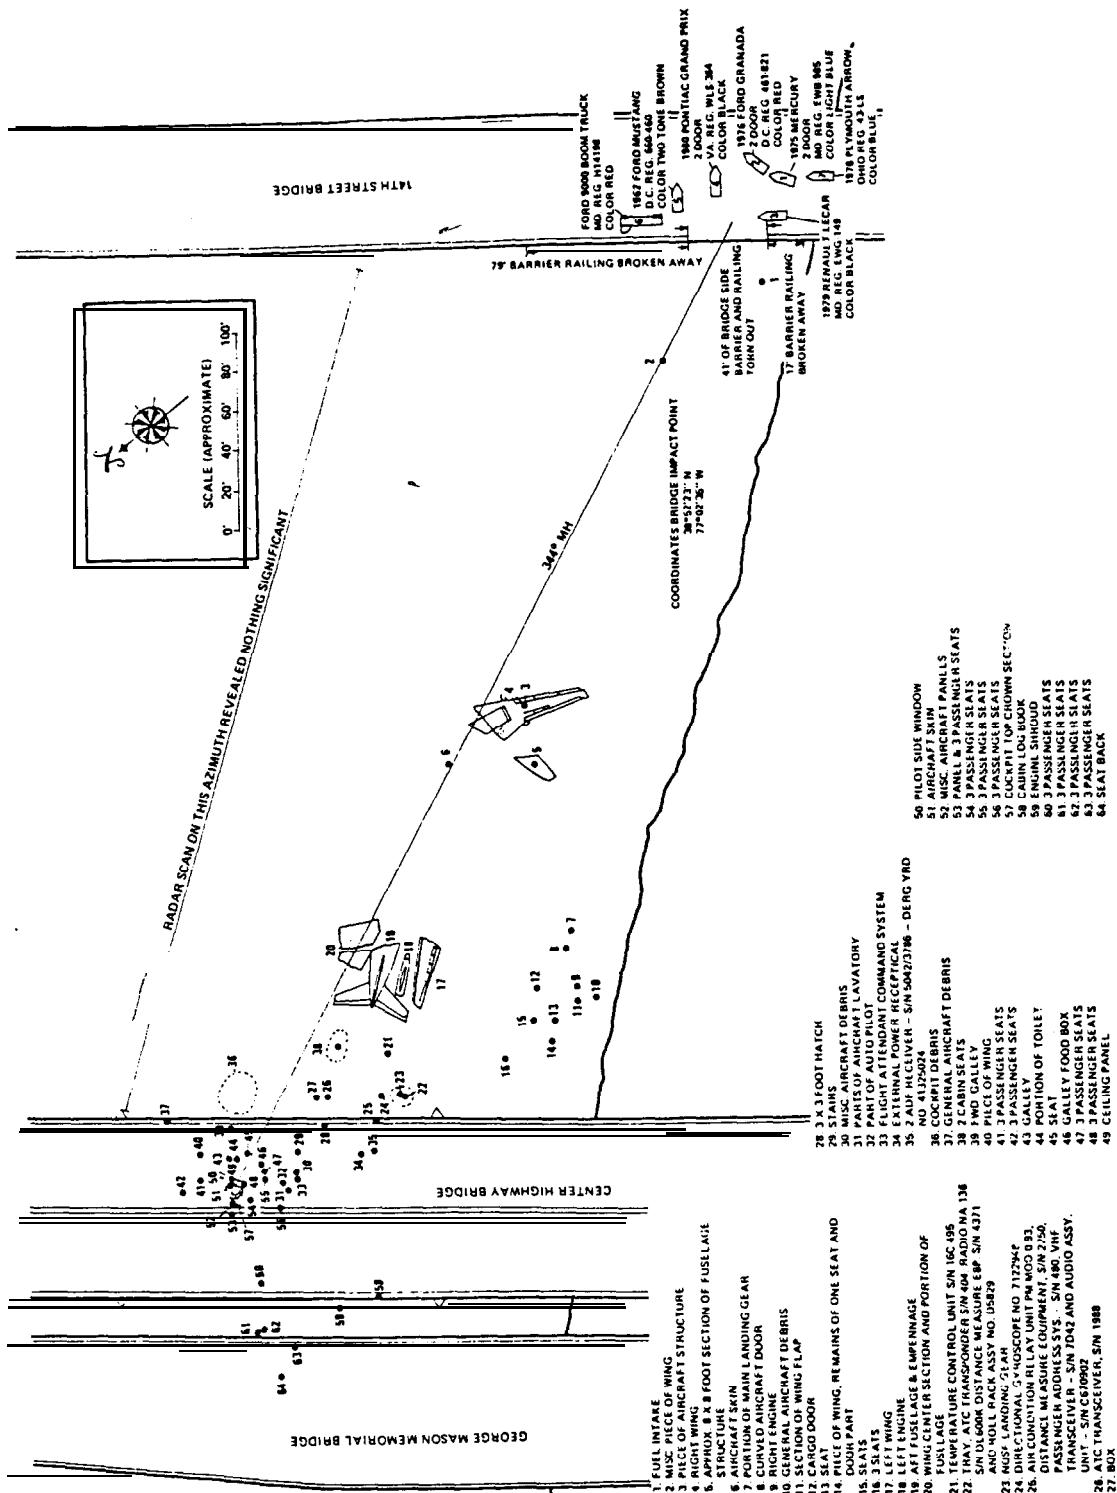
Figure 4. -- Position of Wreckage in the Water.

After initial impact, the aircraft broke into several major pieces. The fuselage broke into four major pieces which included: (1) nose section with cockpit; (2) fuselage section between nose section and wing center section; (3) fuselage-to-wing intersection; and (4) aft body structure with empennage attached. The wing structure was separated into three major pieces which included: (1) left wing outboard of the No. 1 engine, including all associated flight control surfaces; (2) wing center section, lower surface, including wing lower surface stubs between the No. 1 engine mounts and the No. 2 engine mounts; and (3) right wing outboard of the No. 2 engine with the outboard 20 feet mostly disintegrated. The left main landing gear was separated from the wing, and the right main gear remained attached except for the wheels and oleo piston. The nose landing gear and its attaching structure were separated from the nose section. Both engines and their pylon structures were separated from the wings. There was no evidence of fire on any of the recovered structure.

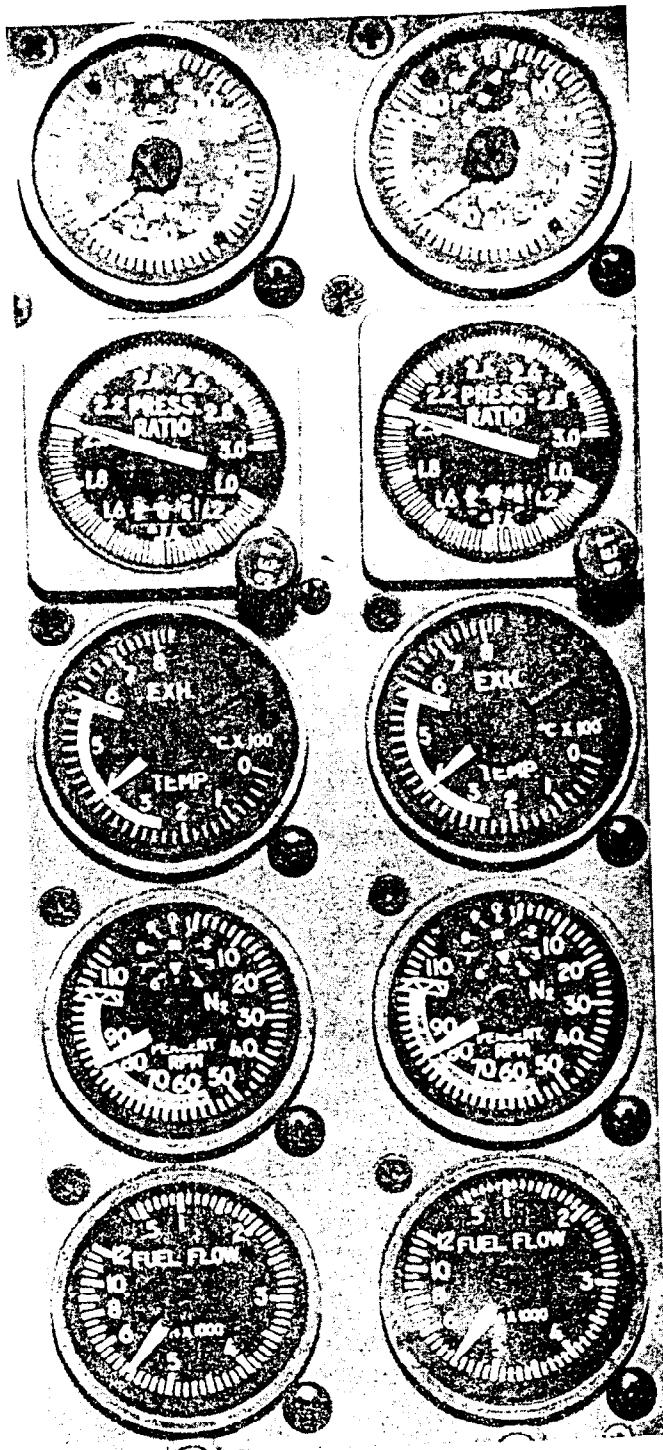
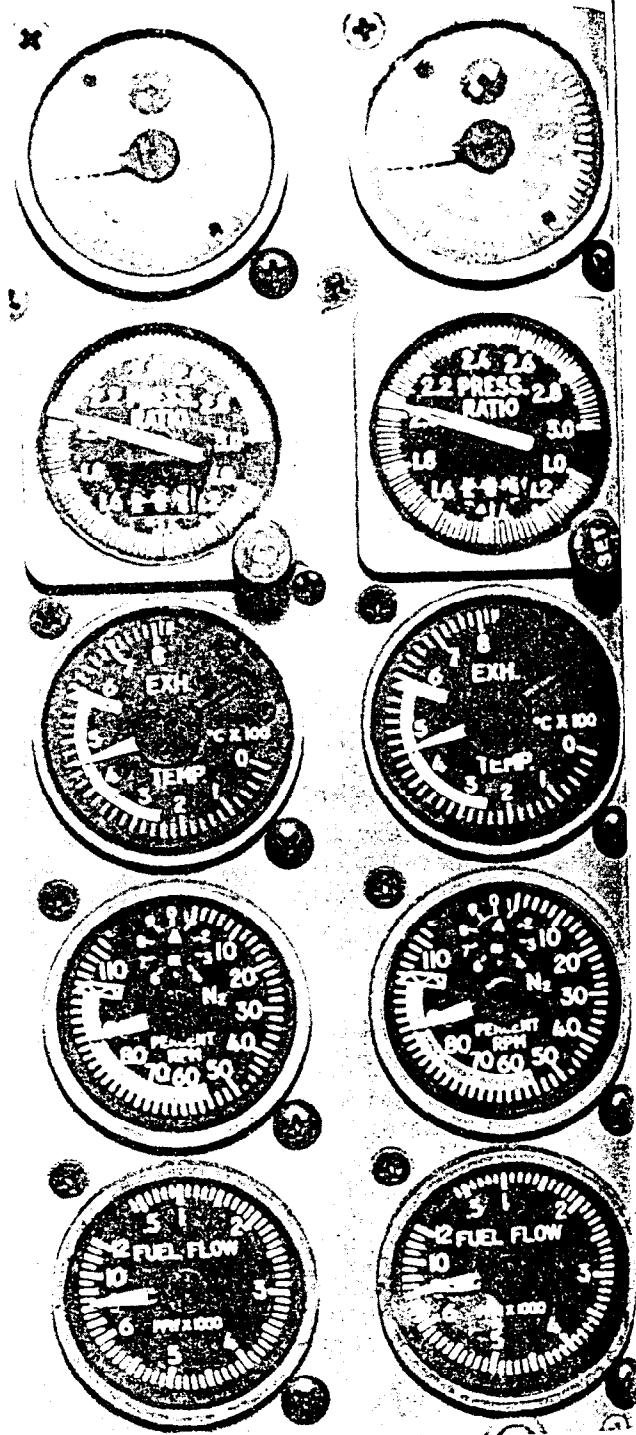
Figure 6.—Comparison of Instrument Readings -- 1.70 EPR vs. 2.04 EPR.

Engine Instrument Indication:
1.70 EPR P_{t2} probe blocked
Engine anti-ice-Off

Engine Instrument Indication:
2.04 EPR
Normal Operation

~~With the engine~~ operating, a false indication of the actual EPR can be indicated in the cockpit when ice blocks the inlet probe. Under this condition, the Pt_2 probe is vented to the nose cone pressure through a siphon-break hole in the sense line. The interior of the engine nose cone is vented to the engine inlet static pressure, which is lower than the engine inlet total pressure normally sensed by the Pt_2 system. Under severe icing conditions, if the engine inlet anti-icing air bleed system is shut off and the normal Pt_2 sensing port is blocked with ice, the Pt_2 sensor will sense the lower pressure at the vent port in the nose cone. The cockpit indication may become slightly erratic as icing begins to block the probe and will indicate a significantly higher reading when ice fully blocks the probe. Tests have demonstrated that with a blocked probe at takeoff, engine power can indicate an EPR of about 2.04 with the engine actually operating at an EPR ratio of 1.70. Under these circumstances, a pilot would unknowingly attempt takeoff at a considerably lower thrust than desired. However, the pilot has available other indications of engine operation displayed in the cockpit, such as a lower N_1 , N_2 , EGT, and F/F consistent with the reduced engine thrust. (See figure 6.)

Should the pilot activate the engine inlet anti-icing system with a blocked probe, he would immediately notice a substantial drop in the indicated EPR, incorrectly indicating a low engine thrust as long as the normal Pt_2 sensing port remains blocked. This results from the introduction of engine anti-icing air flow into the nose cone and resultant increase in the pressure in the interior of the nose cone. This pressure is higher than that which would be sensed at the normal Pt_2 port. Falsely low indicated EPR's have been detected by pilots when they found that they were unable to set takeoff power without exceeding redline N_1 , N_2 , and EGT.

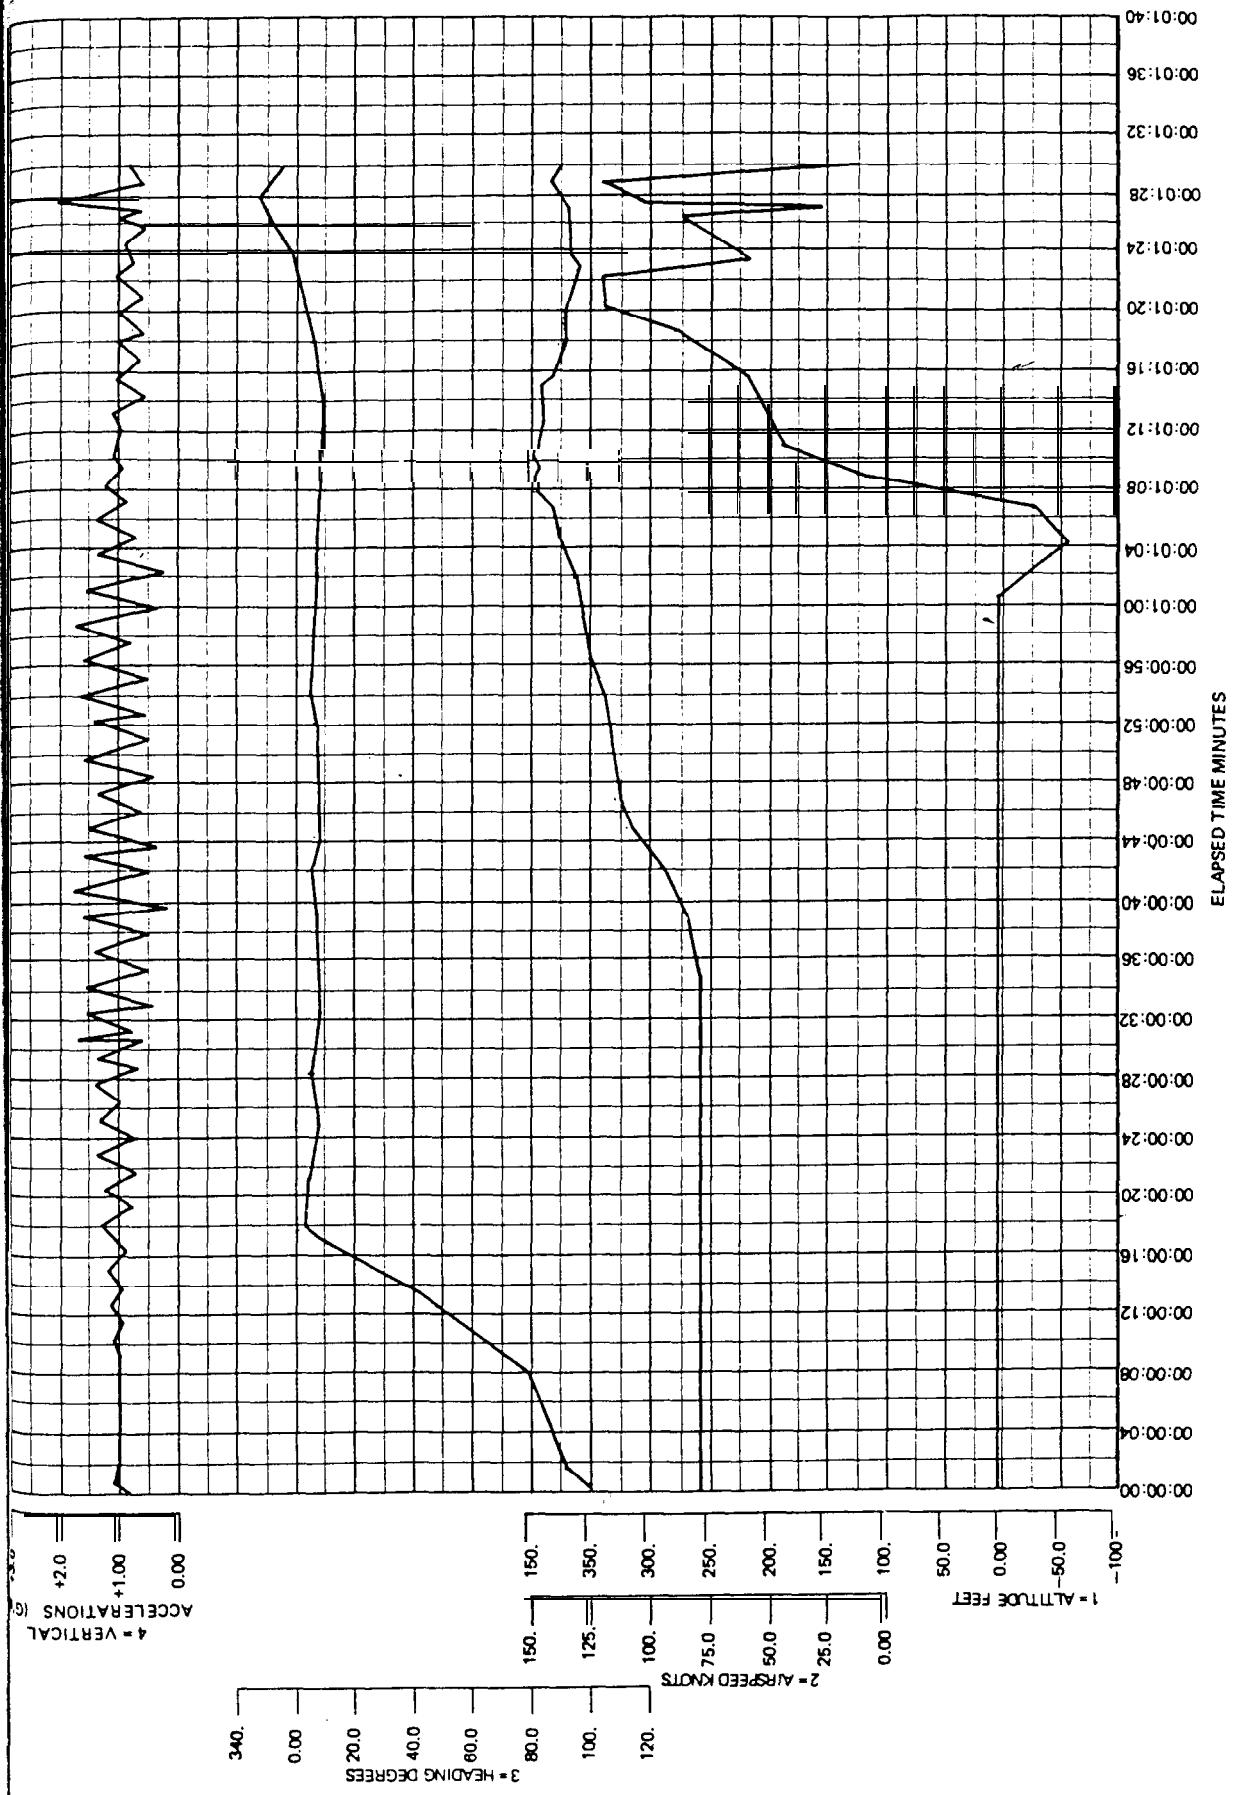
Flight Data Recorder Graph

The recorders were only superficially damaged. The foil recording medium was removed from the FDR and examination disclosed that all parameters and binary traces were present and active. The altitude and airspeed traces were derived from the aircraft central air data computer. Other data recorded were magnetic heading, vertical acceleration, and radio transmitter (microphone) keying, all as a function of time. (The FDR readout is presented in appendix E.)

A timing discrepancy was found in the FDR which made it necessary to evaluate carefully all values obtained from this unit. The first two radio transmissions were timed correctly and matched the timing obtained from the CVR and the ATC transcript within 1 second. The third transmission ("okay") came only a measured 3 seconds after takeoff acknowledgement, instead of the 6 seconds indicated by the other sources. This discrepancy affected all recorded traces simultaneously and probably occurred a number of times throughout the accident flight. Examination of data from previous flights showed that it was irregular in occurrence and duration; the foil slowed for short periods of time then speeded up, thus rendering the overall timing correct while leaving short-term timing errors. This was caused by a malfunction of the foil takeoff drive system. Therefore, FDR data were considered reliable only if validated by the other two data sources.

The FDR showed a sharp decrease and then a gentle rise in the altitude trace beginning at 1600:31.6 (0002:00.6); this is characteristic of the change in static pressure caused by aircraft rotation. Airspeed at this time was recorded as 130 knots. The V callout occurred at 1600:37, and the sound of the stall warning (stickshaker) began 2 seconds later and continued until impact.
