AIRCRAFT ACCIDENT REPORT 2/2003

Air Accidents Investigation Branch

Report on the accident to Shorts SD3-60, G-BNMT near Edinburgh Airport on 27 February 2001

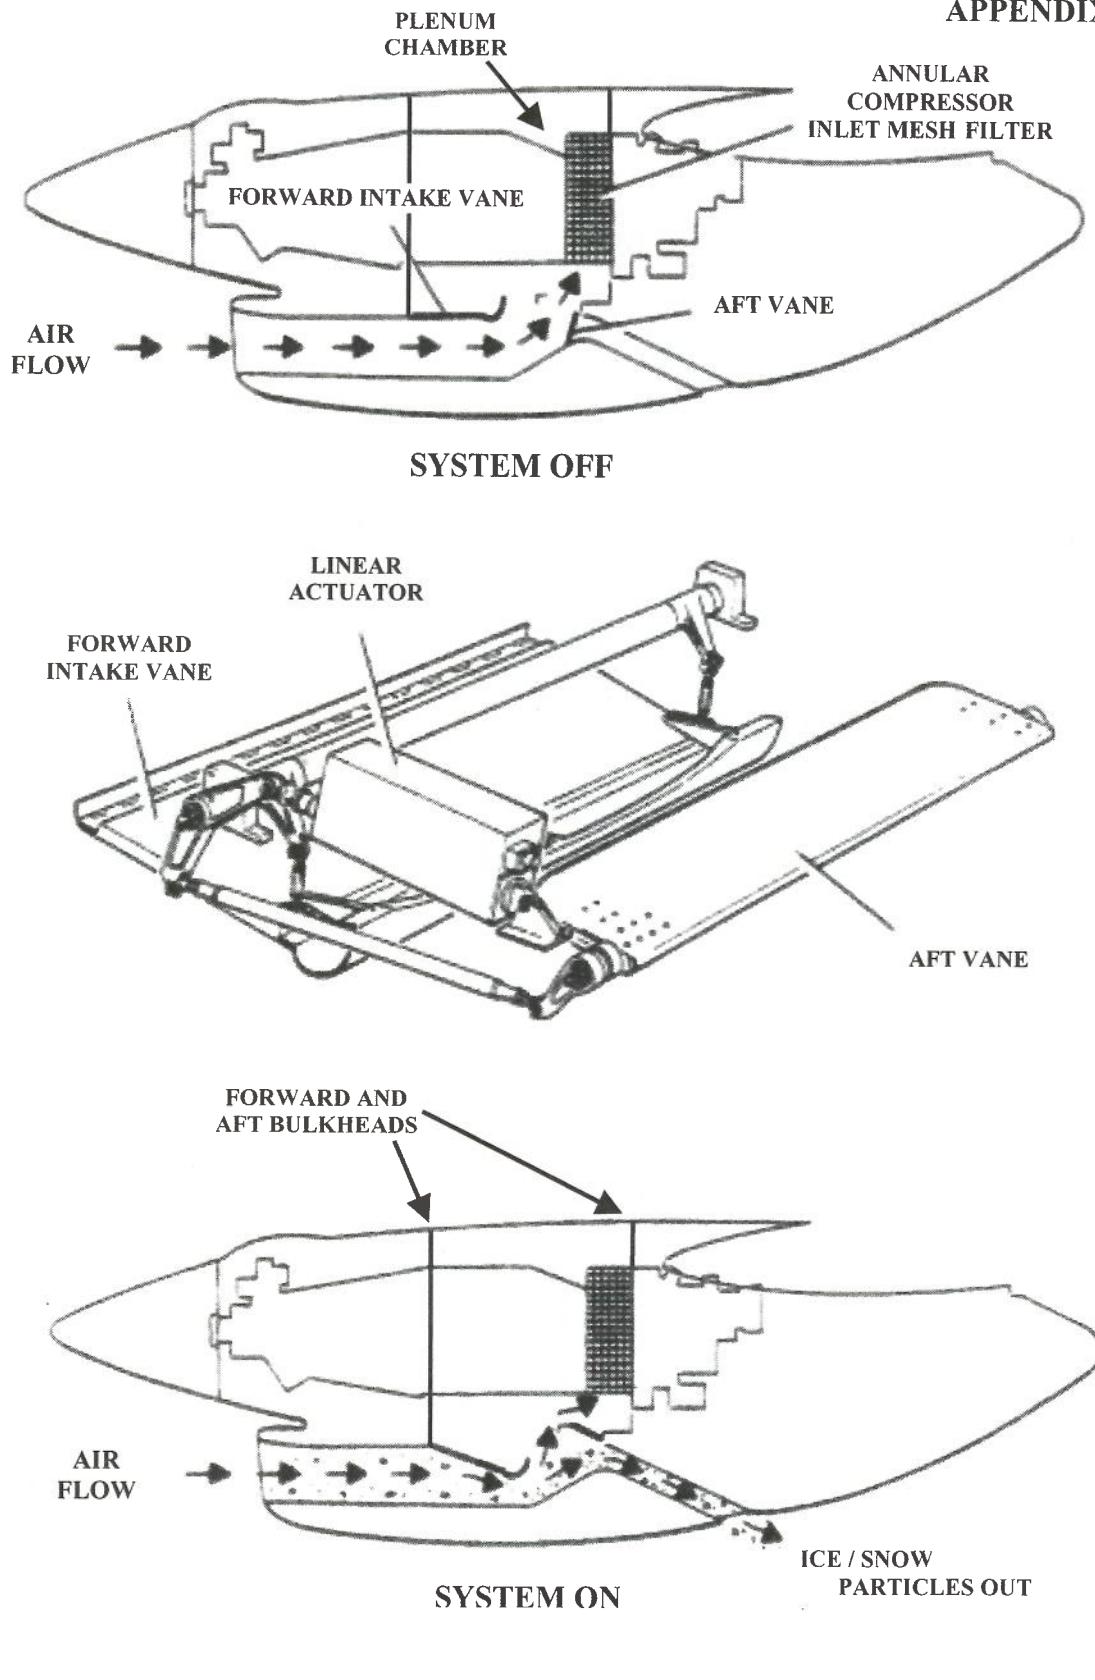
Figure 2 Cross-Section of Engine Nacelle Showing
Intake Inertial Anti-Ice Vane System

- 5 Movement of the intake anti-icing vanes, acting in conjunction with the presence of snow, ice or slush in the intake systems, altered the engine intake air flow conditions and resulted in the near simultaneous flameout of both engines.

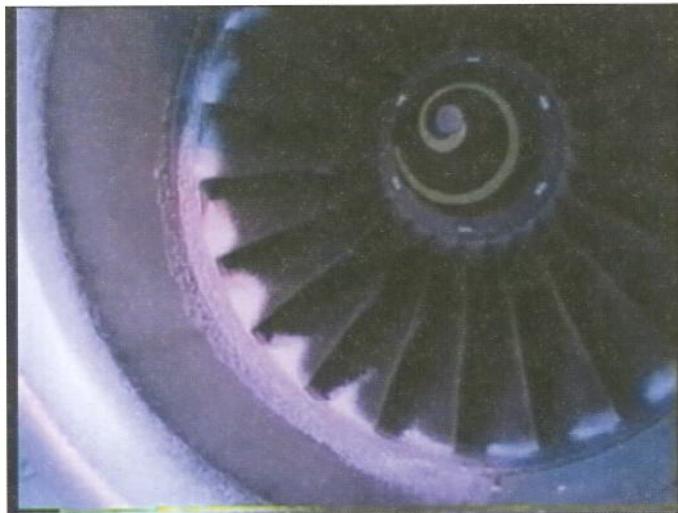
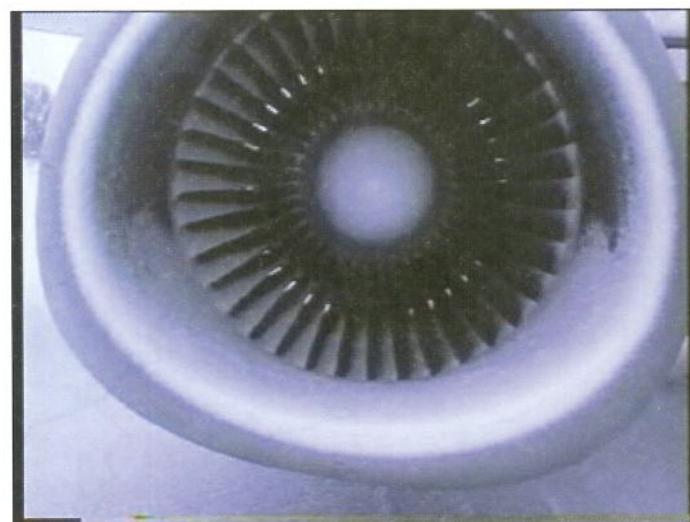
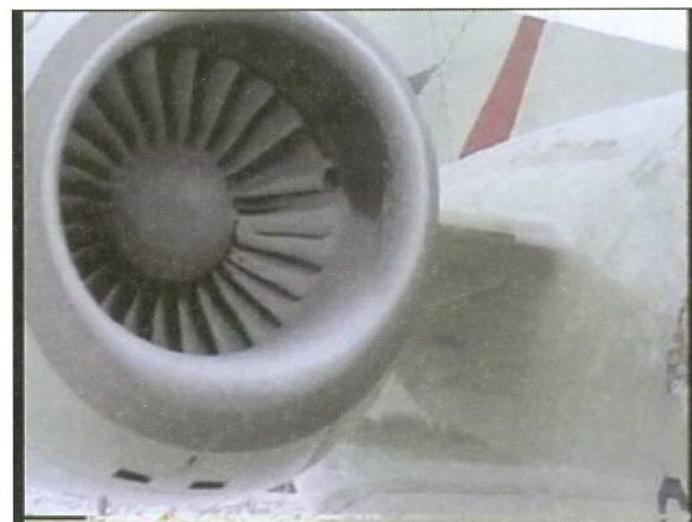
Figure 3 Snow Deposits in Engine Intakes of other Aircraft at Edinburgh during the morning of 27 February 2001

- 2 A significant amount of snow almost certainly entered into the engine air intakes as a result of the aircraft being parked heading directly into strong surface winds during conditions of light to moderate snowfall overnight.

- 4 At some stage, probably after engine ground running began, the deposits of snow, ice or slush almost certainly migrated from the plenum chambers down to the region of the intake anti-ice vanes. Conditions in the intakes prior to takeoff are considered to have caused re-freezing of the contaminant, allowing a significant proportion to remain in a state which precluded its ingestion into the engines during taxi, takeoff and initial climb.

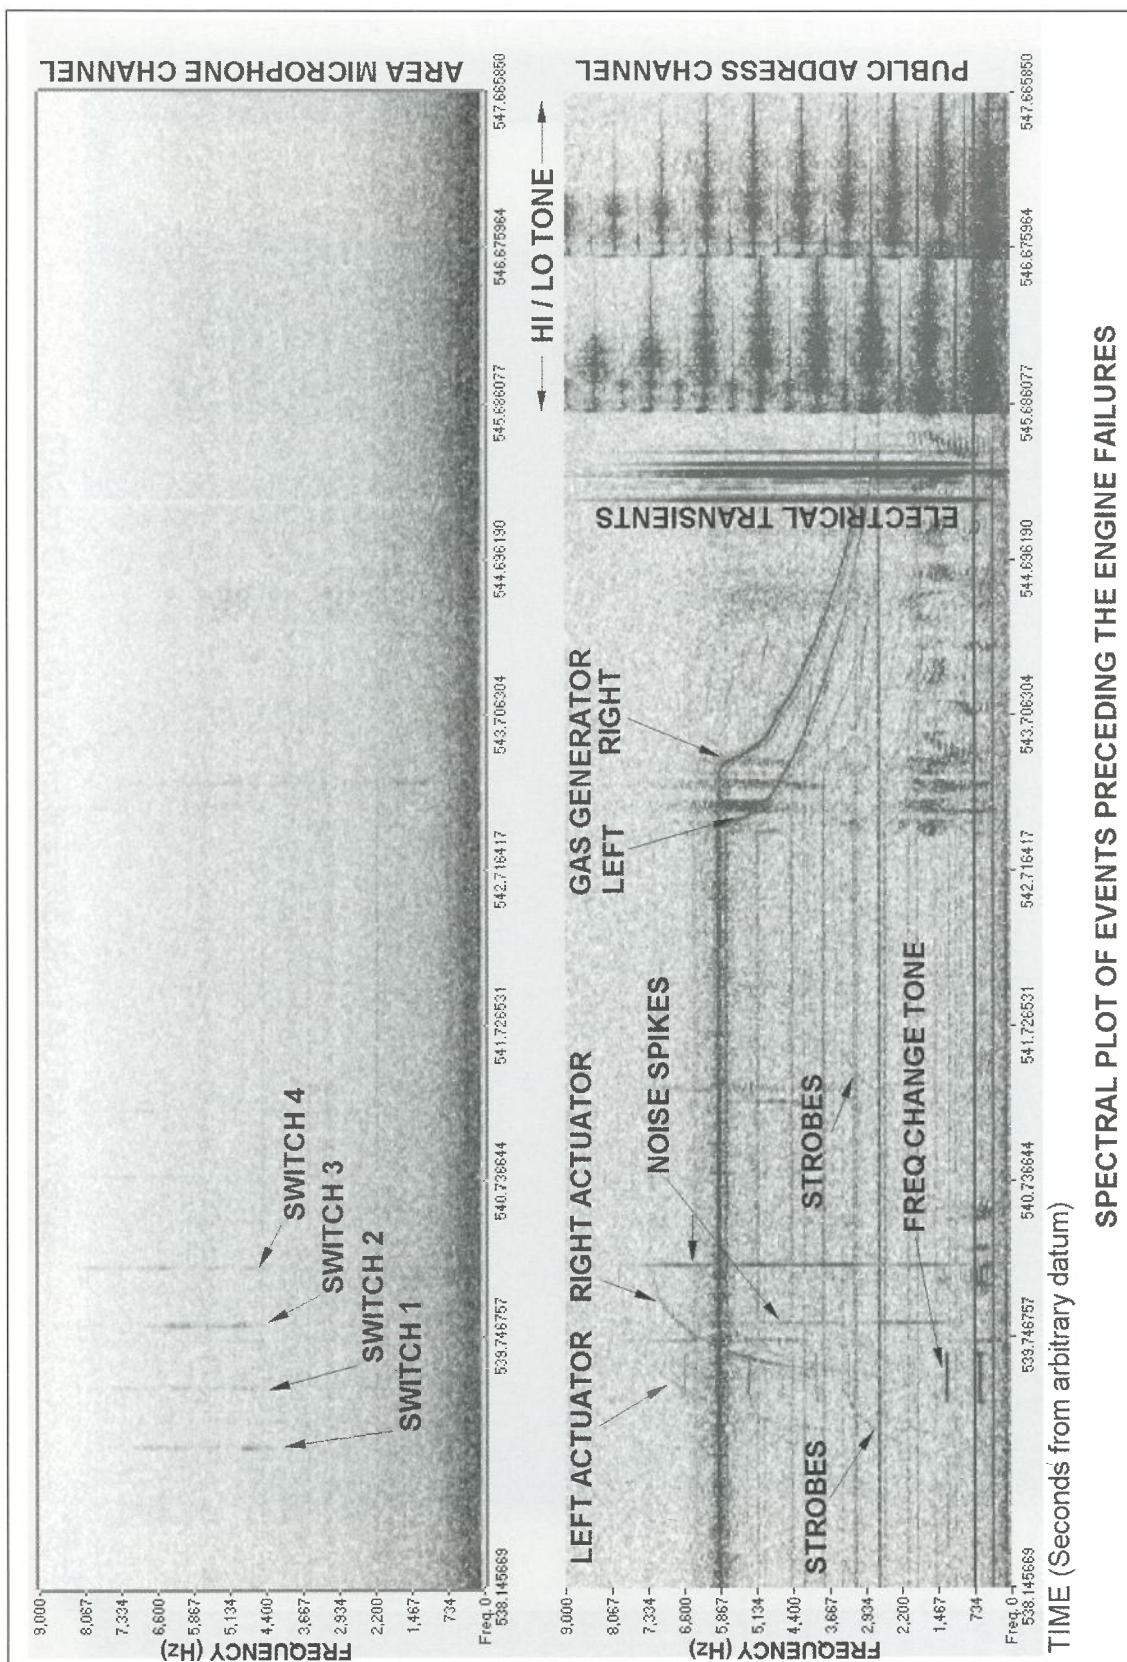
Figure 1 CVR Spectral Analysis – Pre Engine Failures

As the crew conducted the Autofeather test (part of the engine checks required on the taxi checklist) the speed of both propellers began to decay and two faint audio signatures were recorded on Channel 1 of the CVR. These signatures rose rapidly in frequency, levelled off for a period of just under 10 seconds and then stopped. Immediately after this, the first officer commented “ANTI-ICE, BOTH ON”. Then the sound of a switch selection was recorded through the area microphone and both propellers began to increase speed again. As they did so, two more audio signatures of similar characteristics and duration were recorded.

Three point nine five (3.95) seconds after the first audio signature started, the CVR showed the gas generator speed of one engine starting to drop rapidly. That of the other engine began to drop 0.4 seconds later (3.95 seconds after the second switch movement). From the CVR alone it was not possible to determine which engine had started to fail first, but the FDR recording showed that the left engine torque began to reduce towards zero slightly before that of the right.

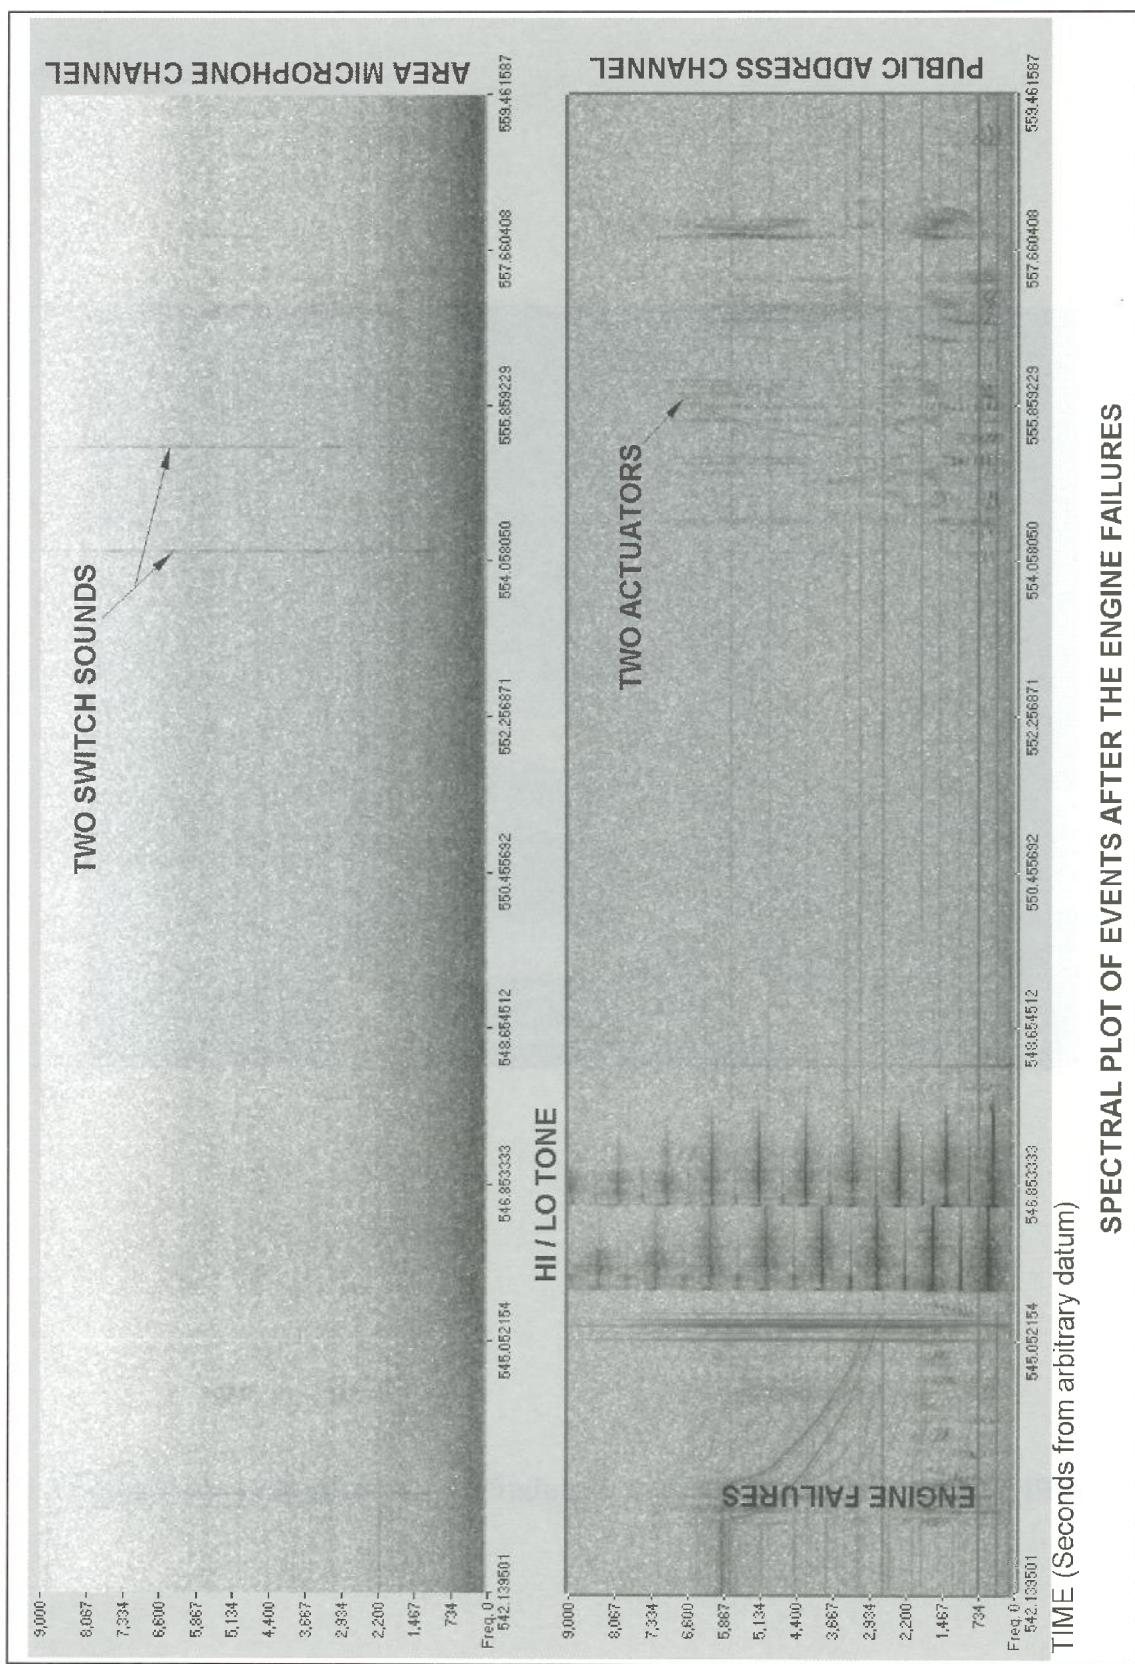
Figure 2 CVR Spectral Analysis — Post Engine Failures

Eleven seconds after the loss of engine power, the area microphone recorded the sound of a switch selection being made; there was no associated noise spike recorded on the public address channel of the CVR. One second later, the sound of another switch selection was recorded and the public address channel recorded the concurrent start of two of the faint audio signatures observed during the Autofeather test. (Subsequent analysis, combined with detailed wreckage examination, concluded that this was the selection of the anti-ice vanes to the 'OFF' position, see Sections 1.11.5 and 1.12.1).
