Runway incursion – Perth airport safety vehicle

Perth Airport, Western Australia, 15 June 2012

ATSB Transport Safety Report
Aviation Occurrence Investigation
AO-2012-086
Final

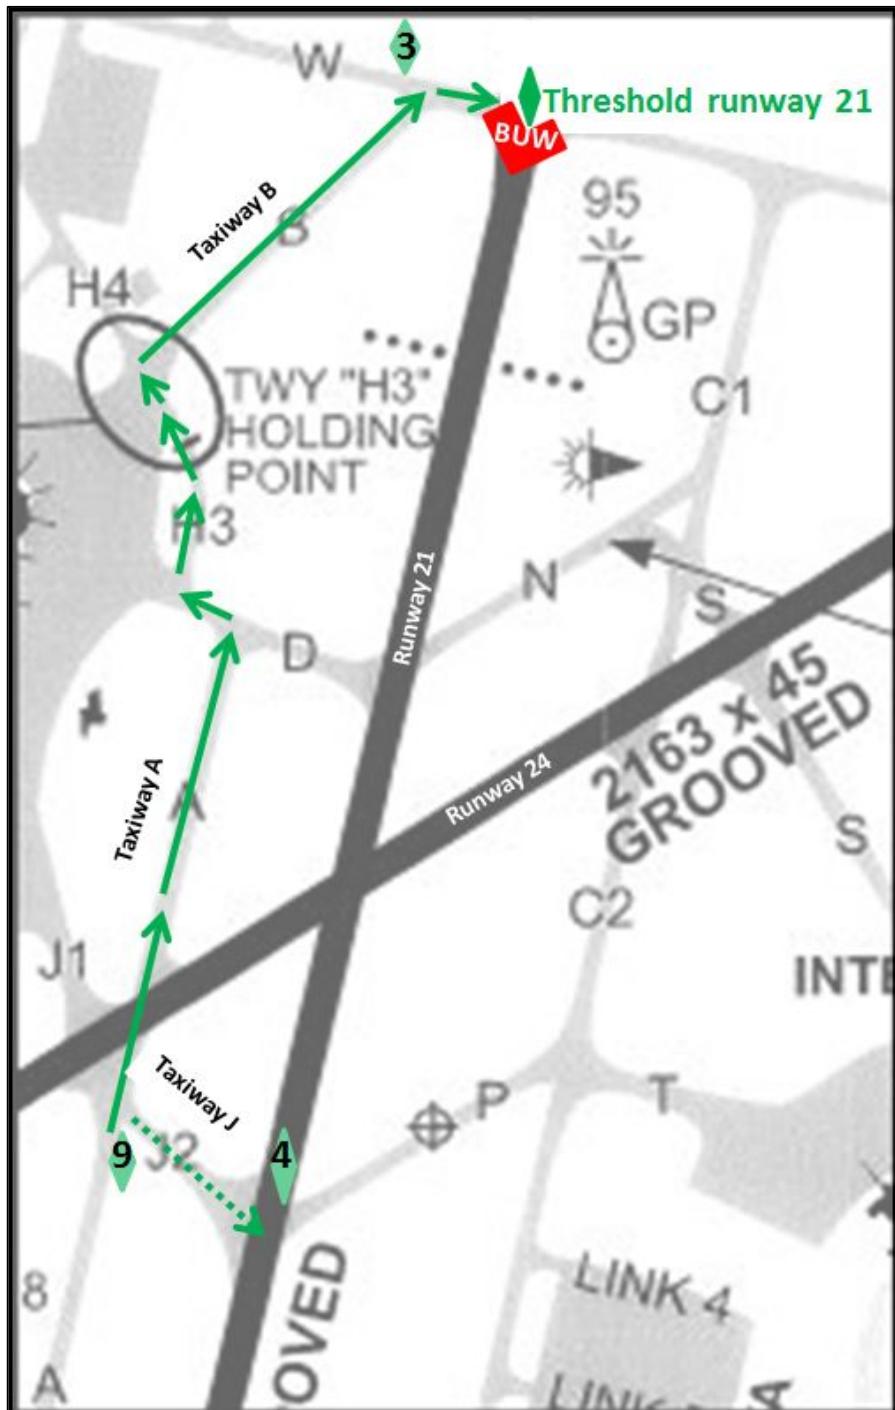
To calculate the visibility, the AOO was required to drive along the runway that was in use, from the threshold of runway 21 (Figure 1) to a documented intermediate observation point (position 4³ for runway 21). The AOO then reported the number of runway edge lights observed from each location. When not measuring the runway visibility, the AOO was required to park the vehicle at a designated position (position 9) away from the runway monitor the Perth Tower (Tower) radio frequency on 120.5 MHz.

At about 0555, the air traffic controller (Tower) instructed a Piper PA-42 aircraft, registered VH-BUW (BUW), to line up on runway 21. The controller, using non-standard phraseology (Table 1), then instructed Safety 2 to provide a count of runway edge lights. At 0557, during the exchange between Tower and Safety 2, Safety 2 entered runway 21 without a clearance at taxiway J. When instructed by Tower, Safety 2 immediately vacated runway 21 via taxiway J.

Figure 1: Location of safety vehicle positions (green diamonds), actual path of Safety 2 (dotted green line), path of Safety 2 as intended by ATC (solid green line) and location of BUW at the threshold of runway 21 (red)

An airside driver's guide to runway safety, published by Airservices Australia, also emphasised the need for standard phraseology. The use of non-standard phraseology by the Tower controller resulted in Safety 2 misunderstanding an instruction and entering the active runway.
