Investigation Report

Type of Occurrence:	Accident
Date:	19 March 2008
Location:	Mannheim
Aircraft:	Airplane
Manufacturer / Model:	Dornier Luftfahrt GmbH / Do 328-100
Injuries to Persons:	5 minor injuries
Damage:	Aircraft severely damaged
Other Damage:	Minor field damage
Information Source:	Investigation by BFU
State File Number:	BFU 1X001-08

German Federal Bureau of
Aircraft Accident Investigation

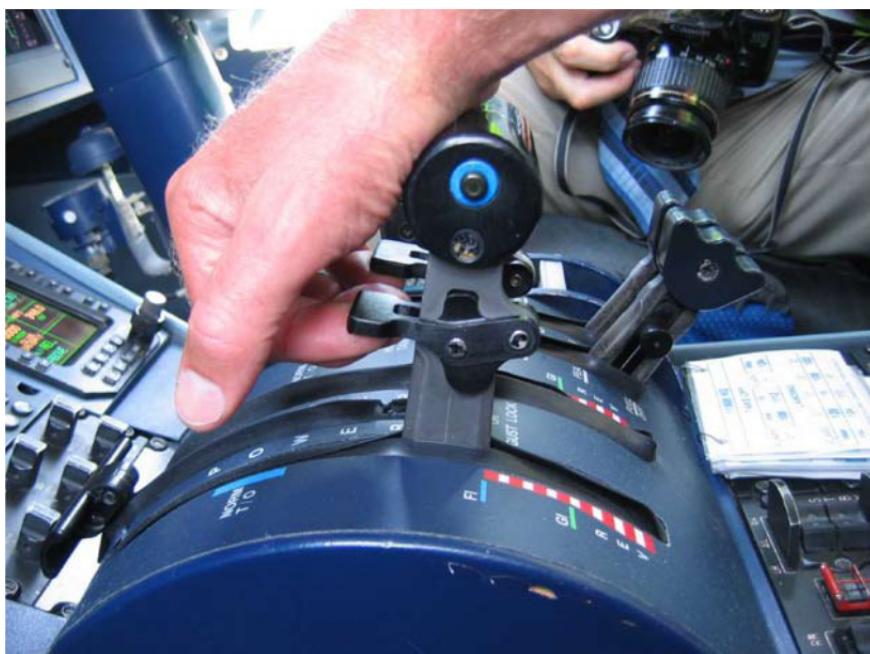
Power Lever und Latches Source: AAIB

Aug 2006 The AAIB published the Bulletin S7/2006. It stated that it was not possible for the crew to move the power levers back from FI into the BETA position. The Bulletin included the following safety recommendation:

"It is recommended that Avcraft Aerospace GmbH i.I advise all operators of Dornier 328 turboprop aircraft to detail procedures, and provide adequate training, to ensure that their pilots are able to act appropriately if the beta control range on the power levers cannot be selected after landing."

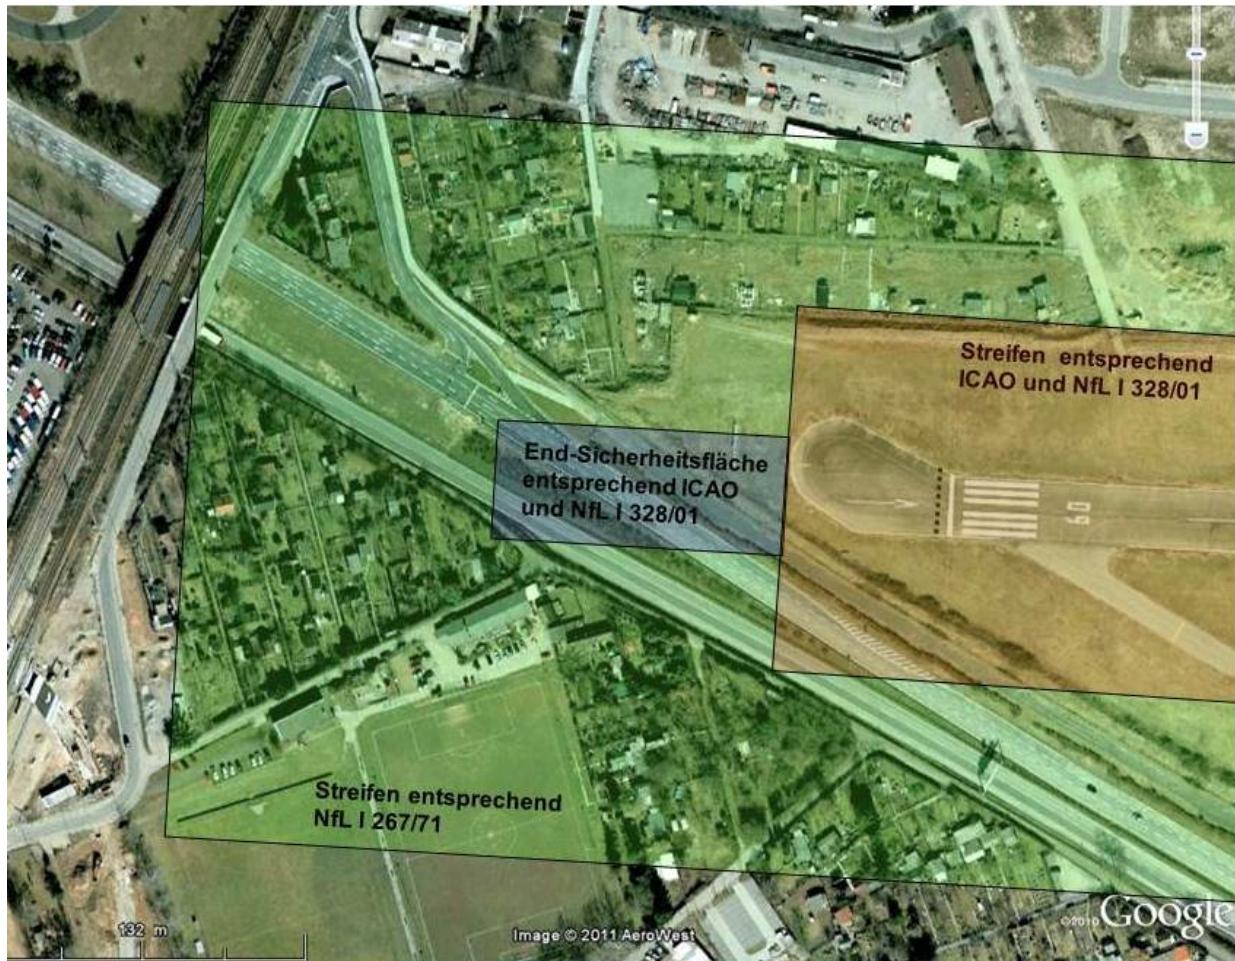
Intended safety areas of runway 27 at EDFM

safety areas have to have at least a length of 90 m. Furthermore, a length of 120 m was recommended. The width of these areas was to be the same as that of the strip or at least twice the runway width. Objects which could be dangerous to aircraft should not be within the strip or the safety areas.

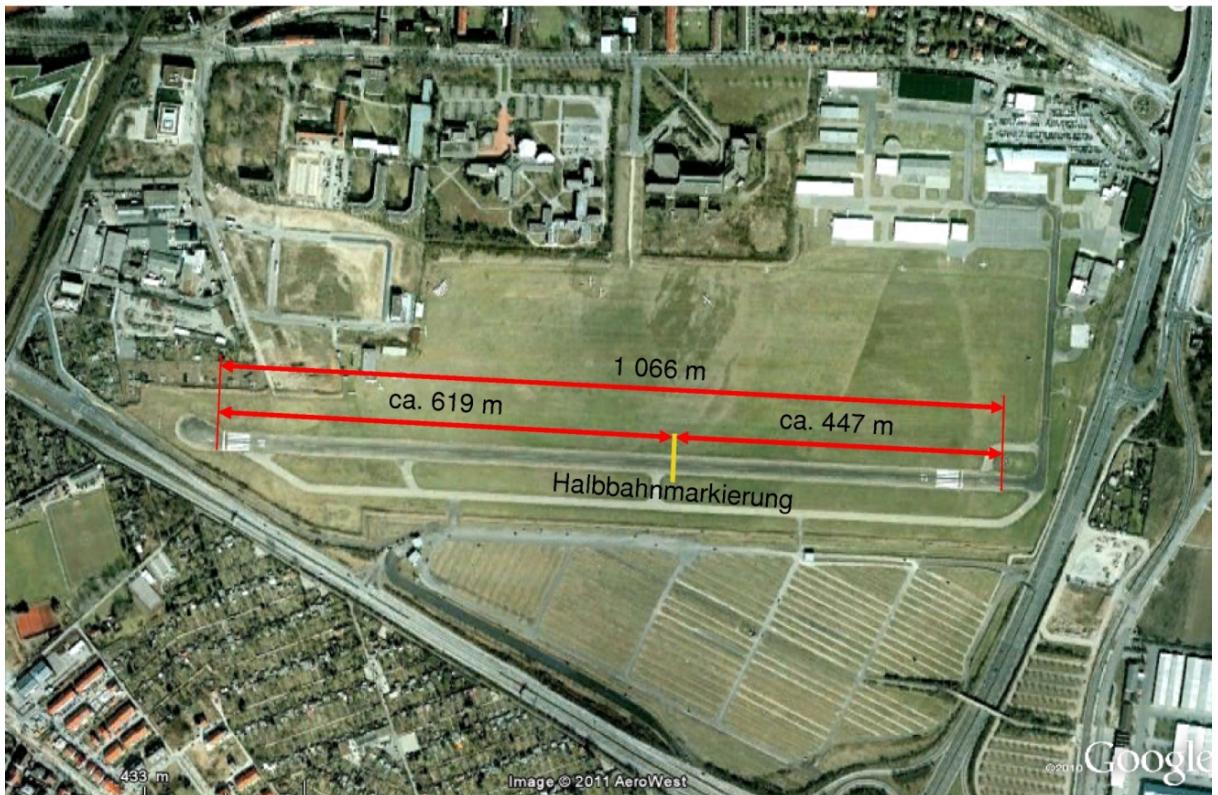
Runway markings at EDFM

In spite of the conclusion that from a flight operational point of view the approach to Mannheim City was difficult the runway markings did not comply with the respective regulations. There was neither the required aiming point marking nor the recommended touchdown zone marking. Such markings would have given the crew some support concerning the distance and the glideslope and, if necessary, been an

additional visual indication whether the approach was stabilised or not. The required but missing aiming point marking was therefore a safety deficit. The landing zone markings would have improved the safety level of the runway and the existing safety deficit caused by the missing safety areas would have been somewhat lessened.

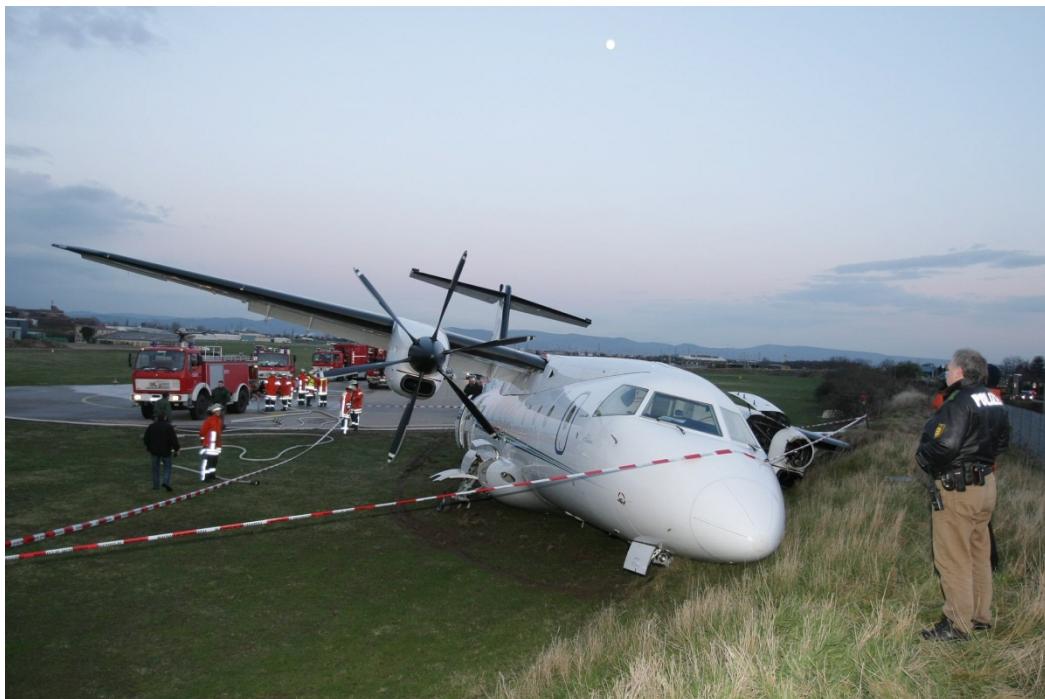
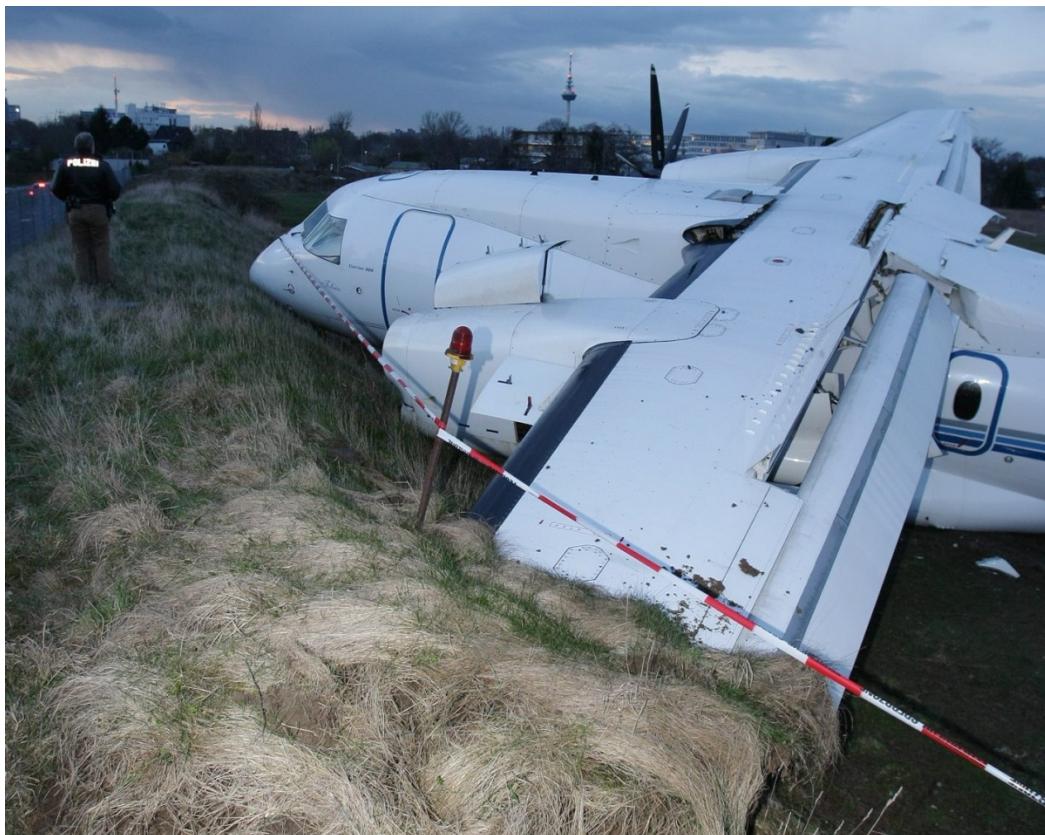
Accident site

The airplane was found south of the localizer antennas beyond runway 27. The aircraft nose had contact with an earth wall. The airplane axis was about parallel to the runway and the airplane had a tilted position to the left. The left wing stuck in the earth wall. The left landing gear was buckled. The propeller had been severed from the left engine and lay behind the cockpit beneath the fuselage. Flaps and spoilers were extended. The wing to body fairing was severely damaged.

The power levers for the engines were free. The connection to the engines was severed. The condition lever of the right engine was free. It was no longer connected with the engine. The condition lever of the right engine was jammed. It was in the front third position.

The runway was dry. None of the touch-down traces found on the runway could be assigned to the accident aircraft. On the last 150 m of runway 27 deep-black, continuous skid marks were visible which could be assigned to the accident aircraft. After the runway end the skid marks crossed a utility shaft (electrical equipment). This utility shaft was open and the concrete lid lay about 5 m to the side. Parts of the wheel well doors and the left propeller were found in the immediate vicinity of the utility shaft.

The examination of the airplane showed no traces of fire. The left engine nacelle showed discolouration on the cowling and melted rubber parts. Witnesses observed severe smoke development on the left engine after the accident.

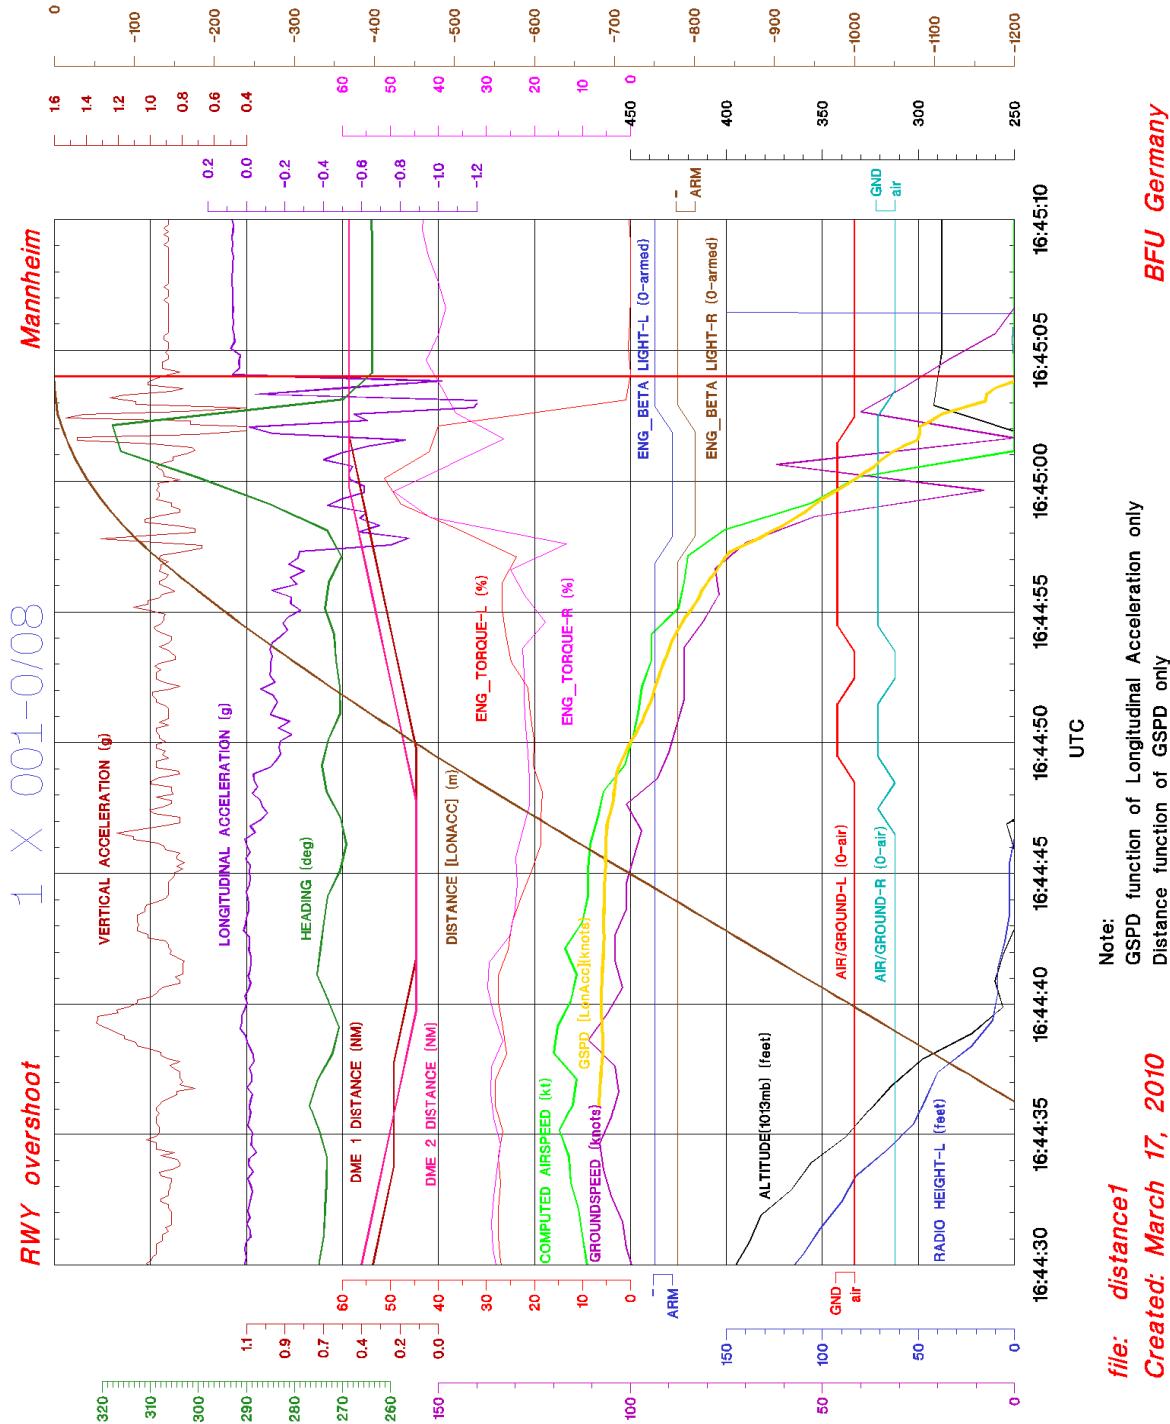
Flight No 1, Accident Flight

However, since the engine torque was not reduced to F1 after passing the threshold - as stated in the SOPs - the landing distance calculation was invalid. The position of the power levers was the cause for the later apparent problem when selecting the GI position and reverse. In theory, the long flare should have been an indication for the crew that something was amiss.
