SERIOUS INCIDENT

Aircraft Type and Registration:	Boeing 737-8F2, TC-JKF	
No & Type of Engines:	2 CFM 56-7B22 turbofan engines	
Year of Manufacture:	2006	
Date & Time (UTC):	13 March 2011 at 1412 hrs	
Location:	London Stansted Airport	
Type of Flight:	Commercial Air Transport (Passenger)	
Persons on Board:	Crew - 2	Passengers - N/K
Injuries:	Crew - None	Passengers - None
Nature of Damage:	None	
Commander's Licence:	Airline Transport Pilot's Licence	
Commander's Age:	49	
Commander's Flying Experience:	7,700 hours (of which 4,400 were on type) Last 90 days - 220 hours Last 28 days - 80 hours	
Information Source:	AAIB Field Investigation

Synopsis

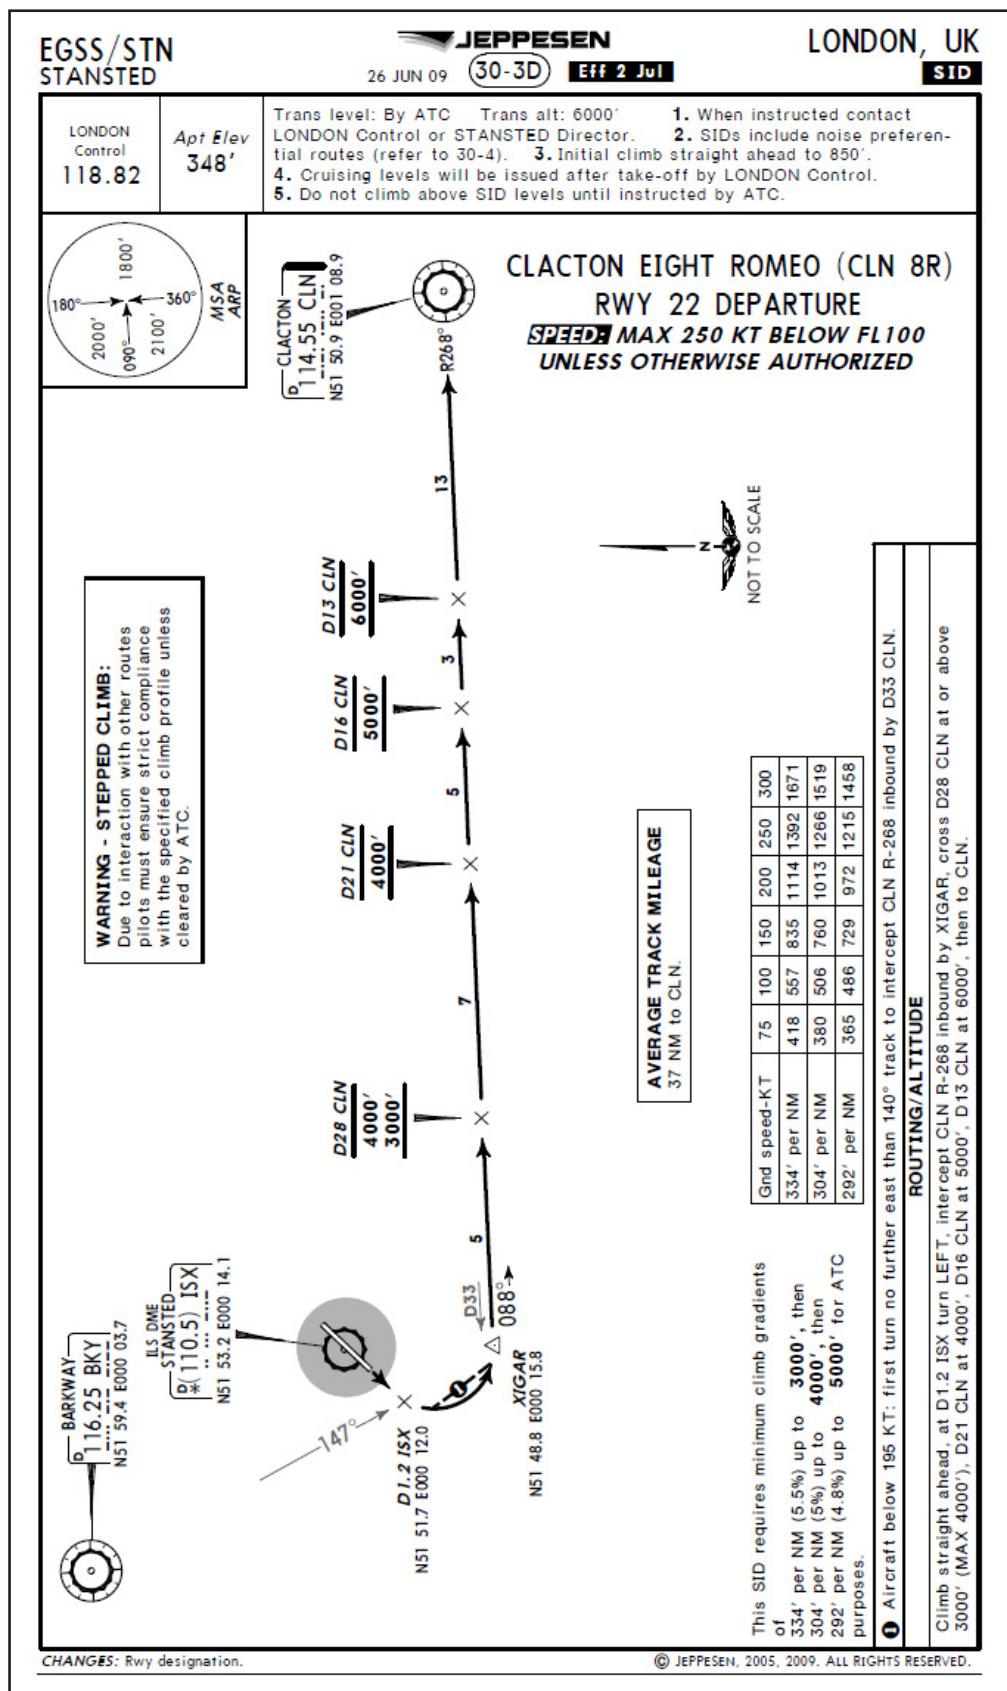
Figure 1
Clacton 8R SID

The pilots were using Jeppesen charts and the relevant chart for the CLN 8R SID is shown in Figure 1. The SID chart contains a panel of general information at the top of the page. Items 3, 4 and 5 state:

- 3. Initial climb straight ahead to 850'*
- 4. Cruising levels will be issued after take-off by LONDON Control*
- 5. Do not climb above SID levels until instructed by ATC'*

The information displayed on the Jeppesen chart reflects the information published in the UK AIP although the positioning of this information on the page is different and the UK AIP states 847 ft instead of 850 ft.

is grammatically similar to the phraseology specified in CAP 413 that ATC would use to instruct an aircraft to climb to and maintain a specified altitude (*'Climb to altitude 850 ft'*). The pilots interpreted 850 ft as the first SID level that they were required to maintain pending further instructions by ATC and they configured the aircraft accordingly.

The instruction not to commence a turn below 500 ft aal is shown in one of two different ways on SIDs published in the UK AIP. The commander's previous experience of a Stansted departure was on a Dover SID that presents this restriction using a different phrase to a Clacton SID. The pilot considered that this difference in phrasing was one of the factors that reinforced his misinterpretation of the information on the chart.

The pilots caused the aircraft to level incorrectly at 800 ft aal because they misinterpreted the information written in the general information section of the departure chart. This information originated from the UK AIP. The pilots' misinterpretation of the information was reinforced by the previous experience of the crew.

As a result of this incident NATS has harmonised the general information section of published SIDs so that, where the phrase *'Initial climb straight ahead to...'*

occurs, it is replaced by the phrase *'No turns below...'*. This action was only applied to airports within the London TMA.

It is recommended that the Civil Aviation Authority should ensure that the vertical profile information included within the general information section of all SIDs published in the UK AIP is unambiguous and that the wording used is consistent across all UK SIDs.
