# Investigation Report

| Type of Occurrence: | Serious incident |
| Manufacturer / Model: | Boeing / 737-800 |
| State File Number: | BFU 5X002-10 |

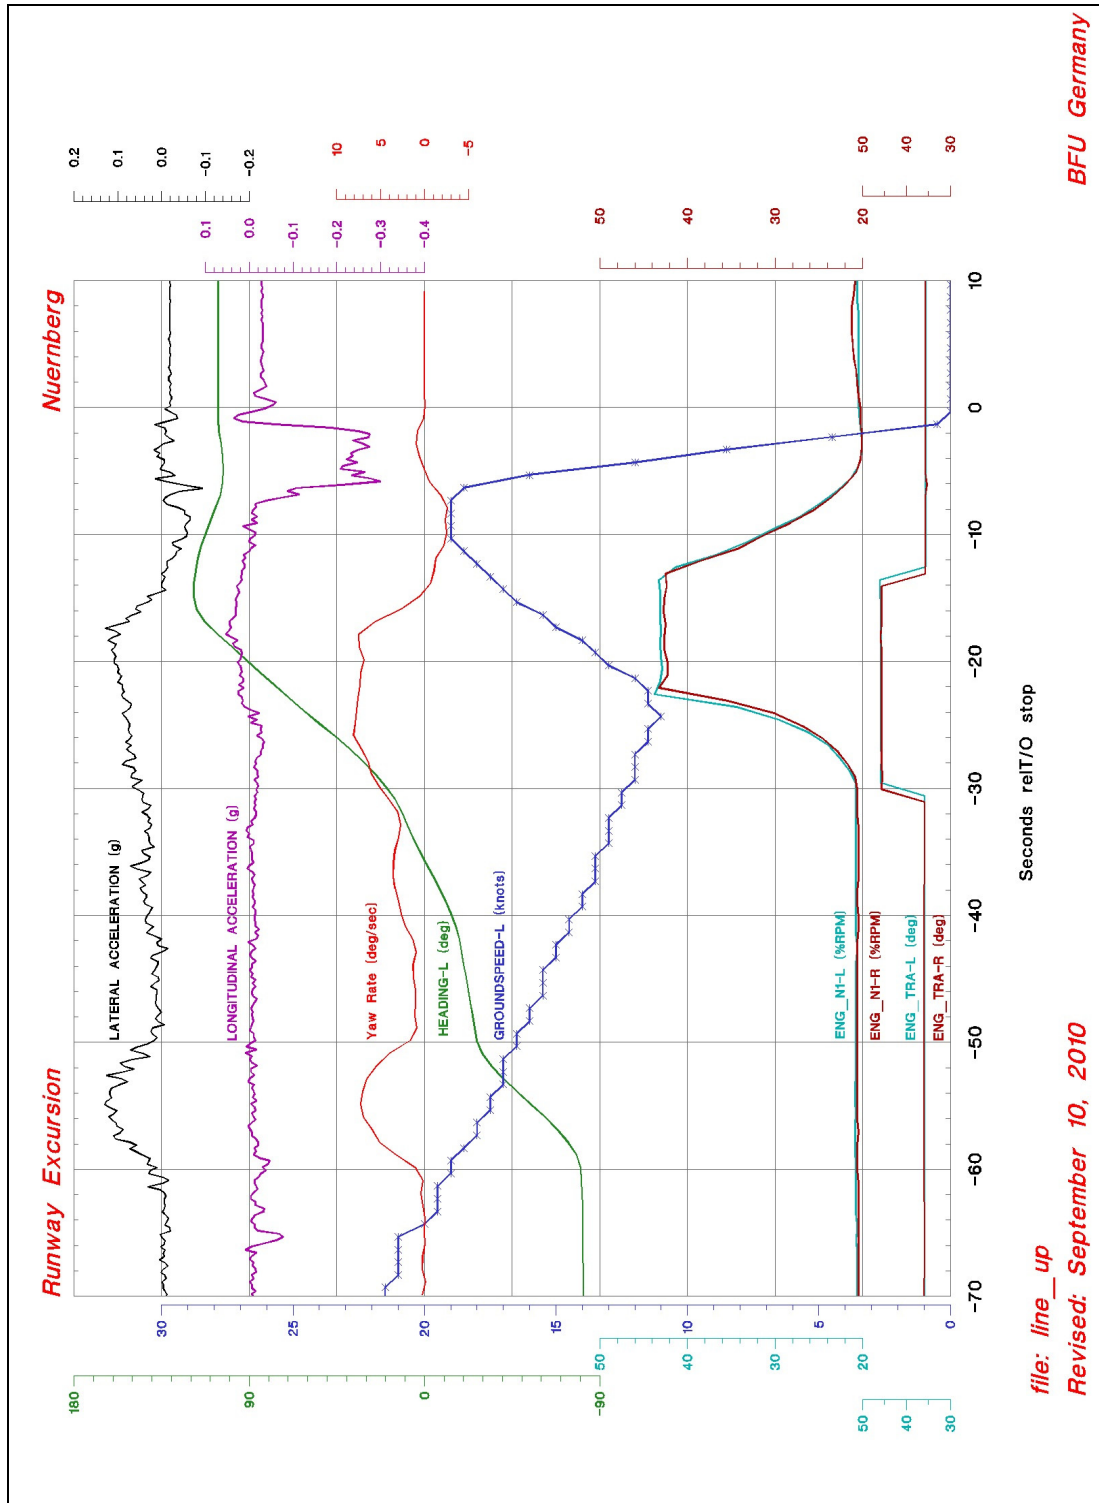
## Excerpt Flight Data Recorder

According to the Flight Data Recorder (FDR) both thrust levers were moved from about 36° to about 46° while passing a heading (HDG) of about 20° with a ground speed of about 12 kt. Thrust of both engines increased from about 21% N1 to about 43% N1. The recordings of the left and right N1 show that the engines accelerated with a difference of initially about 2% and later about 4%; the left engine showed the higher thrust values throughout. After that, N1 of the left engine remained at about 43.2% and of the right at about 42.5%; for the next 9 seconds both values remained constant.

About 43% N1 of the left engine was reached at HDG 73°; at that time ground speed was about 12 kt. The airplane accelerated in 12 seconds from about 12 kt to 19 kt ground speed. The heading of about 112° was passed with a ground speed of about 19 kt. During the acceleration phase the airplane passed a heading of about 120° with a ground speed of about 17 kt. Once these values were reached the thrust levers were pulled back to about 5° and within 9 seconds engine thrust decreased to about 21% N1. Within 6 seconds ground speed decreased from 19 kt to 0 kt.
