Statens haverikommission
Swedish Accident Investigation Board

Final report RL 2011:08e

**Incident involving aircraft SE-MDB, SE-JBN
and seven skydivers above Gärde, AB County, 21 August 2010**

Case L-116/10

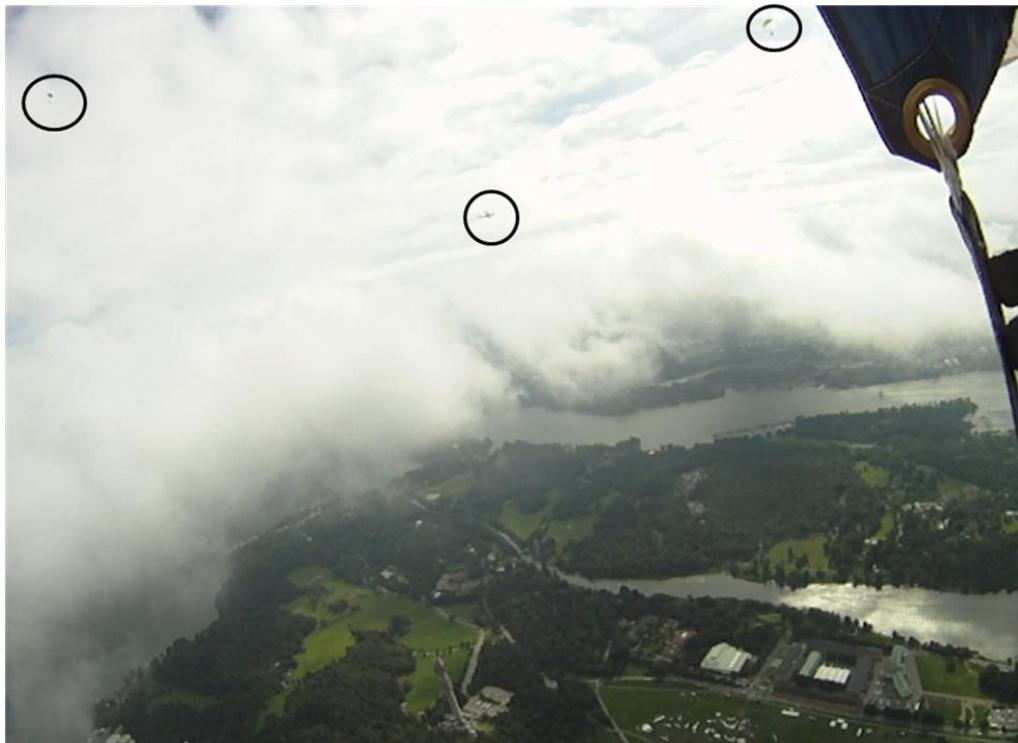
Fig. 1 Three of the skydivers with SE-MDB in the centre of the image.

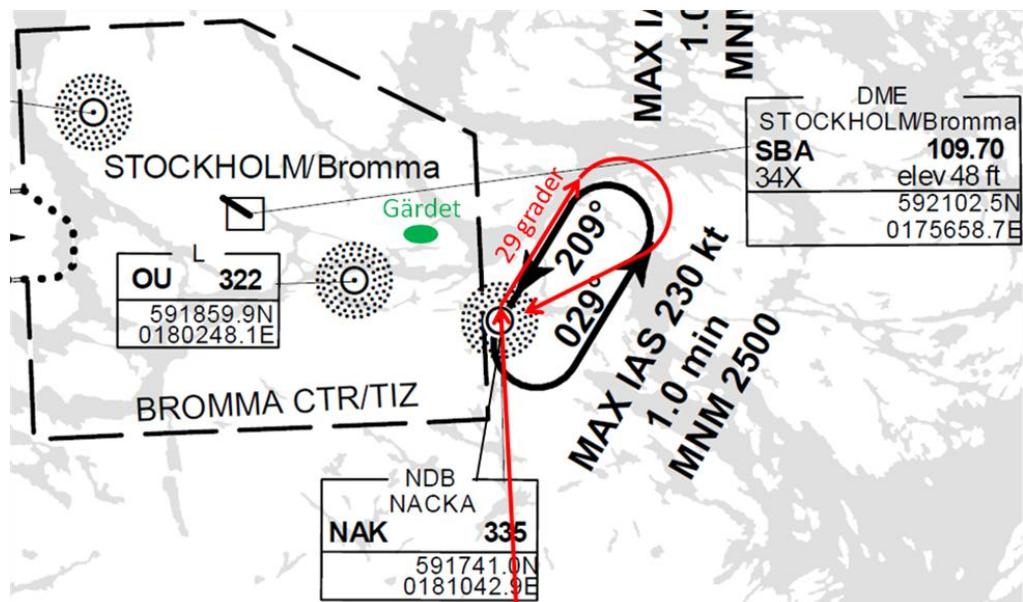
NAK holding pattern is published in AIP⁴, in the chapter Airports under the tab Stockholm/Arlanda, Holding Procedures (see fig. 5). Under the tab Stockholm/Bromma there is a reference to Stockholm/Arlanda, ESSA 4–3, regarding holding patterns that are established for Bromma airport.

Fig. 5 NAK holding pattern according to the AIP, parallel entry in red, Gärdet is highlighted in green

Entering the holding pattern is carried out in different ways depending on which direction the aircraft is coming from. In the present situation, SE-MDB approached the beacon from the south with a heading of 355°, which meant that a parallel entry would be performed at an initial track of 29° after the beacon had been passed (see fig. 5).

The Swedish Transport Agency is recommended to ensure that the holding patterns belonging to a specific airport will be published in their entirety under the heading for that airport (*RL 2011:08e, R1*).

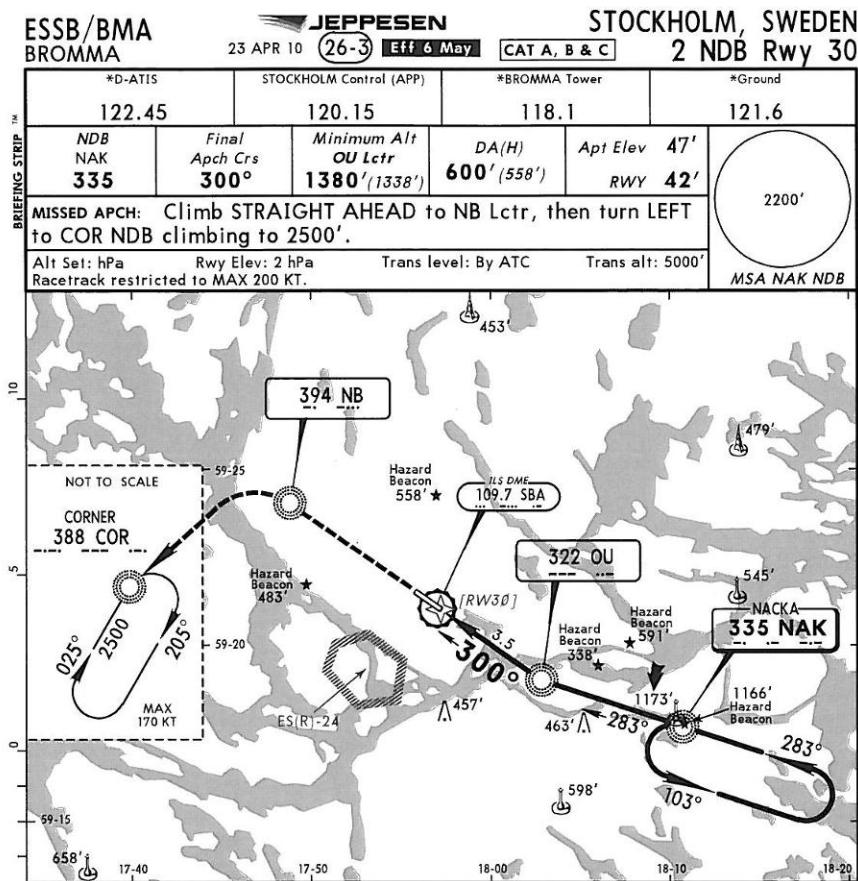
One of the approach maps that the pilot had access to indicates NAK as part of an approach procedure to runway 30. The approach track during this procedure is 283° (see fig. 6).

Fig. 6 Approach map with the NAK NDB.

The crew of the SE-MDB used maps from the US company Jeppesen as navigation data. In these maps the NAK holding pattern was published in the Stockholm/Bromma tab on page 20–22 that is used for approaches from the north. It was not possible to find the holding pattern under the Stockholm/Arlanda tab in this manual.

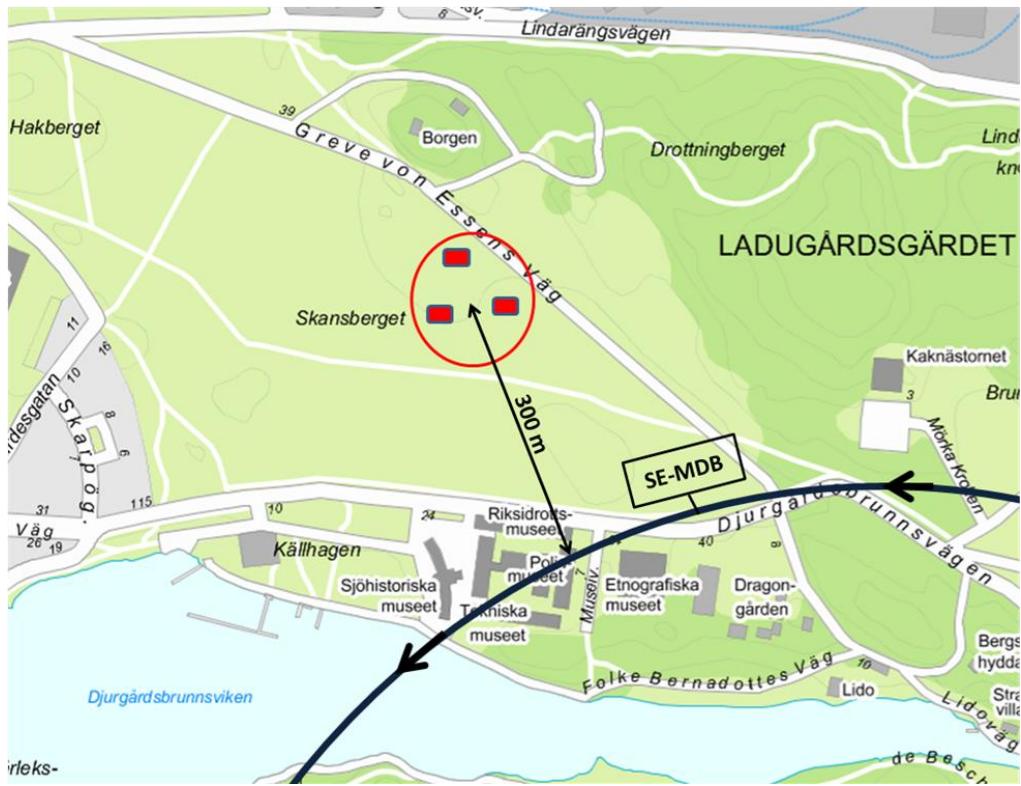
The SHK has gathered the radar records from the Armed Forces and LFV at the time of the actual incident. The records show that the aircraft SE-MDB flew past the skydivers at a distance of approximately 300 metres (see fig. 9).

Fig. 9 SE-MDB's flight line over Gärdet, the skydivers are shown in red.

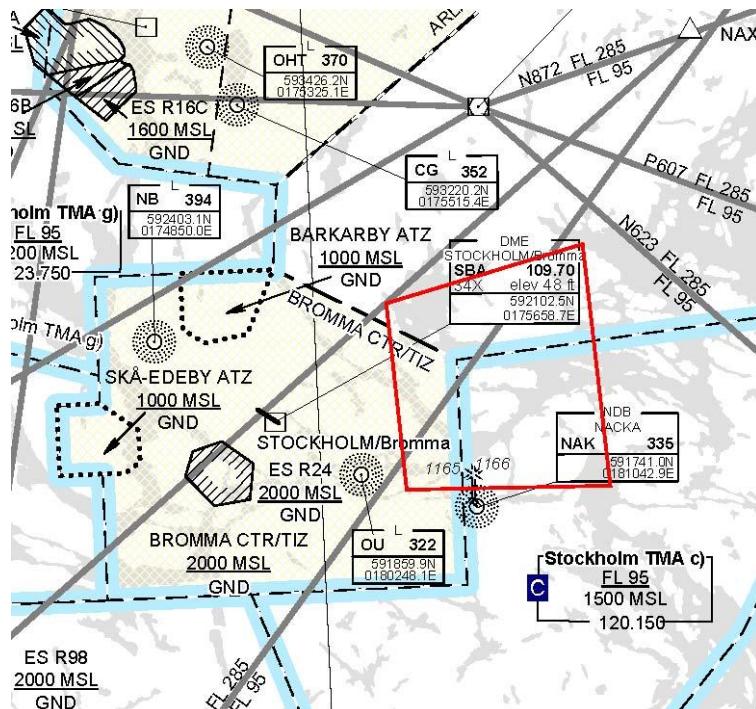
At the time, a civilian and a military NOTAM¹³ applied, and a navigation warning describing a temporarily established airspace for the air show at Gärde (see red frame in fig. 11), from ground level to an altitude of 2,000 feet AMSL¹⁴.

Fig. 11 Map of the incident area.

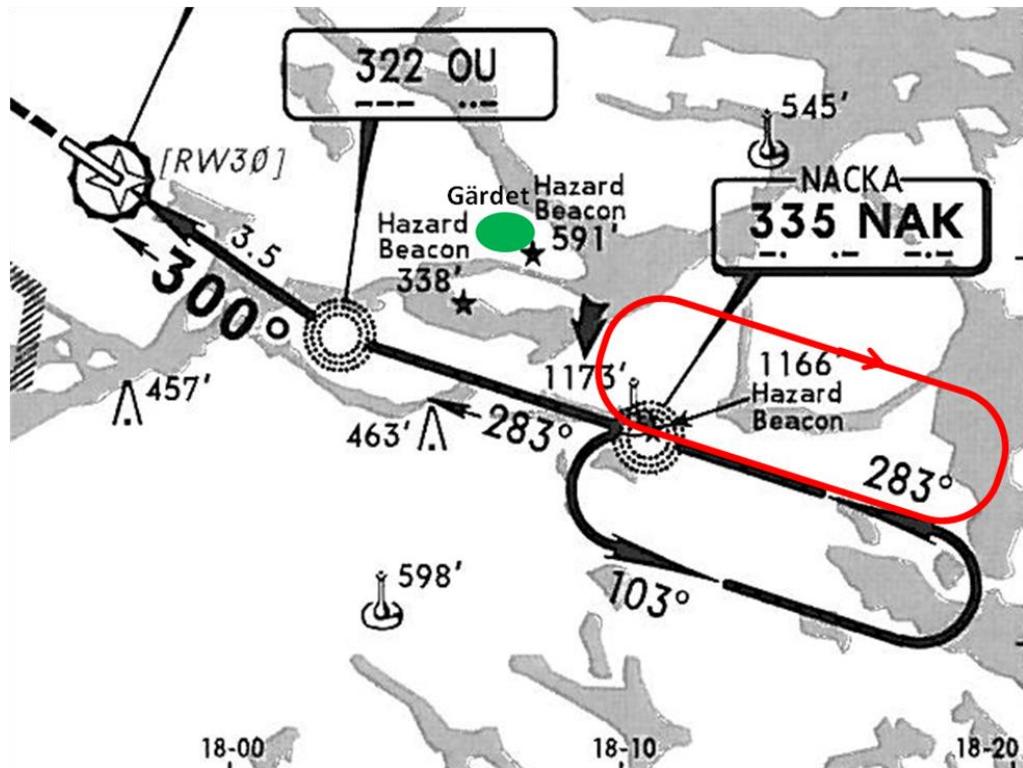
The pilots did not feel there was time to program the FMS and instead chose to navigate to the holding pattern using the ADF RMI instrument. NAK holding was interpreted in accordance with the approach map's available turn procedure. This implicated that the pilot's intention was to turn right on an easterly heading after NAK had been passed (see fig. 13). SHK believes that the pilots did not have the opportunity to rapidly identify NAK holding with the map data used for the approach in question.

Fig. 13 The Nacka procedure turn. Right turn in red.

On this occasion, SE-MDB had still not begun a right turn but was on a heading of 350° . The nearest route to get to the final was to turn left, which is why STO SYD ordered a left turn at 200° . As this left turn was initiated, STO SYD had no knowledge that there were skydivers in the air, which meant that only
