RUNWAY INCURSION

The crew of the Shorts 3-30 aircraft believed they had been cleared to line up for take-off from an intermediate point on Runway 27 at Paris-Charles de Gaulle Airport. As they entered the runway the aircraft was struck by the wing of an MD 83 aircraft which was taking off, using the full runway length. A recent survey of pilots involved in Runway Incursion incidents revealed that 50% believed they had permission to be on the runway when the incident took place.

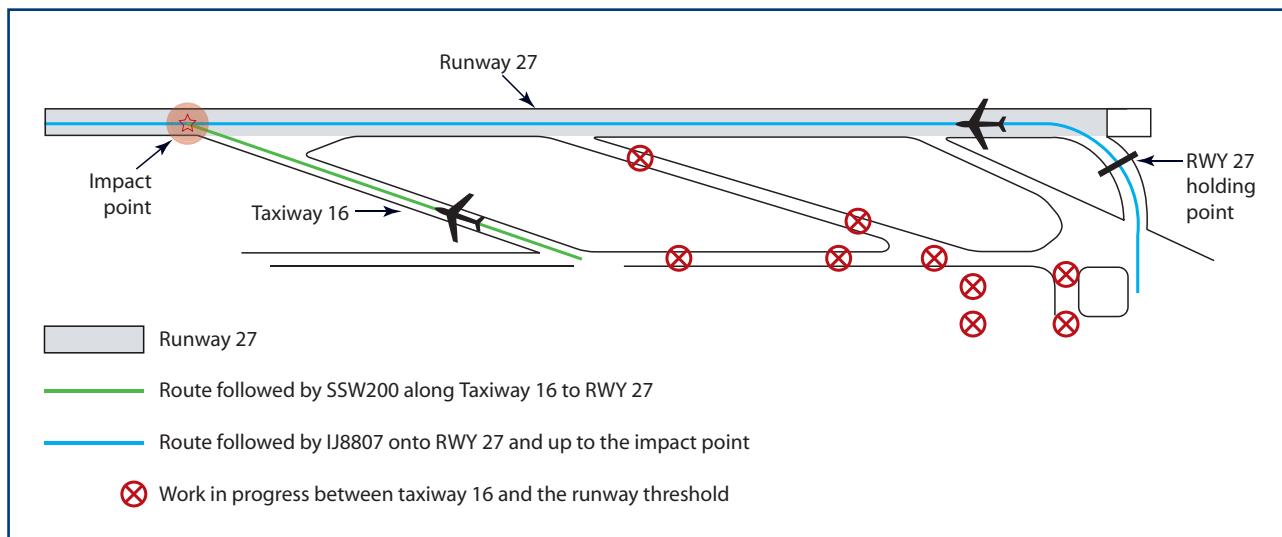
There was work in progress at various points between taxiway 16 and the runway threshold involving some 10 vehicles equipped with orange flashing lights, while the work itself was illuminated by halogen lamps (see diagram).

There were no fixed obstacles blocking the view of the runway threshold from the cockpit of SSW200. The field of view from the Shorts 330 right hand pilots seat extended 120° to the right of the aircraft axis; however, the pilot was unable to see the threshold of RWY 27 while the aircraft was on taxiway 16 because of the extremely acute angle between taxiway and runway.
