## Investigation report

L2012-01

### Risk of Runway Collision Between Two Airliners at Helsinki-Vantaa Aerodrome on 29 December 2011

YL-RAG, SAAB 340A

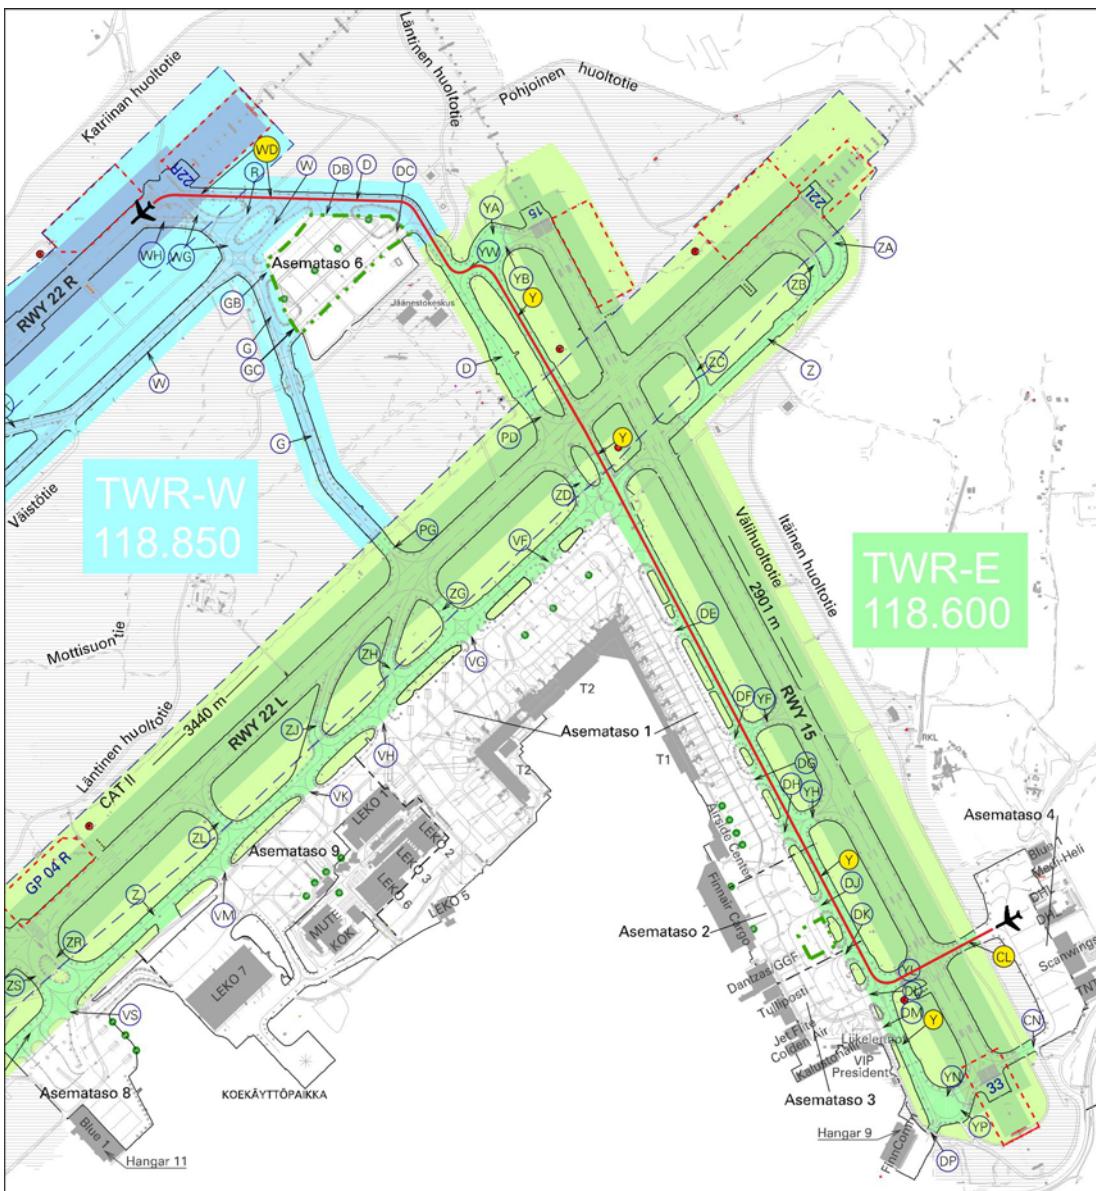
Figure 1. The taxi route of NEF025.

At 14:39:27 NEF025 contacted TWR-W. At that time the controller said: 'NEF025 one landing'. NEF025 read back: 'Landing'. Following this, NEF025 increased the taxi speed and taxied onto RWY 22R.

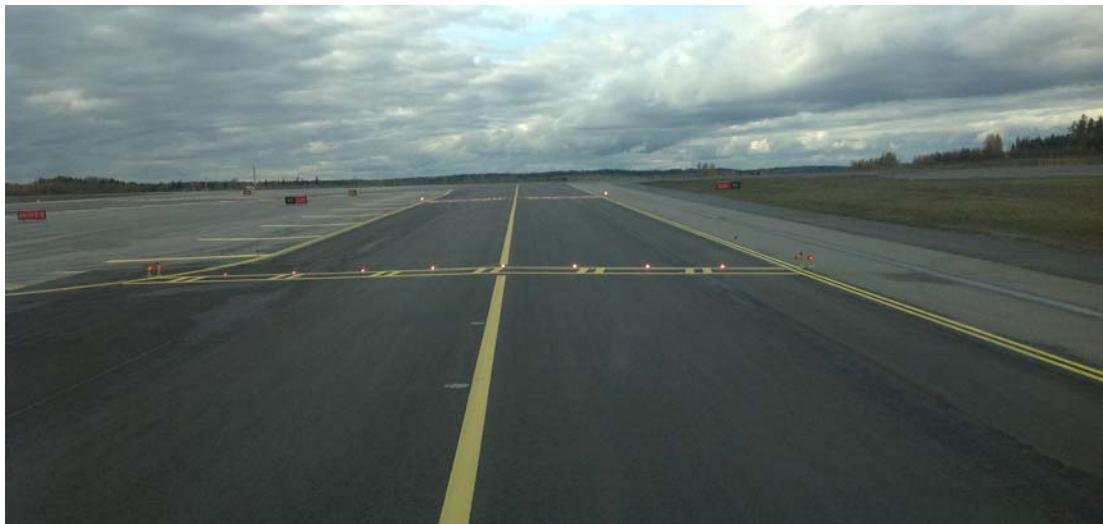
NEF025 decelerated and almost came to a halt at the red stop bar. The stop bar is located at approximately 80 m before holding point WD.

Figure 2. The stop bar on taxiway WD.

*Safety Investigation Authority, Finland recommend that the Latvian Civil Aviation Agency ensure that the pilots of RAF-AVIA Airlines are familiar with the procedures related to stop bars.*

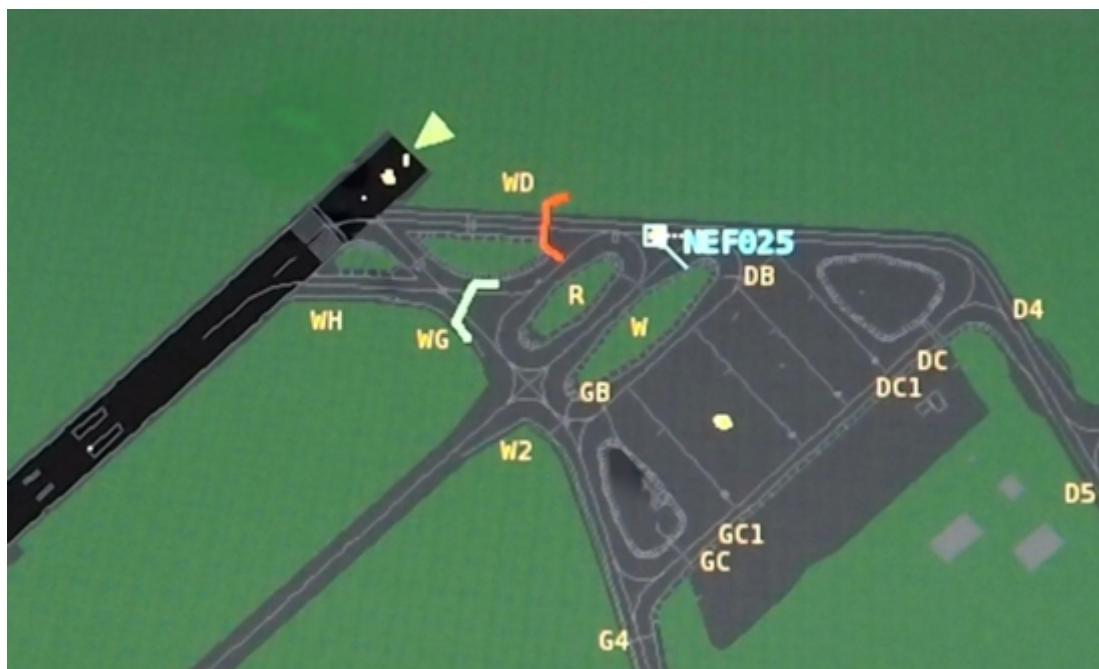
Figure 3. Surface movement radar picture showing illuminated stop bar.

*Safety Investigation Authority, Finland recommend that Finavia Corporation study the possibilities of introducing a system that alerts air traffic controllers of runway incursions.*

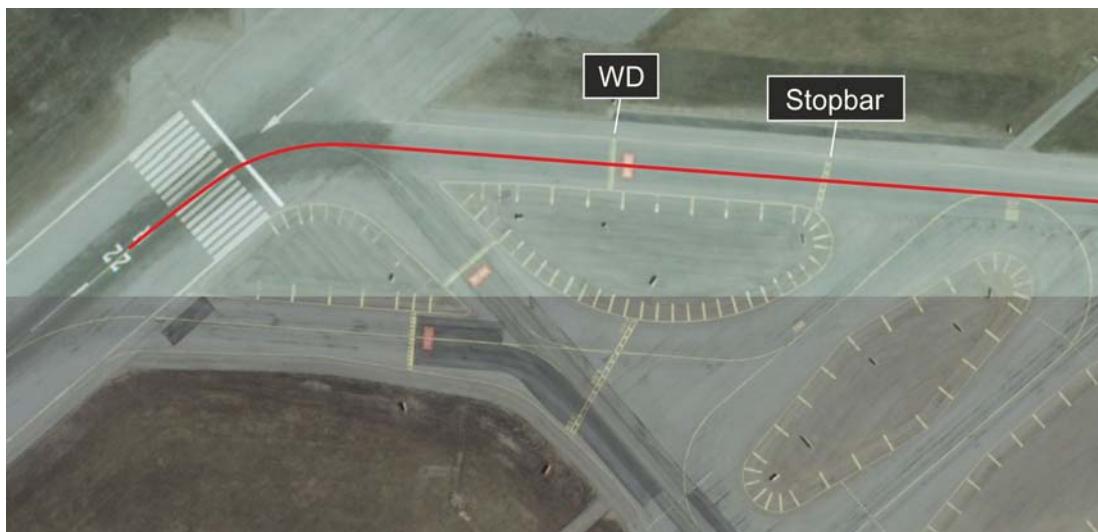
Taxiway WD at Helsinki-Vantaa leads to RWY 22R at an approximate 45° angle. In practice, this means that it is only possible to check the approach sector from the right seat when taxiing onto RWY 22R via holding point WD. In situations like this multi-crew cooperation must make sure that, despite the limited view, the approach sector check is not left undone.

Figure 4. Taxiway WD and taxiroute of NEF025 (KTJ/Oikeusministeriö/MML).
