Runway Overrun and Collision  
Southwest Airlines Flight 1248  
Boeing 737-7H4, N471WN  
Chicago Midway International Airport  
Chicago, Illinois  
December 8, 2005

NTSB/AAR-07/06  
PB2007-910407

# Aircraft Accident Report

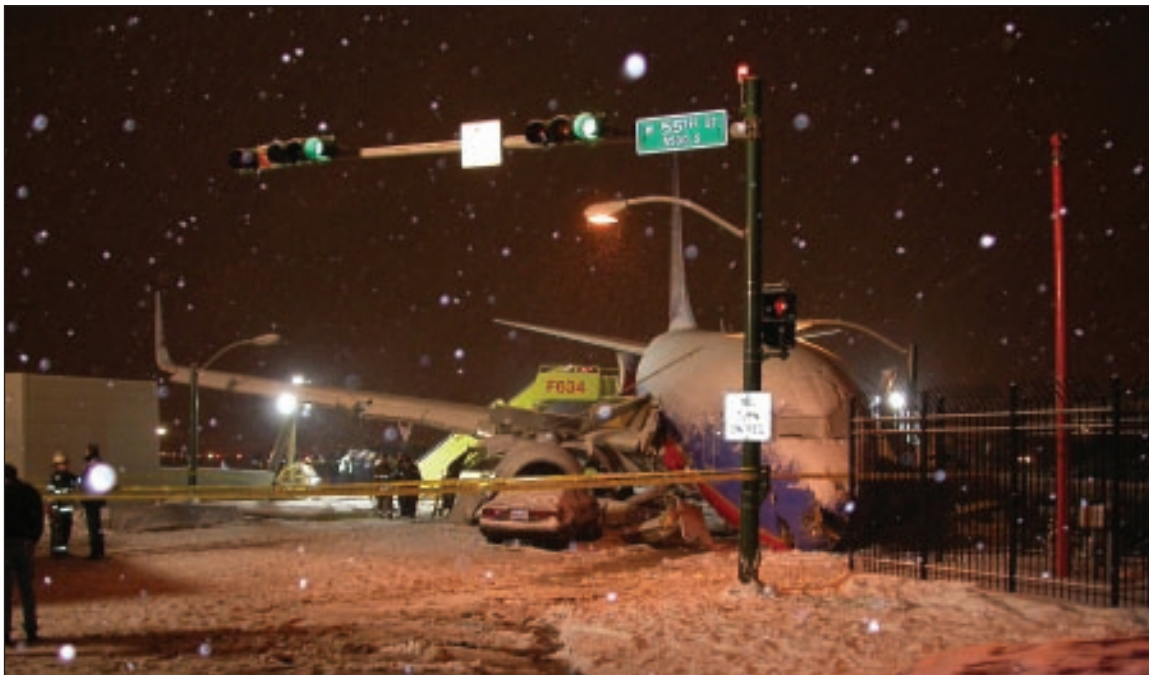
However, the airplane ran off the departure end of runway 31C and continued through the runway safety area (RSA),<sup>12</sup> a blast fence, a navigational aid antenna, across an airport road, through an airport perimeter fence, and onto an adjacent public roadway. The airplane struck a northbound automobile on that roadway before it came to rest near an intersection located on the northwest corner of the airport. (Figures 1 and 2 show the airplane's position off the end of runway 31C.)

**Figure 1.** Photograph of the accident airplane in the roadway intersection. (Looking southeast, towards the departure end of runway 31C.)

The airplane rolled through an airport blast fence, an ILS array, a frangible airport perimeter fence, and onto a roadway, where it struck an automobile and a fire hydrant. Damage to the wing leading edges and engine nacelles of the airplane aligned with vertical posts from the airport perimeter fence; there was no damage observed in the airplane cockpit or cabin.

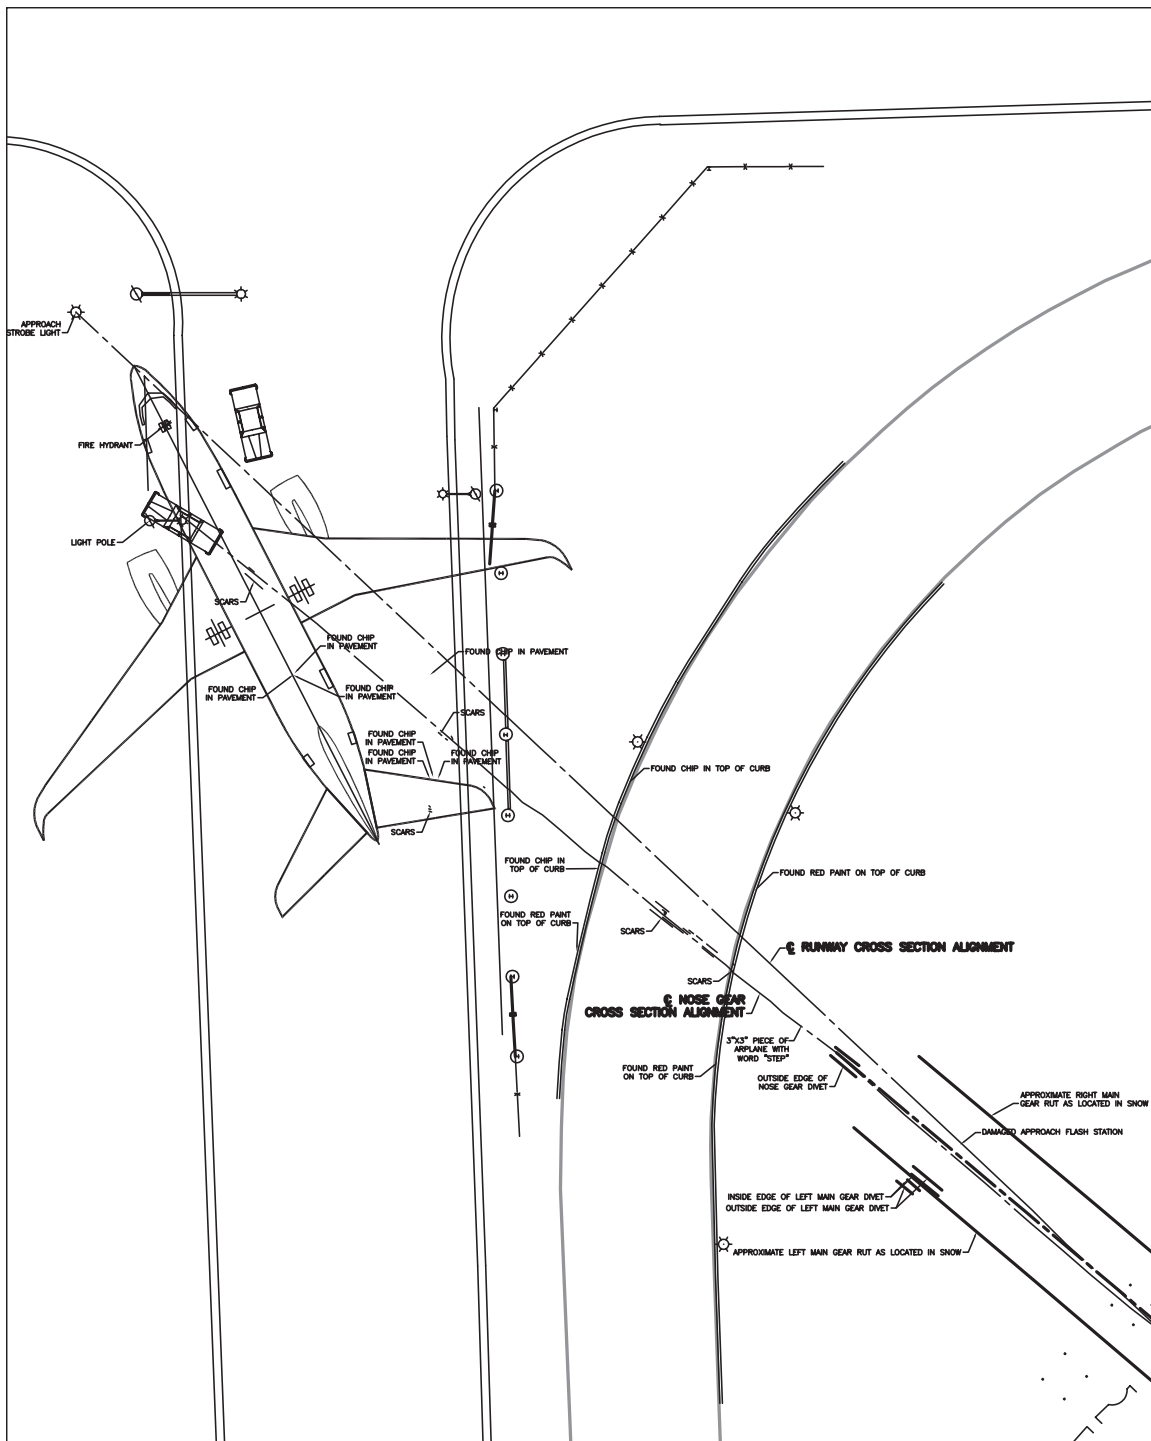
**Figure 2.** Diagram showing the accident airplane where it came to rest (on a heading of 340°) in the intersection off the end of runway 31C.

The airplane came to rest on a magnetic heading of about 340° at the south side of an intersection located on the northwest corner of MDW. The airplane was resting on the engines, both main landing gear, and the nose of the fuselage, with the nose landing gear collapsed and folded aft. The damage to the airplane was largely limited to the forward lower fuselage, engine cowlings and components, forward portions of the wings, and other wing components,<sup>28</sup> with limited damage farther aft. The rear part of an automobile was found damaged beneath the forward portion of the airplane's left fuselage. Postaccident interviews and physical evidence indicate that the automobile was northbound on the roadway and was struck from behind by the airplane.

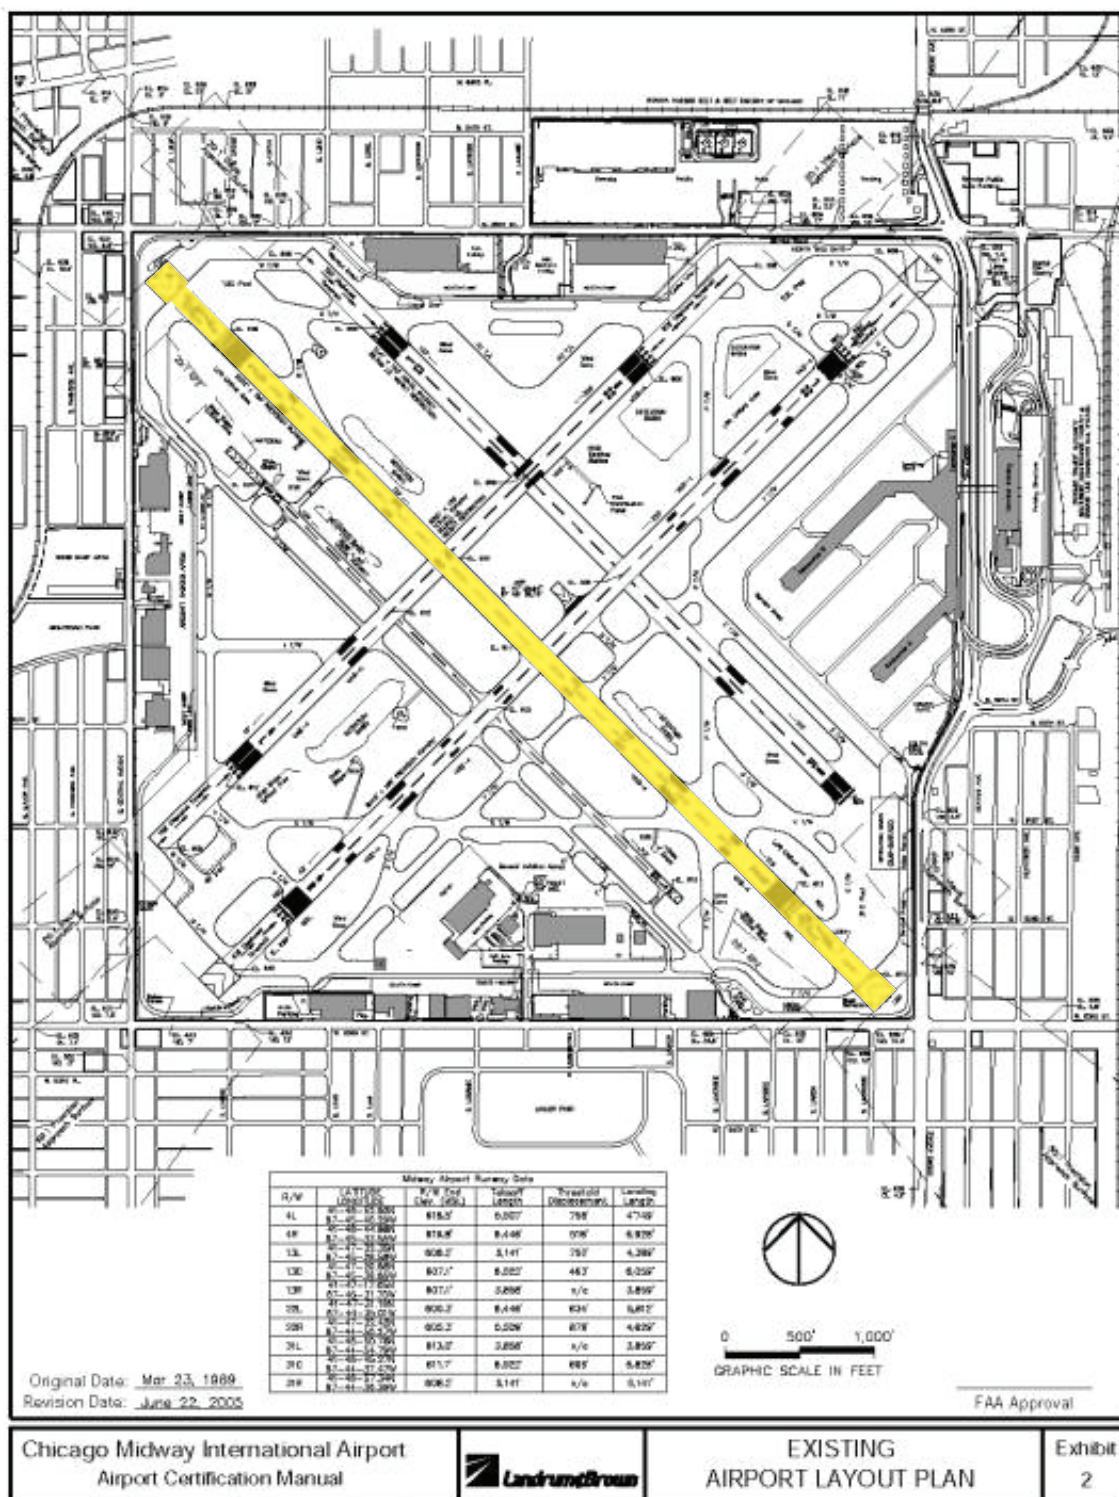
**Figure 3.** The MDW airport layout plan with surrounding streets and properties. Runway 31C is highlighted in yellow.

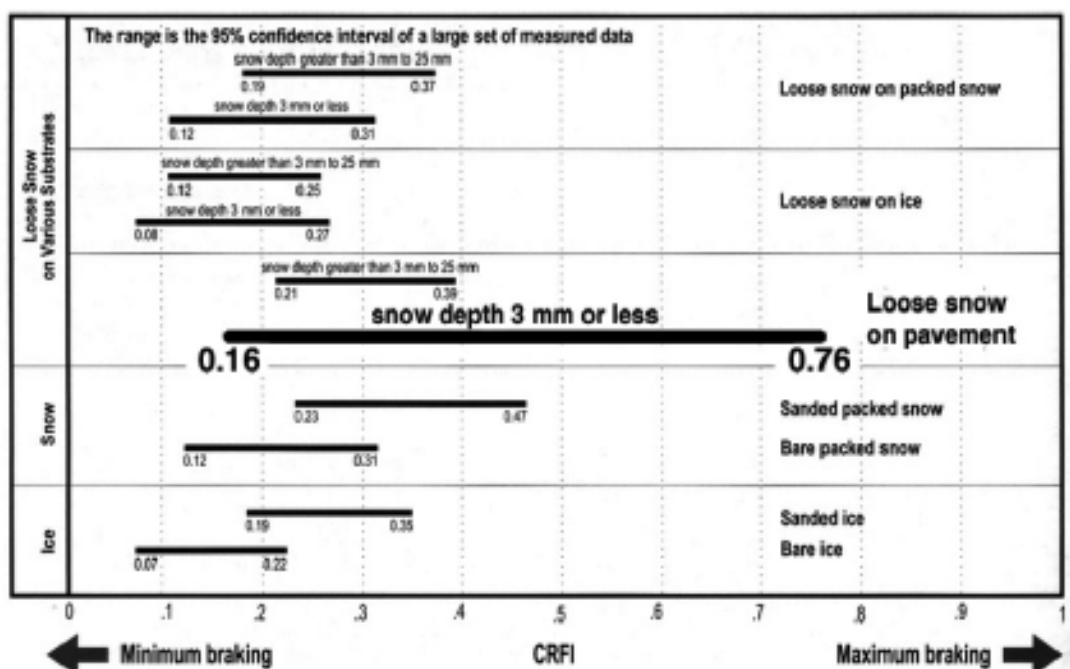
**Figure 7.** CRFI values for various runway surface conditions. Note that the CRFI values for loose snow 3 mm deep or less on pavement ranged from 0.16 to 0.76 (see the bold horizontal line).
