# AIRCRAFT ACCIDENT REPORT 5/2004

**Report on the accident to  
Bombardier CL600-2B16 Series 604, N90AG  
at Birmingham International Airport  
4 January 2002**

**Air Accidents Investigation Branch**

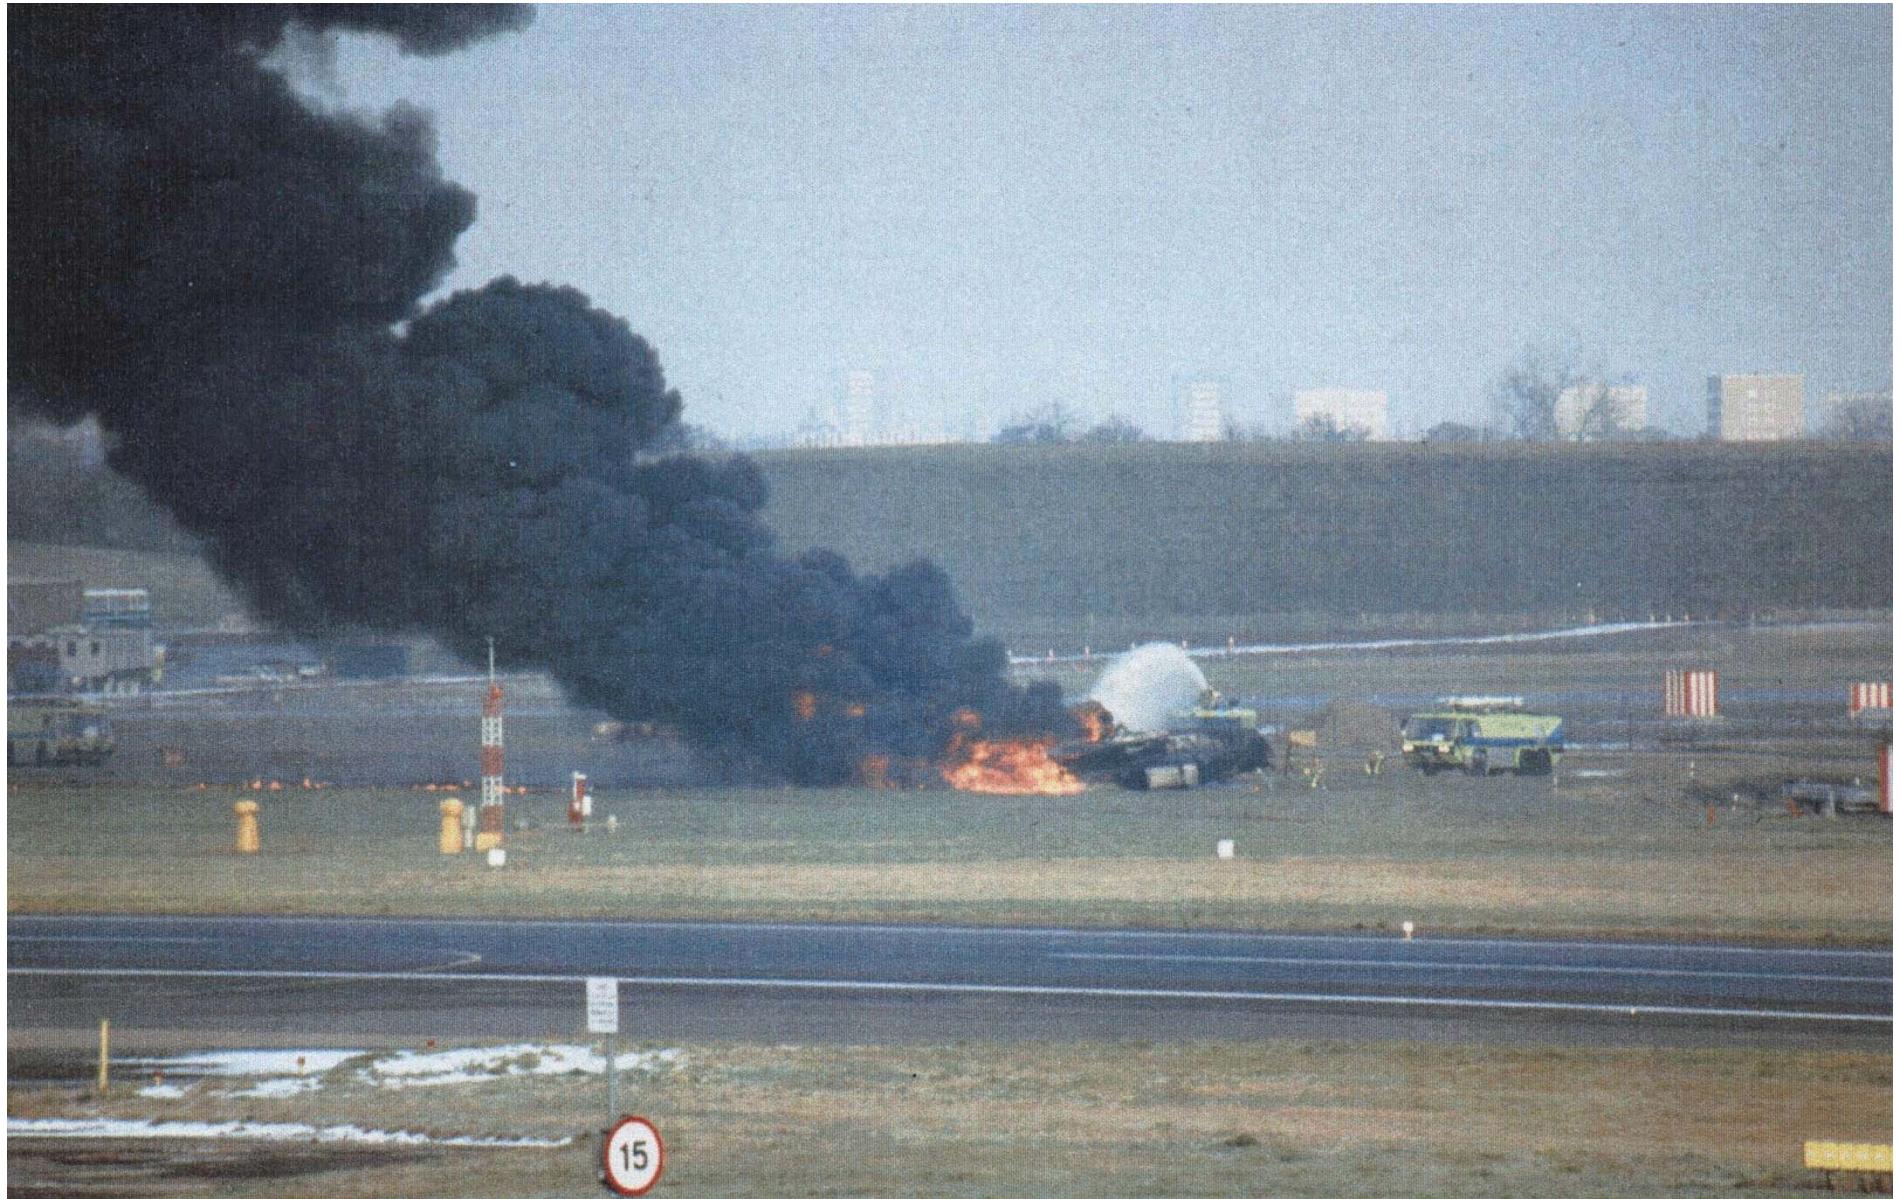
Figure 2

The aircraft was largely destroyed by impact and fire damage (Figure 2).

The main wreckage consisted of the centre and aft fuselage with both powerplants and the wings, with the exception of the outboard part of the left wing, attached. It was lying inverted with both main landing gear legs attached, extended and downlocked. The main wreckage had suffered widespread fire damage that was generally light, but somewhat more severe in the region of the forward part of the wing centre-section and around the left wing stub. The wreckage section comprising the remains of the forward fuselage (forward of the wing centre-section) was found in approximately its normal position relative to the main wreckage, but upright. It was structurally separated from the main wreckage but remained connected to it by cables and pipelines.

The forward fuselage was found with most of the above-floor structure absent. Parts of the missing structure were found in the crater and along the wreckage trail. The remaining parts of the forward fuselage had suffered moderately heavy fire damage, with some destruction of components. However, there were no signs, such as large quantities of ash or re-solidified aluminium alloy deposits, that major parts of the absent structure had been destroyed by fire.

The remainder of the fuselage, aft of approximately the middle of the wing centre-section, remained intact. Three passenger seats remained in situ at the rear of the cabin. The fuselage portion had suffered crushing of the upper parts of the cabin, structural damage at the rear, associated with detachment of the empennage and tailcone, and localised fire damage in the forward areas. The attachments of the fin to the fuselage had suffered fractures consistent with the effects of gross overload.

## N90AG Accident site

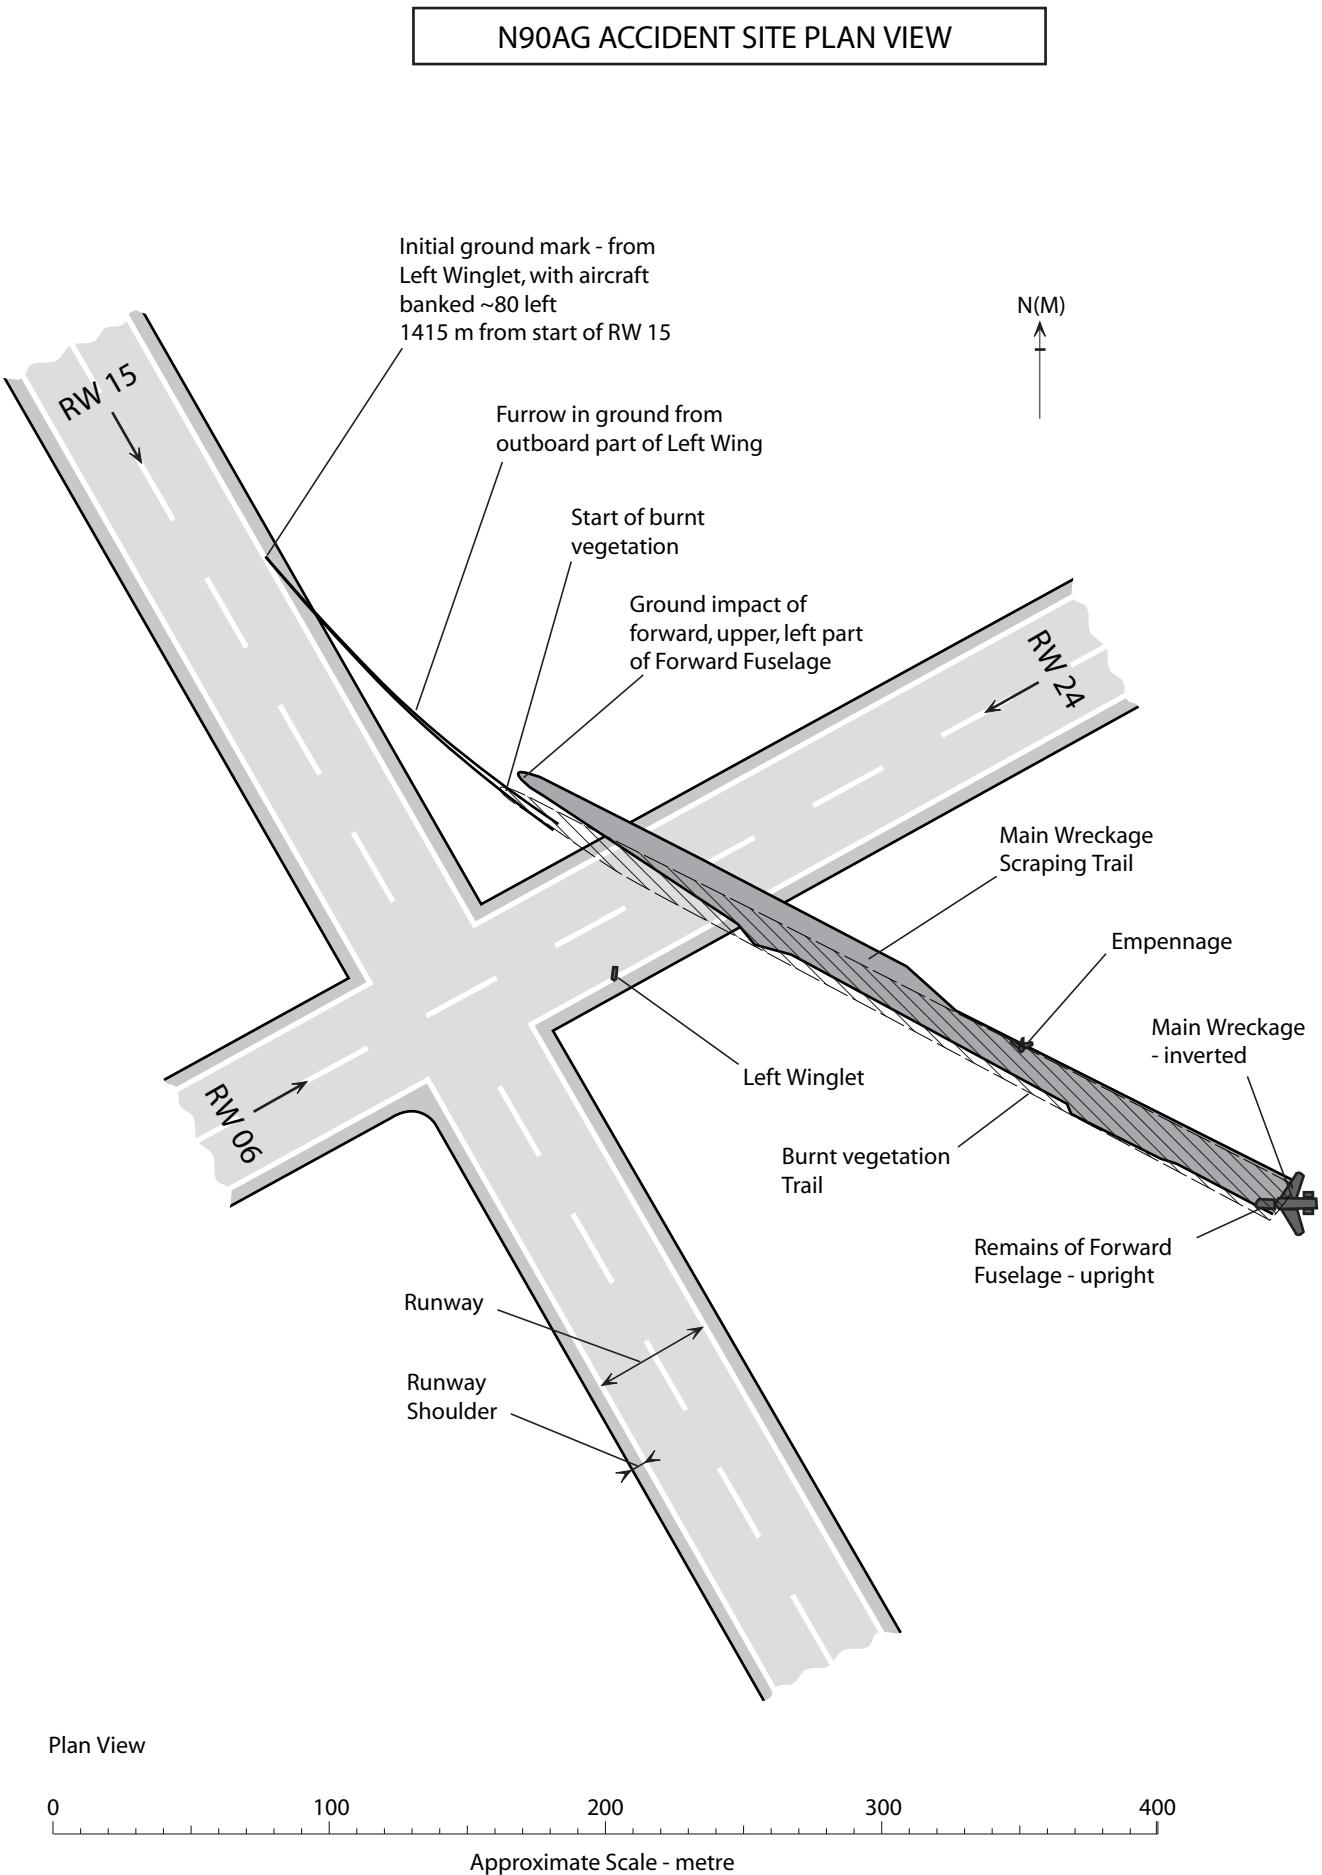
**Figure 4**

Initial ground contact marks attributable to N90AG’s accident were found on the tarmac-surfaced left shoulder of Runway 15, approximately 1,415 metres from the runway start and 24 metres left of its centreline (Figure 4). In the following description distances are measured from the start of the initial mark and directions are in the direction of aircraft travel.

The initial mark consisted of a light, narrow scrape tracking 10° left of the runway heading, followed after 3 metres by a second, parallel, similar mark. Geometric considerations and detailed wreckage damage evidence indicated that the markings had been made by two trailing static wick assemblies mounted on blocks protruding from the left winglet outboard surface. Calculation showed that the winglet would be horizontal over a range of aircraft attitudes, from pitch and bank angles respectively of 0°/81° to 18°/73°, neglecting any wing deflection under load.

Additional paint and aluminium scrape marks on the runway were evident after 5 metres, becoming progressively more prominent, and between 15-30 metres formed an area of heavy, wide marking. The marks could be matched with areas of heavy abrasion damage found on the outboard face of the left winglet.

At 40 metres, the scrape marks crossed the left edge of the shoulder onto the ground adjoining the runway. The terrain was flat, of medium weight soil covered with short grass and was found covered with a heavy frost on the afternoon of the accident. The contact continued, in the form of a furrow ploughed in the ground, generally smooth and becoming progressively deeper, but with areas of unevenness and with signs of increasing anti-clockwise roll. Broken parts of the outer portion of the left wing found in the area, together with damage and packed earth deposits on this portion of the wing, made it clear that the furrow had been created by the outboard part of the left wing. After a total scrape distance of 120 metres, the start of a trail of burnt and sooted vegetation was evident around the furrow. At the same point along the trail, around 7 metres left of the wing furrow, a ground crater had been formed, in which flight deck components were embedded, including structural members and a number of flight deck transparencies. It was clear that the crater had been formed by inverted ground impact of the forward fuselage. Shortly after this point the ground furrow formed by the left wing ceased.

The crater formed the start of a second furrow, which became a progressively wider and shallower trail strewn with increasing quantities of debris from the fuselage structure and internal contents. This trail generally lay within an area of burnt and sooted vegetation. The wreckage in the trail included the empennage and seven of the passenger seats. The trail of debris and burning crossed Runway 06/24 and continued across the grass to the point at which the main wreckage came to rest, 320 metres beyond the fuselage ground contact point.
