Approach above glide path, interception of ILS sidelobe signal, increase in pitch angle commanded by autopilot

Aircraft	Airbus A340-300 registered F-GLZU
Date and time	13 March 2012 at 04 h 50 ⁽¹⁾
Operator	Air France
Place	On approach to Paris Charles de Gaulle Airport (95)
Type of flight	International public transport of passengers
Persons on board	Captain (PF) Co-pilot (PNF)
Consequences and damage	None

This is a courtesy translation by the BEA of the Final Report on the Safety Investigation. As accurate as the translation may be, the original text in French is the work of reference.

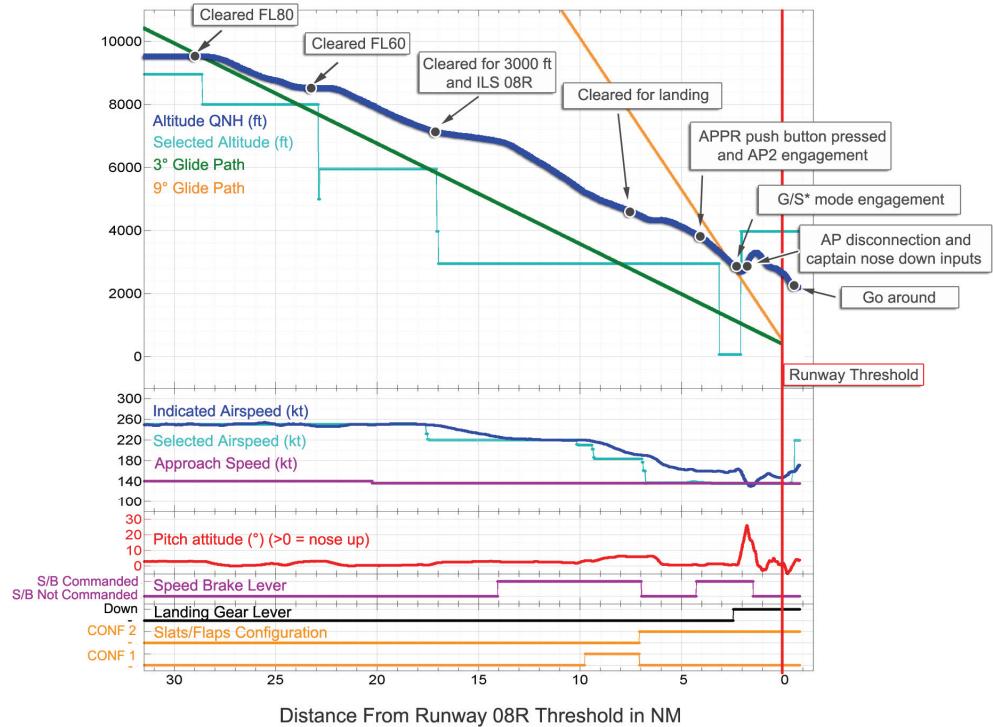
Figure 1: Vertical flight path of F-GLZU

About 30 seconds later, the crew extended the landing gear. The glide path capture mode (G/S*) was activated when the aeroplane was 2 NM from the runway threshold at 2,850 ft (that is about 1,600 ft above the glide path at 3°). The ATHR changed to SPEED mode. The pitch attitude increased from 1° to 26° in 12 seconds. The PNF stated that he had called out the difference in the pitch attitude when the chevrons⁽⁴⁾ appeared. When the aeroplane pitched up, the speed dropped from 163 kt to 130 kt, the vertical speed changed from - 1,600 ft/min to + 3,300 ft/min. When the pitch attitude reached 26°, the crew disconnected both autopilots and the PF made a pitch down input almost down to the stop. The pitch attitude and vertical speed decreased. The crew retracted the airbrakes. The throttle levers were in the IDLE position. The speed was 143 kt and the ATHR disengaged. About 30 seconds later, autopilot 1 was engaged, the levers were repositioned on the CL setting and the ATHR was activated.

The PF explained that he engaged autopilot 1 to perform a go-around on automatic⁽⁵⁾. The LOC and G/S modes were active and the ATHR was in SPEED mode. The speed was 147 kt. The aeroplane was directly above the runway threshold at an altitude of about 2,700 ft. The pitch attitude then decreased from 2° to -5° and the aeroplane descended.

The PF stated that he realised that the modes displayed on the FMA were not appropriate. He then disengaged the AP 8 seconds after having activated it and then displayed a pitch attitude of about 6° and placed the throttle levers in the TOGA setting at an altitude of about 2,000 ft.

The aeroplane entered a sidelobe beam at 10°. The glide path indication strengthened the crew's conviction that they were getting closer to the path at 3° from above whereas in reality they were getting closer to the path at 10° from below. The crew set up the G/S mode while the aeroplane was beyond the FAP, 2,100 ft above the path and 4 NM from the threshold.

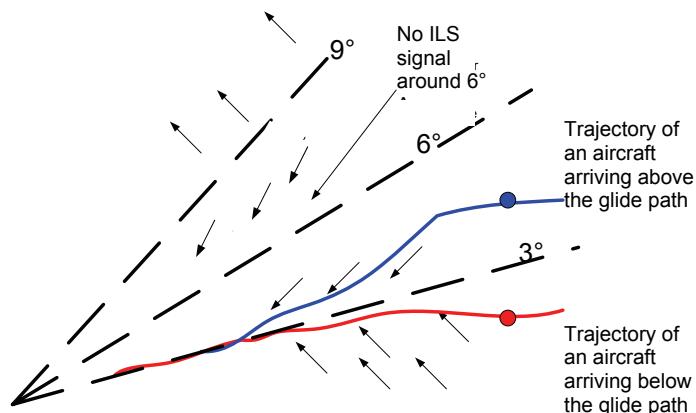
Figure 4: Direction of the ILS signal deviation

The simplified principle of the deviation direction of the glide path signal is described by the diagram below: the main lobe at 3° forms the published glide path and a sidelobe is present at about 9° . In this sidelobe, the signs of deviation are inverted by design.

The parameters recorded by the aeroplane made it possible to determine that the ILS 08R sidelobe slope was close to 10° on the day of the incident.

During this incident, in autopilot, the G/S* mode was engaged on an ILS signal of a sidelobe defining a descent slope of about 10° . The autopilot interpretation of the ILS signal led to an increase in pitch. This pitch up increase continued until it reached 26° . The crew then disconnected the autopilot and performed a missed landing.

The activation on autopilot of the glide path capture mode at 10°, corresponding to an ILS signal sidelobe, led the aeroplane to a nose-up attitude of 26°. Aeroplane systems do not check the consistency of the path signal with the other information available (DME distance, altitude).

- **EASA ensure that aircraft ILS modes are not engaged on an ILS signal other than the one corresponding to the published descent path; that failing this, a system enabling the crew to be alerted be put in place; [Recommendation FRAN-2013-008]**

- **EASA ensure that the activation of aircraft ILS modes in autopilot does not lead to inappropriate attitudes during approach. [Recommendation FRAN-2013-009]**
