Final Report

HCLJ510-2012-172

Serious incident to Airbus A319-131
Registration OY-KBR
At Copenhagen Airport, Kastrup (Denmark)
On 21 November 2012

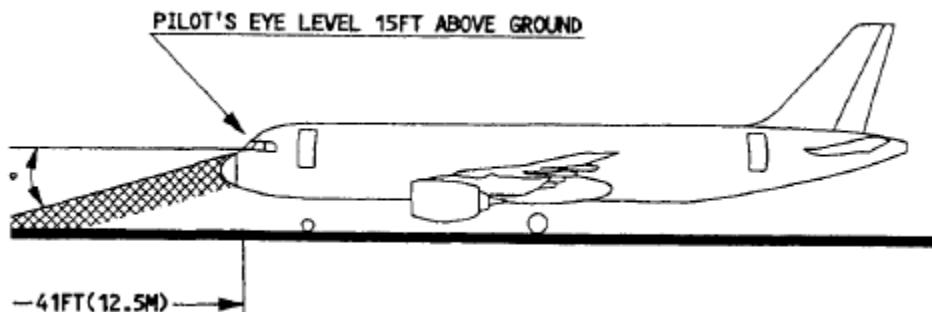
The pilot's eye level is approximately 15 feet / 4.57 meters above the ground as shown on the drawing below.

In addition to this, it is the opinion of the AIB-DK that the 1.2 m higher eye level above the ground compared to the eye level of the MD-80 – in which the CMD was experienced – gave him the impression of a lower ground speed.

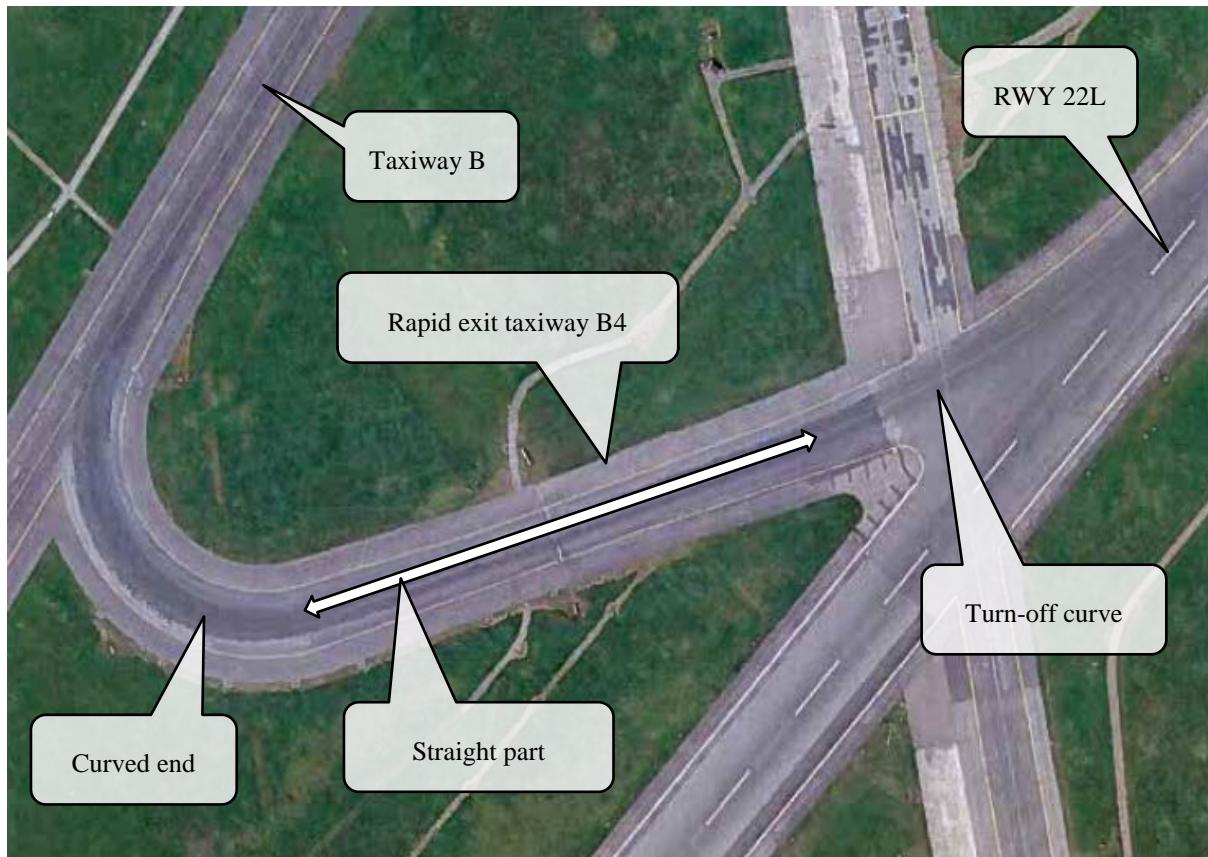
TWY B4 shown below.

Angle of the turn-off curve:	30°
Radius of the turn-off curve (R):	543 meter
Straight part:	226 meter
Angle of the curved end:	142°
Radius of the curved end (R):	76 meters

Another viewpoint related to human factors was the pilot’s perception of TWY B4. The B4 was defined as a “rapid exit taxiway” and the design was according to ICAO Annex 14 standards and approved by the Danish Transport Authority but, the curved end of B4 was a sharp angled curve. It is the opinion of the AIB-DK that this in general mentally was overlooked by the pilots of the airline. The mental focus was on the fact that they used a rapid exit taxiway and therefore, they were surprised when they arrived at the sharp angled curve after a relative short straight distance from the turn-off curve.

In relation to the TWY B4 design the investigation found no deviations from the requirements described in ICAO Annex 14.

"The design of the high speed exit is according to ICAO standards, with a speed limitation of 15 knots on DRY surface. This calls for a significant lower speed in wet or contaminated conditions".

"RWY 22L leaving rapid exit TWY B4, the curved end of TWY B4 is designed for a max 15 knots in dry conditions only. Hotspot chart will be issued SAP in AIP Denmark, AD2-EKCH-ADC".

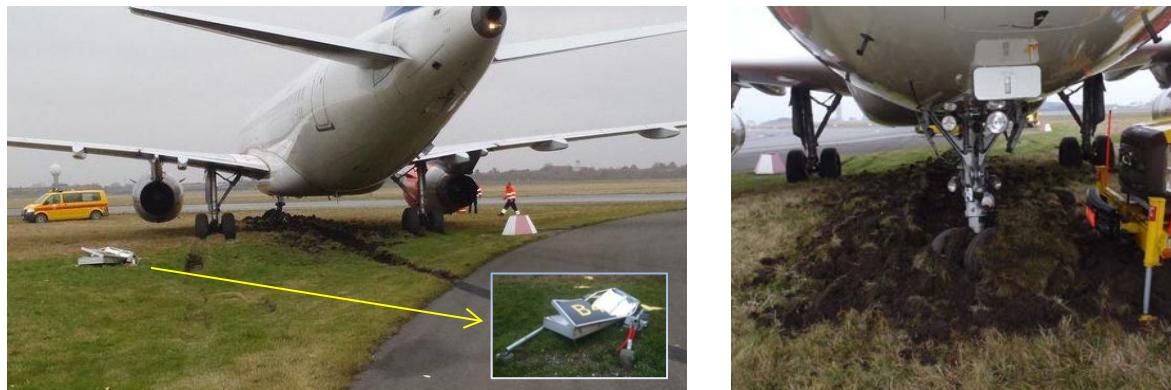
The aircraft impacted the B4 location and B direction sign located in the grass area close to the taxiway (left picture below). The nose landing gear was covered with dirt but undamaged (right picture below).

Broken parts of the B4 location and B direction sign were found inside the engine behind the air inlet fan.

The left engine air intake and the lower engine cowling were damaged.

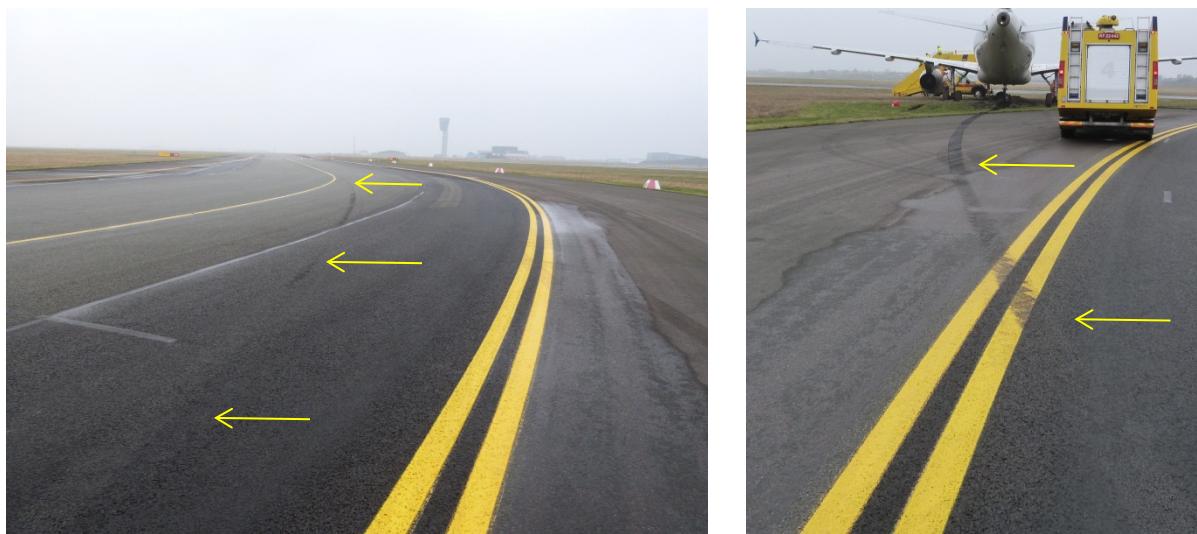
On the pictures below it can be revealed that the nose wheel was skidding on the taxiway asphalt from the point of the beginning of the curved end (at the centerline) to the grass area (marked with yellow arrows).

It appears from the pictures above that the taxiway was damp and drying up.

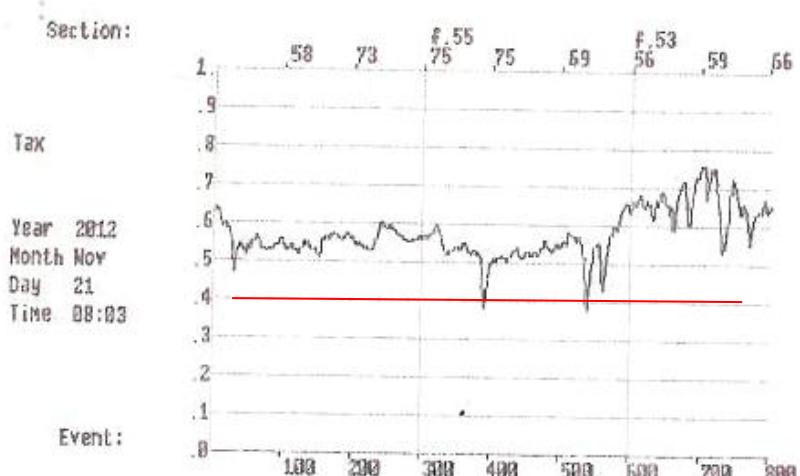
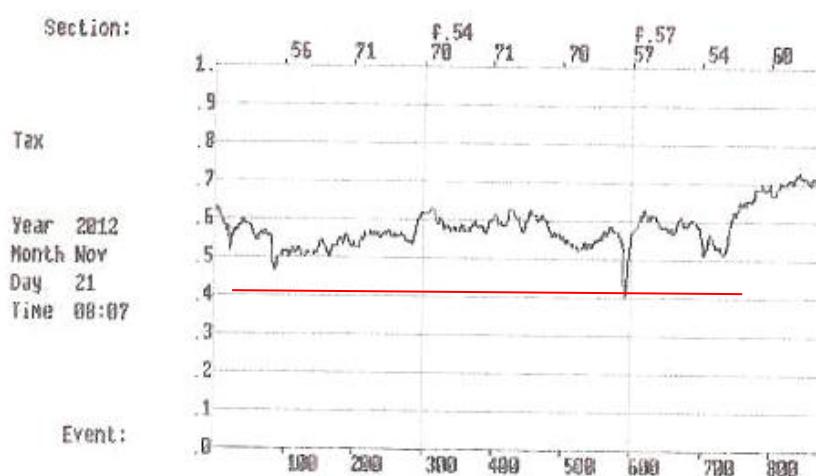
From the friction test strips shown below, it can be revealed that the friction was good (measured friction coefficient 0.40 and above) Friction coefficient 0.40 marked with red lines.

TWY B4 was damp but the friction tests revealed that the friction at the time of the serious incident was good.

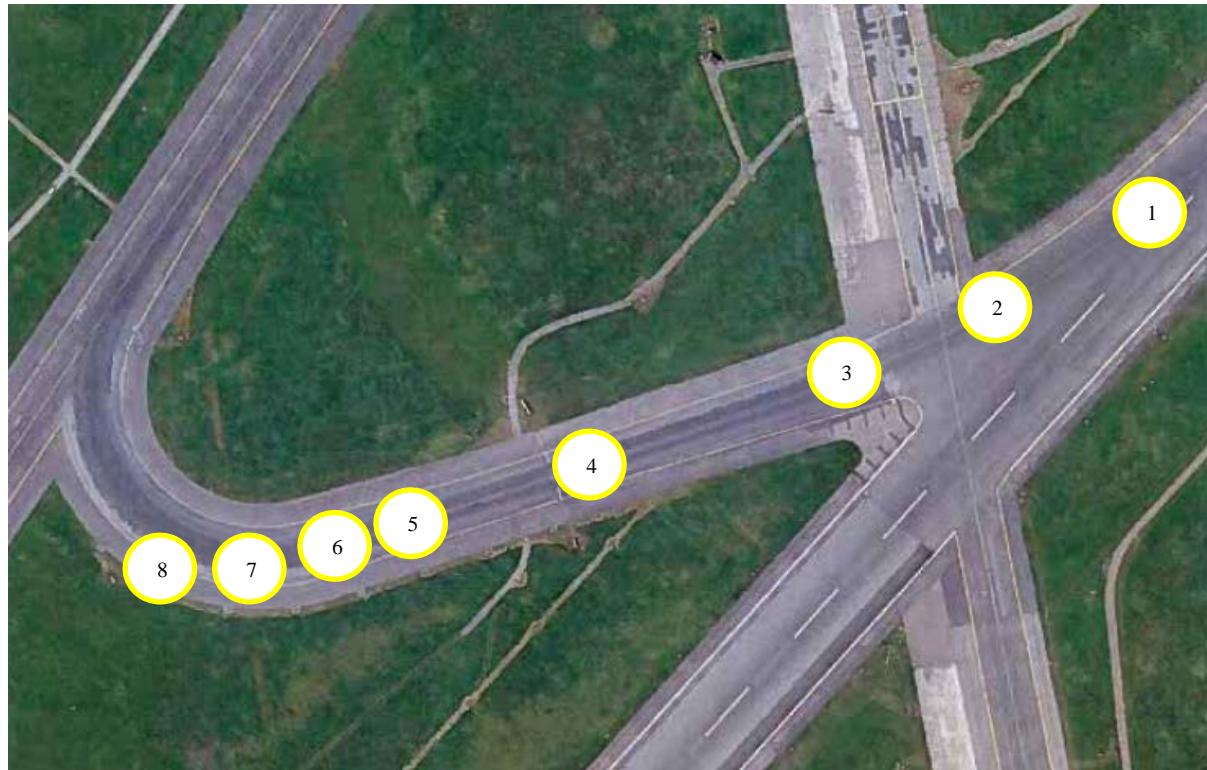
Aircraft Condition Monitoring System (ACMS) data in relation to aircraft position on TWY B4 shown below. The time period between pos. 1 - 8 was 26 seconds.

The brake pressures (not shown) correspond to the brake pedal positions (high units / high pressure).

Analyzing the ACMS data, the AIB-DK found the aircraft turned off RWY 22L at a ground speed of approximately 45 knots and that braking was performed ineffectually (mostly using the left brake) while the aircraft was rolling on the straight part of B4. The AIB-DK is of the opinion that consistently braking on the straight part of B4 could have prevented the serious incident.

From the ACMS data it could also be revealed that the aircraft entered the curved end of B4 with a ground speed approximately 12 knots above the curve design speed.

The inertia (approx. 51.000 kg / 31 knots) exceeded the nose wheel tires friction ability to turn the aircraft in the direction of the curve. As the nose wheel steering was turned right the nose wheel tires ended up with an angle to the direction of the aircraft movement of 47° to 70°. Therefore, the aircraft skidded almost straight ahead and left TWY B4.

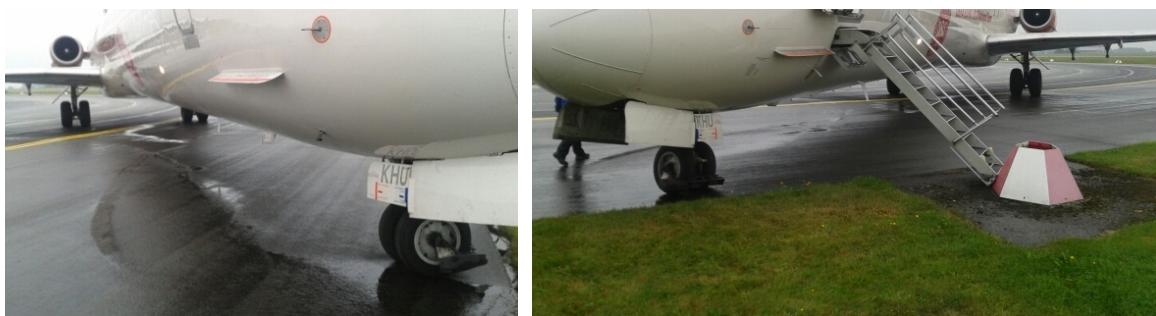
Latest incident was to a McDonnell Douglas MD-87 on 11th September, 2012. The aircraft was unable to follow the centerline of the curved end of TWY B4. The aircraft exceeded the left yellow side marking off TWY B4 as the nose wheel was skidding. The aircraft stopped on the asphalt close to the grass area (pictures below).

FDR data showed the following. When the aircraft turned-off to TWY B4, the indicated airspeed (IAS) was 58 knots and the lateral acceleration reached 0,138 G.

When the aircraft skidded off TWY B4, the IAS was 31 knots or below.

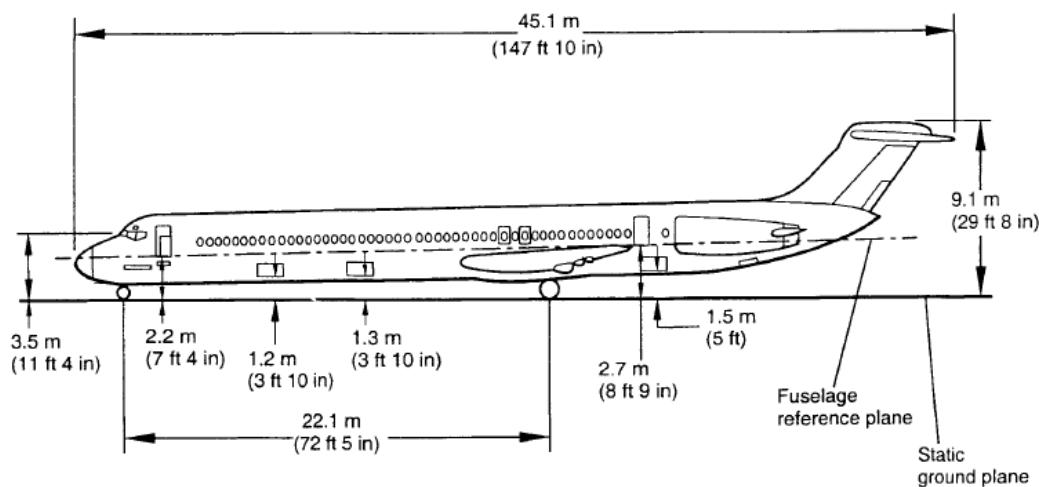
The pilot's eye level is approximately 3.5 meters above the ground as shown on the drawing below.
