Final report RL 2013:11e

**Serious incident involving the aircraft
PH-DCI and SE-MDC in the airspace
north-east of Jönköping, Östergötland
county, on 20 June 2012.**

Ref no L-53/12
2013-06-11

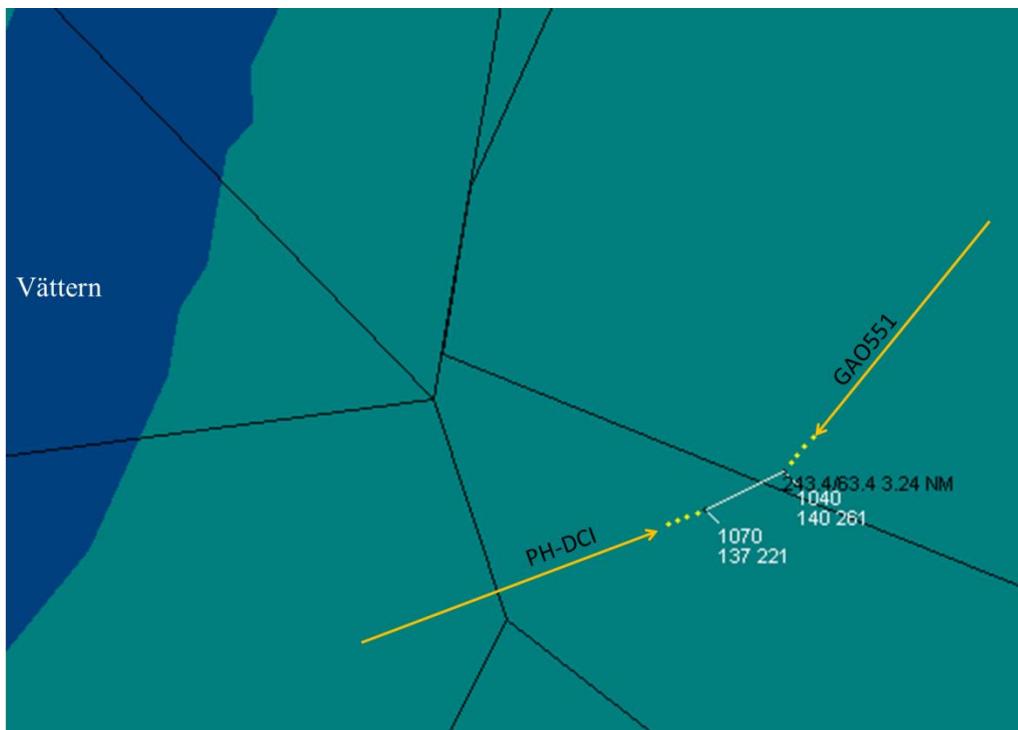
The least vertical distance between the aircraft was 300 feet at a horizontal distance of 3.24 nautical miles (nm). The least horizontal distance was 1.75 nm with an altitude difference of 800 feet, see Fig. 1.

Fig. 1. Radar tracks with the minimum vertical distance of 300 feet at a horizontal distance of 3.24 nm.
