# **Airbus A340, A40-LB and Boeing 757-236, G-BIKG, 23 November 1995**

**AAIB Bulletin No: 7/96 Ref: EW/C95/11/4Category: 1.1**

**Location:** Heathrow Airport

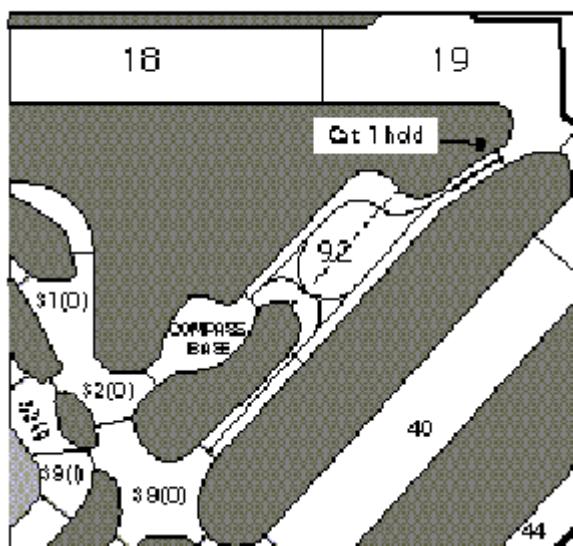
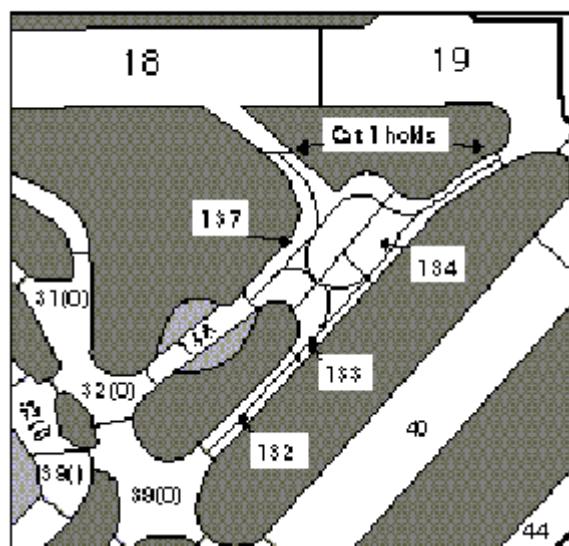
RUNWAY 27R HOLDING AREA BEFORE OCT 95    RUNWAY 27R HOLDING AREA ON 23 NOV 95

The accident occurred in the holding area for Runway 27 Right. During the autumn of 1995, a new access to Block 18 of Runway 27R was constructed as shown below. With the introduction of this taxiway the old holding area (Block 92) was subdivided into three new blocks and the compass base was moved to another part of the airport. Each block has a taxiway centreline marked on the ground by a yellow painted line and green lights. (For clarity only the centrelines within the holding area are shown in the diagram below). At the end of each block there are stop lines and red lights across the centrelines marking the extremity of the block.

The boundary line at the top of Block 137 in the right hand diagram is also the Cat I Hold line. The line was painted parallel to the runway and 105 metres from its centreline. This is also the edge of the runway strip. (The runway strip is defined in CAP168; essentially it is an area enclosing the runway which must be kept clear of obstacles). There was also a Cat II/III Hold parallel to and 137 metres from the runway centreline.

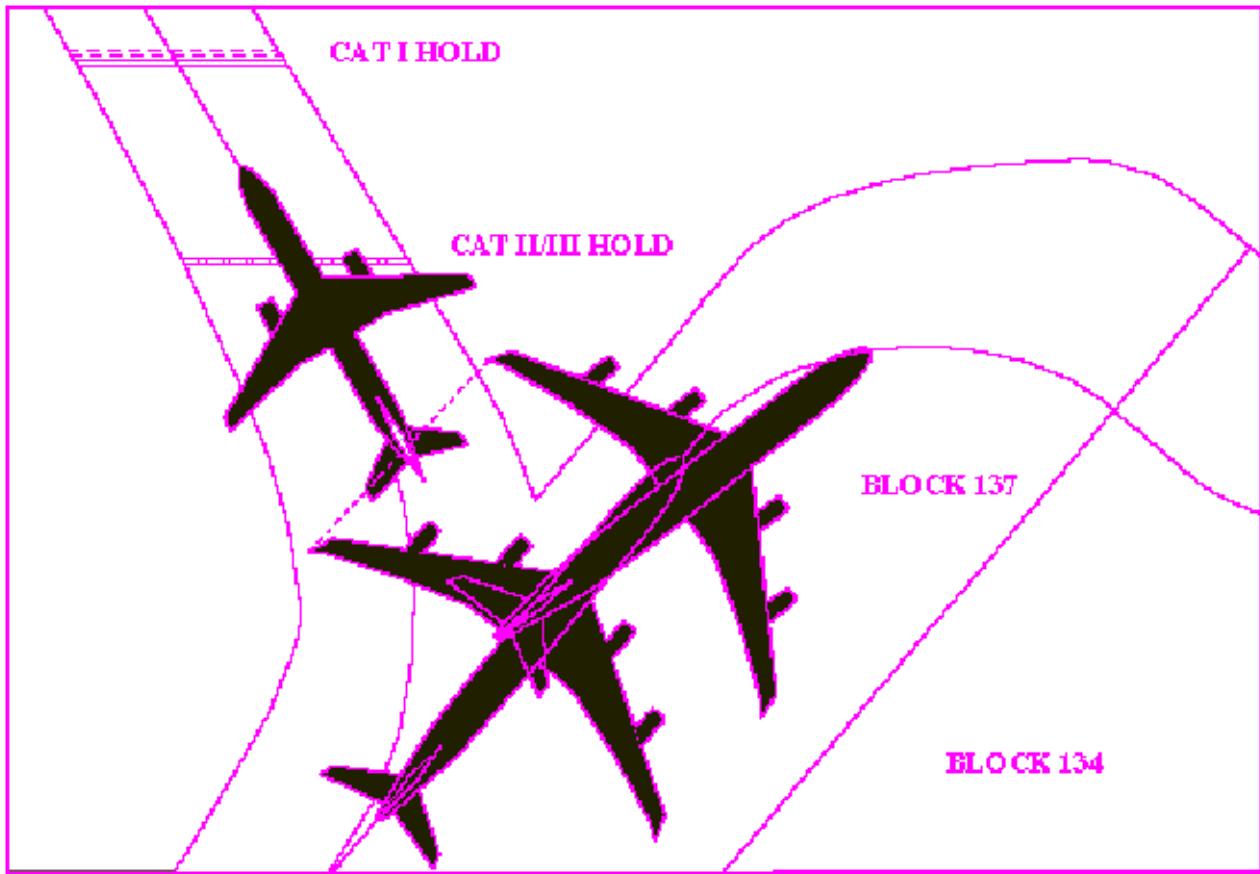
Measurements taken after the incident showed that the nose landing gear of G-BIKG was 23.6 metres (along the taxiway centreline) behind the CAT I stop bar and 8.6 metres ahead of the CAT II/III stop bar. Profiles of the two aircraft imposed on a plan view of the taxiways and holding area are shown below. The diagram shows that, with G-BIKG in its measured position and A40-LB in its final position, the contact measured on the winglet and rudder would have occurred with A40-LB on its taxiway centreline at the point of contact.
