Accident  
Investigation Board  
Norway

SL 2013/29

## REPORT ON SUPPLEMENTARY INVESTIGATION - AIR ACCIDENT AT TORGHATTEN NEAR BRØNNØYSUND ON 6 MAY 1988 WITH DHC-7-102, LN-WFN

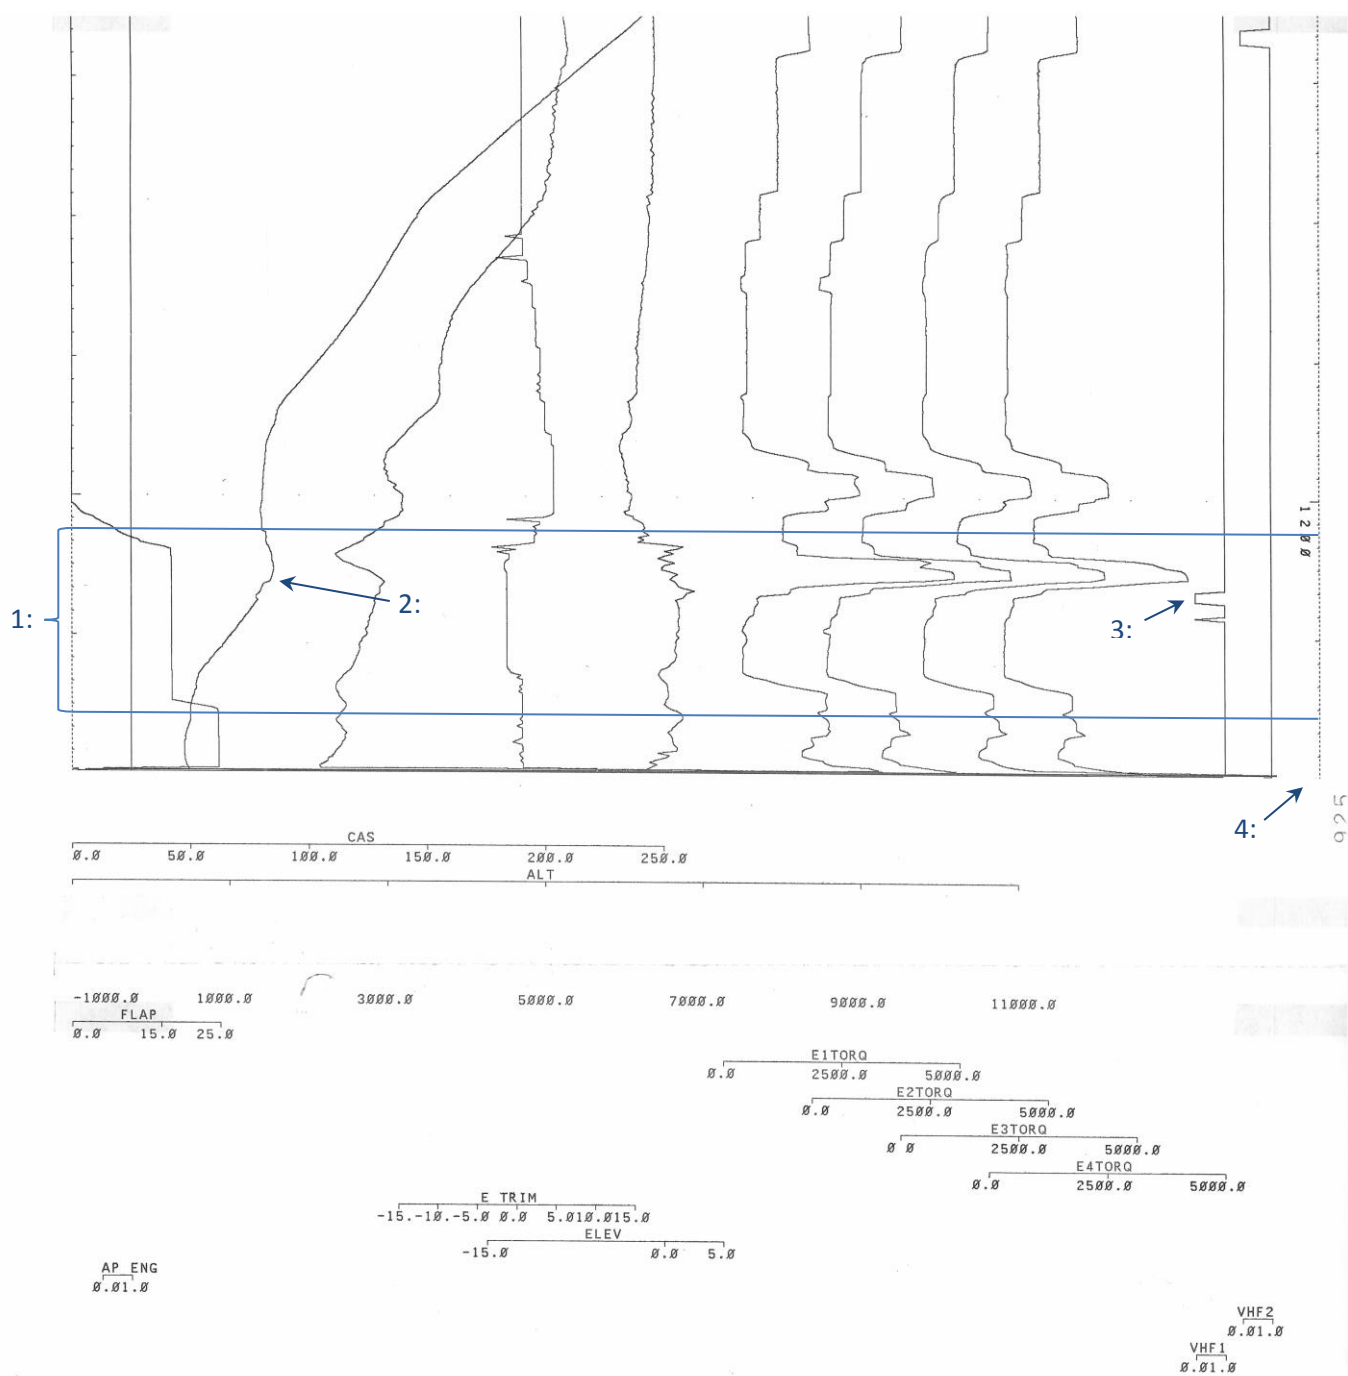
A graphic representation of data from the flight recorder was published as Attachment 5 "Printout of flight recorder" to [Report 1989/04](#). A key sequence of about 90 seconds after second 1200 on the graph timeline appears to have been omitted by error in the printing process<sup>3</sup>. The SHT believes that this sequence is important to illustrate the last part of the course of events – also with a view towards considering any disturbances from mobile telephones. A new graphic representation, showing complete data from second 1200 and up until the accident, has therefore been enclosed with this report (see Appendix B).

The SHT will in addition direct attention to the fact that the crew adjusted engine power as one would with a controlled descent (see Appendix B) and that the air speed was adjusted in a systematic and planned manner (see also Appendix B).

- 1: Sequence that was omitted in Attachment 5 to Report 1989/04 by a printing error
- 2: Start of descent from 1 500 ft on the altitude presentation (about 8 NM from the airport)
- 3: The crew reports to Brønnøysund TWR that LN-WFN is 8 NM from the airport
- 4: Time line

From the accident flight: Flight Data Recorder graphs showing the final part of the approach towards Brønnøysund airport

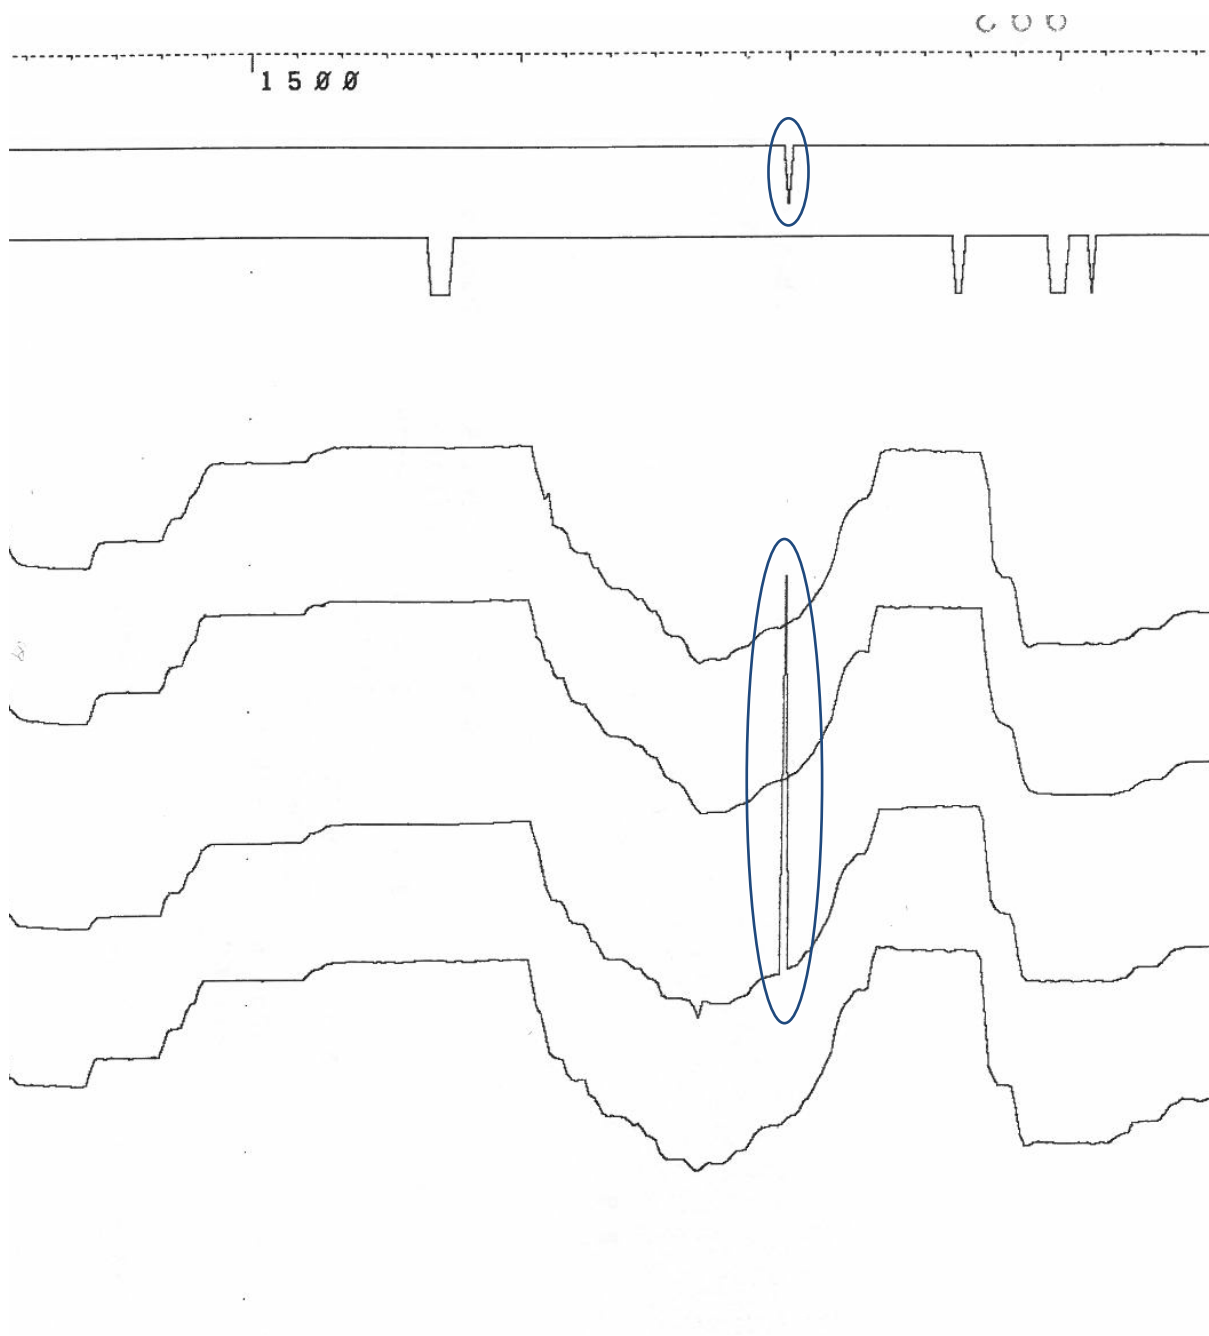
Trondheim to Namsos, for instance, the performance graph for engine number two (E2TORQ) showed a sudden, short peak (see Appendix C). The SHT wanted to know if this was a possible sign of disturbance from one or more mobile telephones.

Concerning the peak on engine no. 2 on the flight between Trondheim and Namsos, the UK AAIB expert points out a coincident peak on the VHF2 parameter (radio no. 2) and explains that these two parameters are quite close in the data frame layout. It is therefore, according to the UK AAIB, likely that this is a single bit of the data stream (data dropouts/minor corruptions). This is a well-known and frequent phenomenon with this type of flight recorders, and is not considered to have any connection to interference from mobile phones.

Flight Data Recorder graphs from the previous flight (Trondheim to Namsos). The sudden peak on the performance graph for engine number two (E2TORQ) and the coincident peak on the radio no. 2 (VHF2) are circled in.

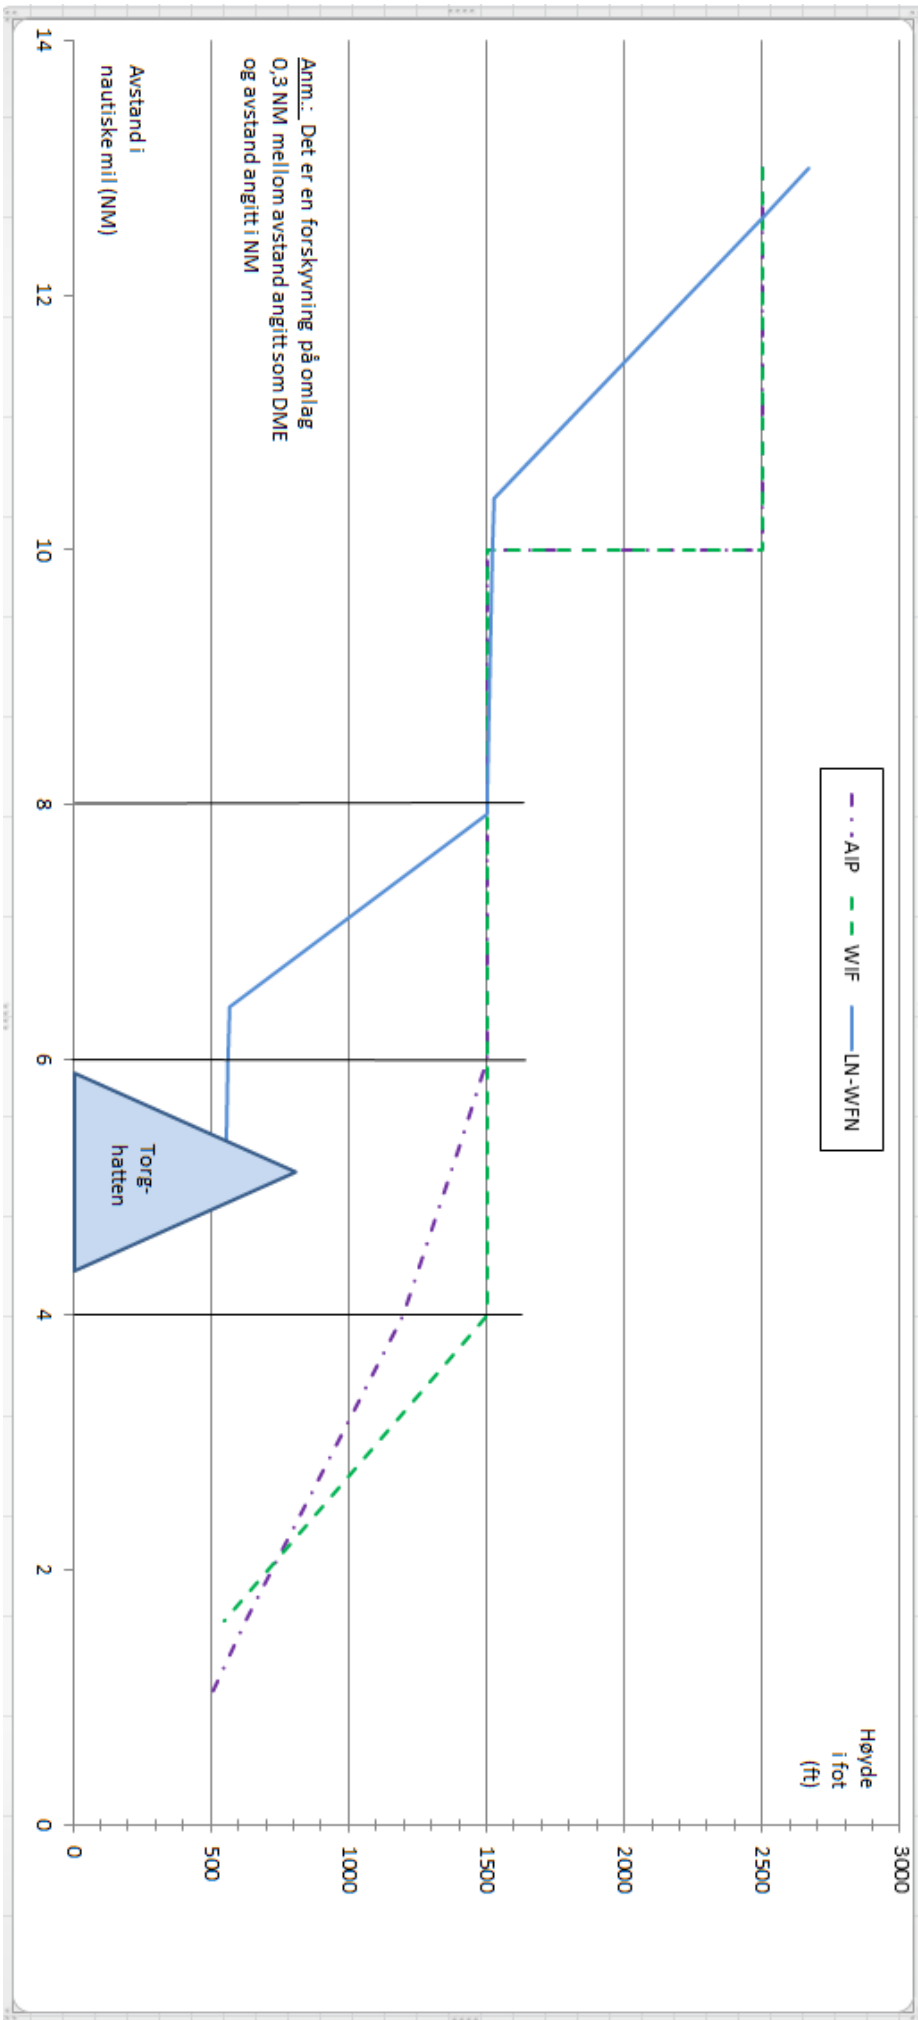
Based on flight recorder data, and our own calculations, the SHT has prepared a new sketch showing the approach in the vertical plane. This provides a simplified presentation of the altitudes and distances LN-WFN had to the runway during its approach, seen in relation to the two approach procedures mentioned in the previous paragraph (see Appendix D).

Schematic presentation of the approach to Brønnøysund Airport – seen in the vertical plane. The lines marked AIP and W/F shows the AIP Norway and the Widerøe step-down – procedures, respectively. The graph for LN-W/FN: The distances with corresponding altitudes are based on measurements taken from the FDR-graph (Appendix B), together with factual information in Report 1989/04. Each coordinate in the graph has subsequently been calculated and connected with straight lines.

Note: Due to the VOR/DME location on the airport there is a difference of about 0.3 NM between “DME” and “NM” distances.
