# AAIB Bulletin S3/2012

## *SPECIAL*

| <b>Aircraft Type and Registration:</b> | EC225 LP Super Puma, G-REDW | |

This Special Bulletin details the progress made in identifying the failure mechanism that caused the 360° circumferential crack, in the bevel gear vertical shaft in the helicopter's main gearbox, which was identified in the early stages of the investigation and published in AAIB Special Bulletin 2/2012 in May 2012. It also details progress on the investigation into the indicated failure of the main gearbox emergency lubrication system.

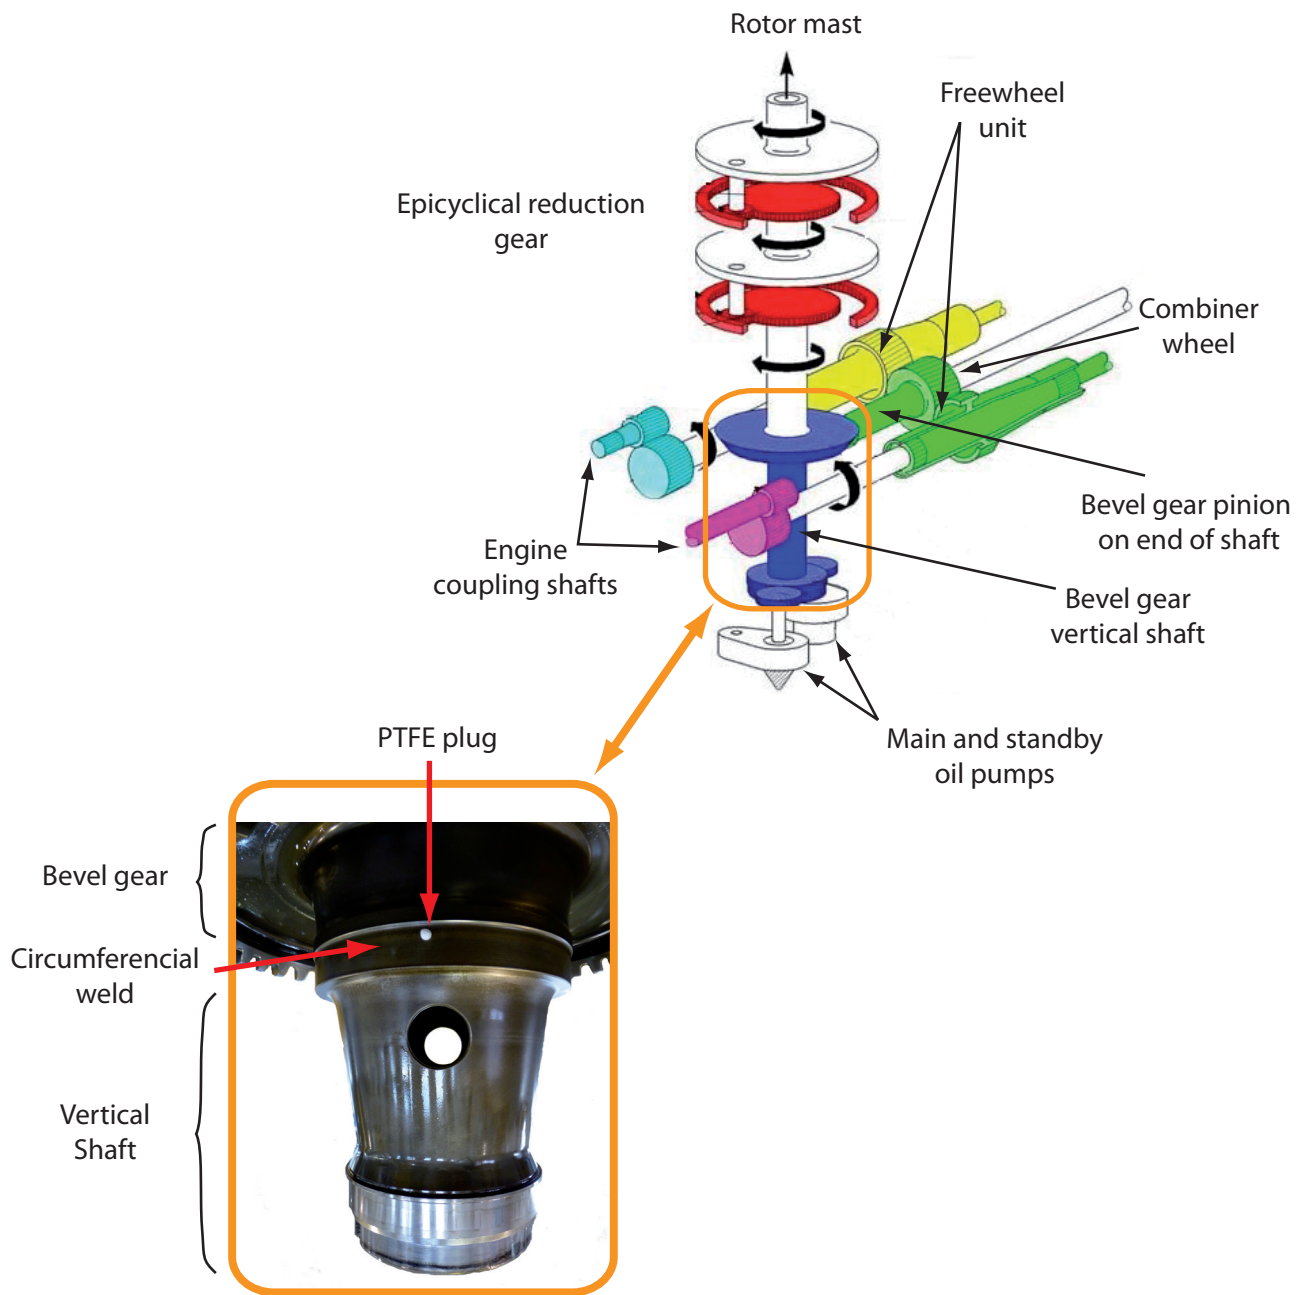
**Figure 1**

The MGB transmits power from the engines to the main rotor. The power from the engines is transmitted to the bevel gear through the combiner wheel and bevel gear pinion. The majority of this power is then transmitted upwards into the epicyclical reduction gear module. Two pinion gears, mounted at the bottom of the bevel gear vertical shaft, drive the main and standby oil pumps. The power train through the gearbox is illustrated at Figure 1.

MGB power train

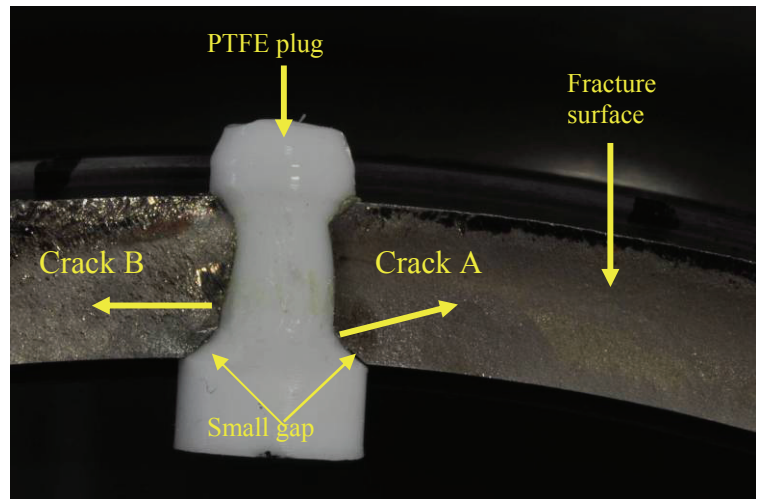
**Figure 2**

Examination of the fracture surface on both parts of the bevel gear vertical shaft revealed the presence of three cracks, identified as 'A', 'B' and 'C' (see Figure 2). Cracks 'A' and 'B' started from the 4.2 mm diameter hole in the weld and there was evidence of beachmarks

and striations along both cracks, which are indicators of a fatigue failure. Crack 'A' was 336 mm long<sup>2</sup> and extended for approximately 250° around the circumference of the shaft. This crack appeared to have initiated from a small corrosion pit, approximately 60 µm deep, on the inner countersink. Crack 'B' was 106 mm long and extended for approximately 80° around the circumference. This crack appeared to have initiated at a small defect in the internal surface of the hole. Crack 'C' was 42 mm long and extended for approximately 30° around the circumference. One end of this crack joined Crack 'A' and the other end ran under Crack 'B'. While there were striations on the surface of Crack 'C', there was no evidence of any beachmarks.

4.2 mm diameter hole in the weld

It was established that when the PTFE plug is fitted in the hole, with a  $90^{\circ} \pm 1^{\circ}$  countersink, a small annular gap (approximately 0.37 mm x 0.05 mm in cross-section) can remain between the plug and the side of the countersink (see Figure 2).

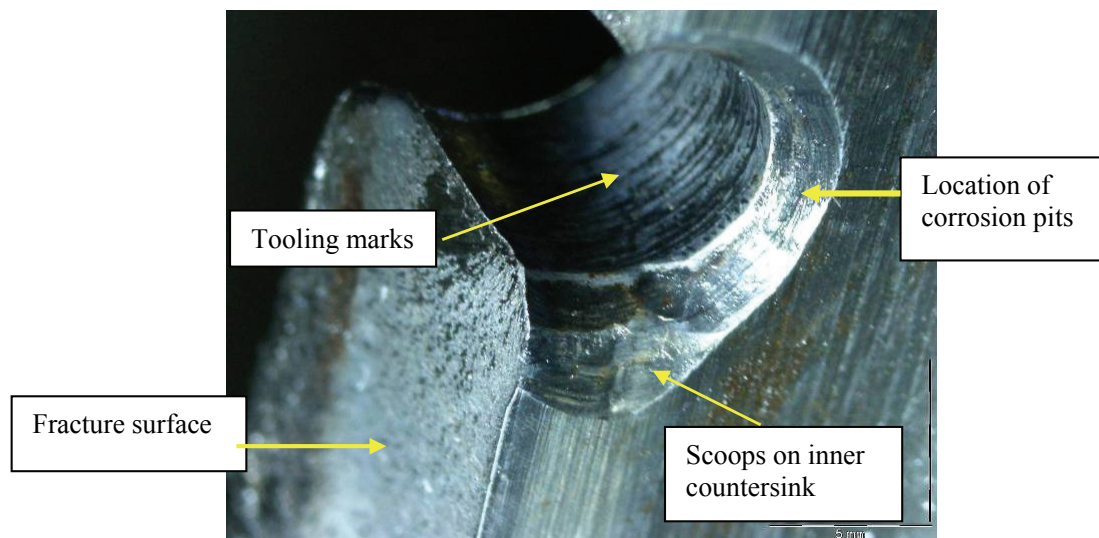
**Figure 3**

The diameter of the 4.2 mm hole was within the design specification. However, there was evidence of tooling marks and, what appeared to be, a spiral scratch that ran along the length of the hole. The geometry of the inner and outer countersinks was found to be outside the design specifications and there were a number of 'scoops' in the inner countersink (see Figure 3). There were patches of very small corrosion pits around the inner countersink, in the area where there is a gap (crevice) between the PTFE plug and the countersink. These corrosion pits were only initially detected using a scanning electron microscope.

Condition of the 4.2 mm hole and countersink

The dimensional inspection also calls for the average roughness (Ra) of the hole to be measured, to ensure that it is less than 1.6  $\mu\text{m}$ . However, when shaft serial number M385 was manufactured there was no acceptance criterion for surface scratches. Since the accident, the manufacturer has introduced acceptance criteria for scratches of a maximum depth of 5  $\mu\text{m}$ .
