# AAIB Bulletin S5/2012

## ***SPECIAL***

### ACCIDENT

| <b>Aircraft Type and Registration:</b> | EC225 LP Super Puma, G-REDW | |

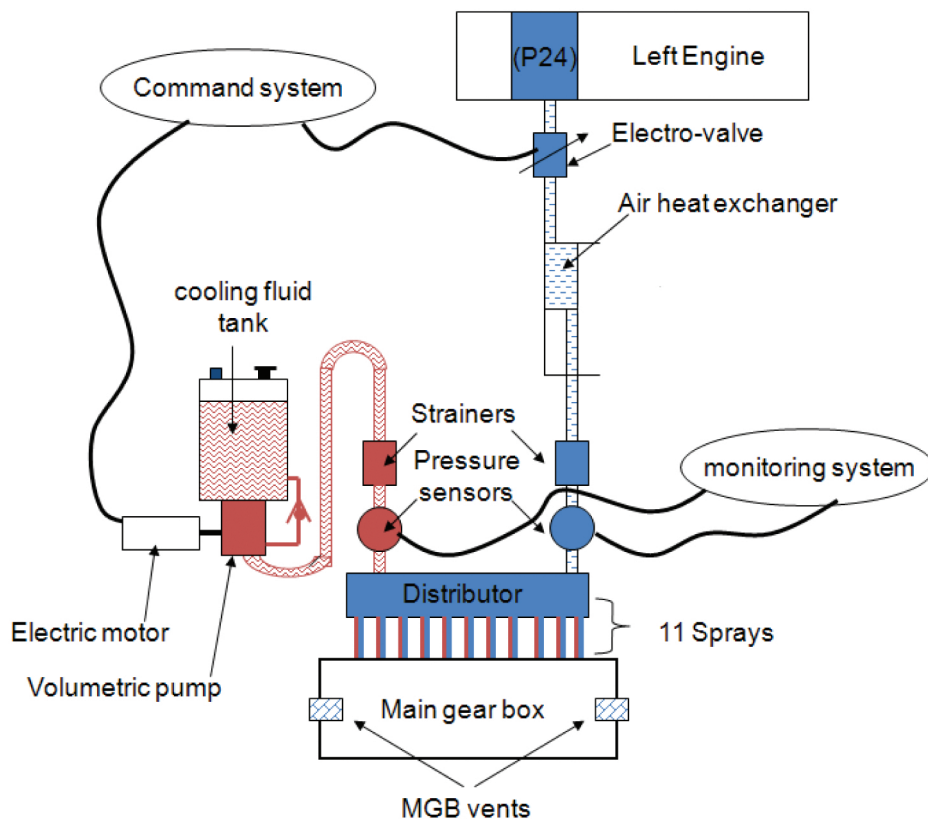
Figure 1

The MGB lubrication system includes two mechanically-driven oil pumps and a crew-activated emergency lubrication system (see Figure 1). The latter comprises: a bleed air supply from the left engine, a Hydrosafe 620 supply from an 11 litre reservoir, a series of small pipes around and inside the MGB, to deliver the Hydrosafe 620 in a spray, and monitoring and command systems on a dedicated Printed Circuit Board (PCB).

When the emergency lubrication system is activated an electro-valve, called the P2.4 valve, opens and bleed air from the left engine enters the system, after passing through an air heat-exchanger. At the same time, an electric pump supplies Hydrosafe 620 from the reservoir. There are two similar sensors that monitor the pressure in the Hydrosafe 620 pipes and bleed air lines; these sensors are mounted on the MGB. A MGB EMLUB caption will illuminate if low pressure is detected in either the Hydrosafe 620 pipes or the bleed air lines. This warning is inhibited for approximately 30 seconds after the system is activated, to allow the system to reach a steady state.

Schematic of the Emergency Lubrication System
