# AAIB Bulletin S7/2012

| <b>Aircraft Type and Registration:</b> | EC225 LP Super Puma, G-CHCN | |
| <b>Nature of Damage:</b> | Fracture of the Main Gear Box bevel gear vertical shaft | |

This Special Bulletin contains information on the progress of the investigation into identifying the cause of the 360° circumferential crack in the bevel gear vertical shaft on G-CHCN (AAIB Special Bulletin S6/2012). It also compares the findings with those recorded previously on another EC225 LP accident involving a similar failure on G-REDW on 10 May 2012 (AAIB Special Bulletin S3/2012) and provides a further update on the investigation into both accidents.

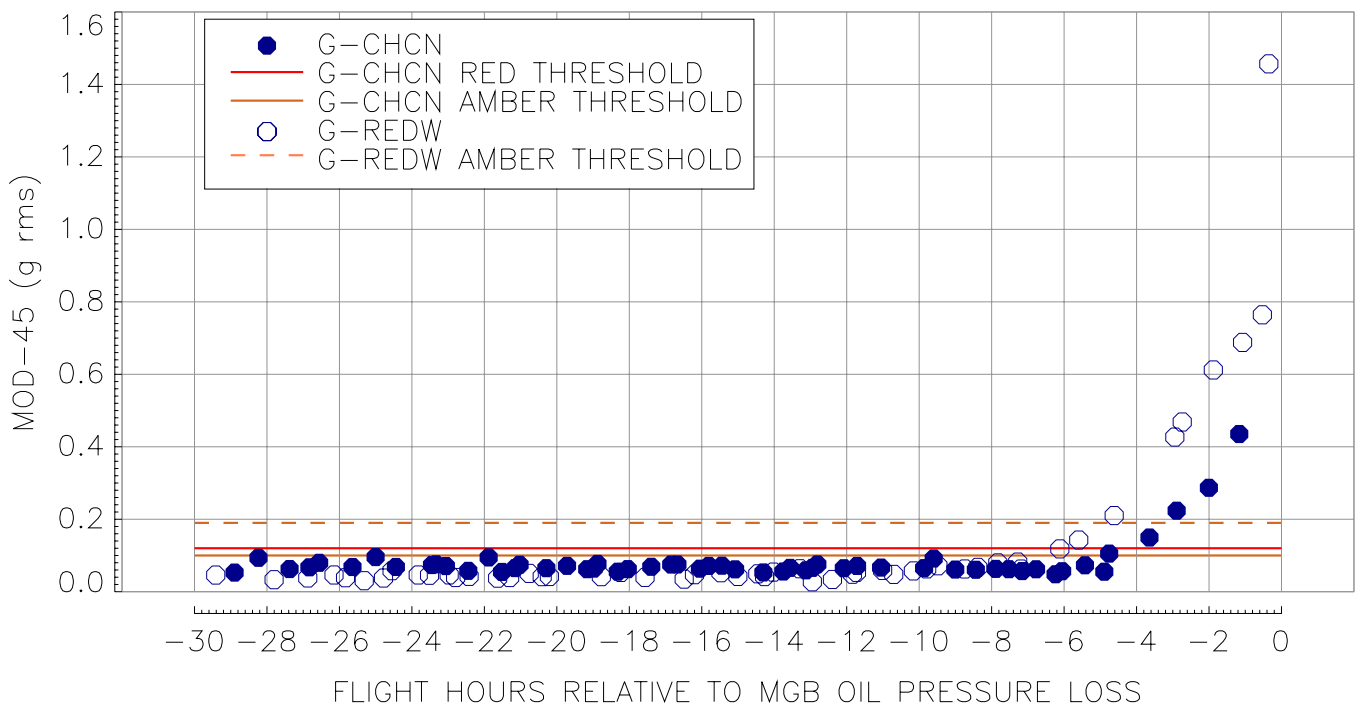
**Figure 1**

Comparison MOD-45 trend indications between G-CHCN and G-REDW

Figure 1 shows that the MOD-45 indicator for G-CHCN, exceeded its 'learned' amber threshold (0.10) 4.75 flying hours and its 'learned' red threshold (0.12) 3.63 flying hours prior to the loss of oil pressure. For G-REDW the MOD-45 indicator exceeded its 'learned' amber threshold (0.19) 4.62 flying hours before the loss of the MGB oil pressure.

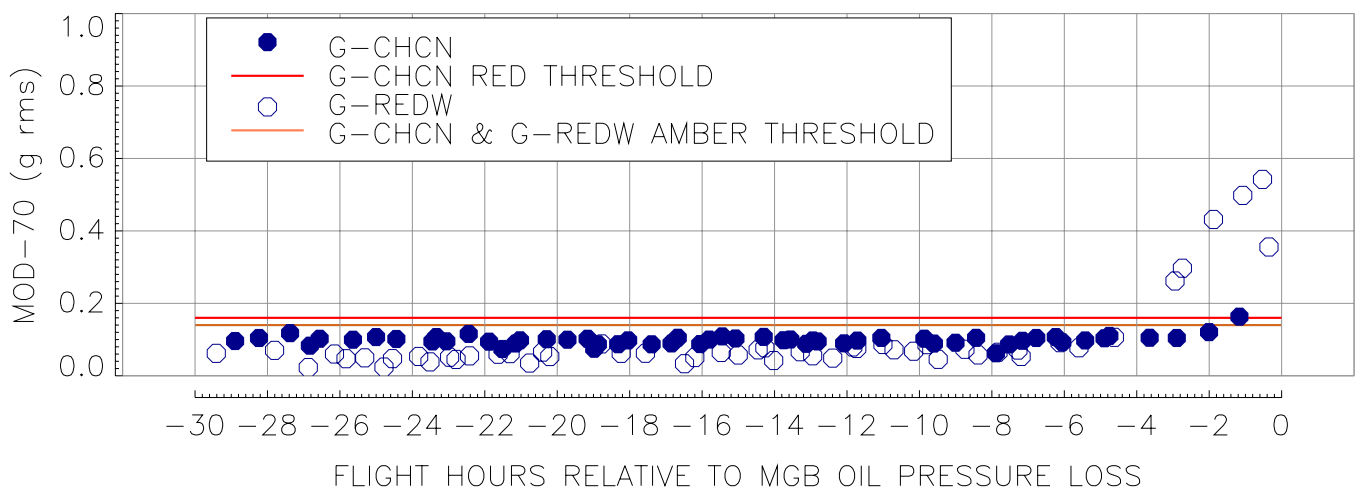
**Figure 2**

Comparison MOD-70 trend indications between G-CHCN and G-REDW

Figure 2 shows that for the MOD-70 indicator, the first instance that it exceeded the 'learned' amber threshold (0.14) for G-REDW was 2.95 flying hours before the loss of MGB oil pressure. However, for G-CHCN only the last recorded value of this indicator, which was captured 1.17 flying hours before the loss of the MGB oil pressure, exceeded both its amber (0.14) and red (0.16) 'learned' thresholds.

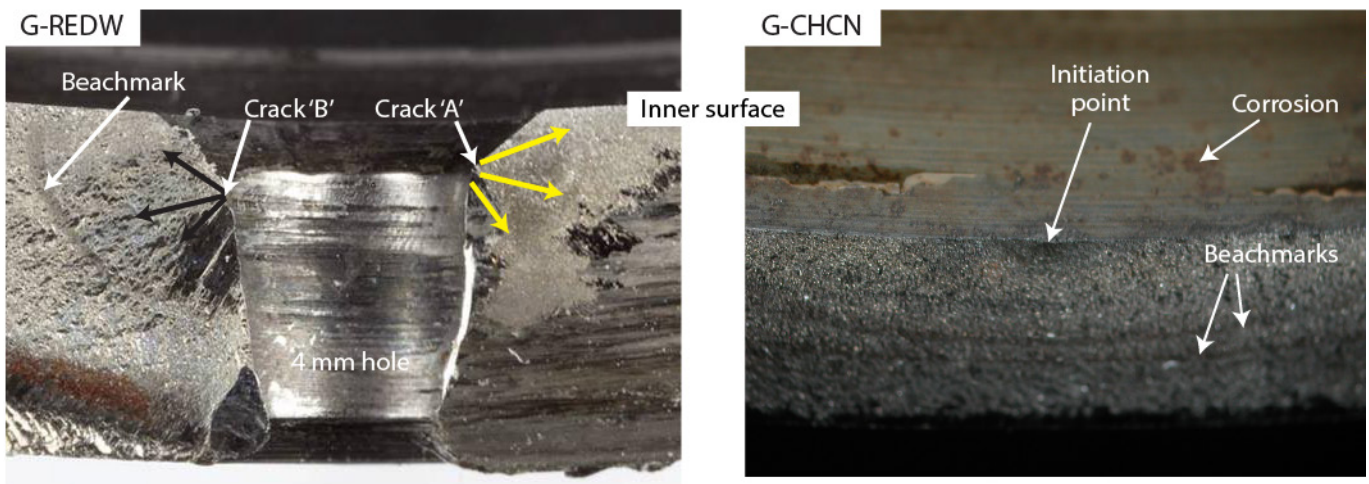
**Figure 3**

Location of crack initiation on G-REDW and G-CHCN

On G-REDW, the first crack to develop was identified as Crack 'A', which initiated at a corrosion pit approximately 0.06 mm deep located in the inner countersink of the Ø 4 mm hole (Figure 3). The crack then propagated along the fusion line between the area of the weld which had been previously melted, and the heat affected zone in the parent material in the vertical shaft. A second crack, Crack 'B', initiated after Crack 'A' at a small scratch in the internal surface of the hole. Numerous corrosion pits that could only

On G-CHCN the fatigue crack initiated at an area of corrosion on the inner surface of the shaft (Figure 3), approximately 47° around the circumference from the Ø 4 mm hole (Figure 4). It has not yet been determined where the crack initiated in relation to the heat affected zone. Away from the initiation point, the crack propagated in both directions in the parent material in the vertical shaft. Small areas of corrosion were also visible in the machining marks around the inner flange that had been machined during manufacture to remove the root of the weld. The initial examination has not identified corrosion on any other part of the bevel gear vertical shaft.

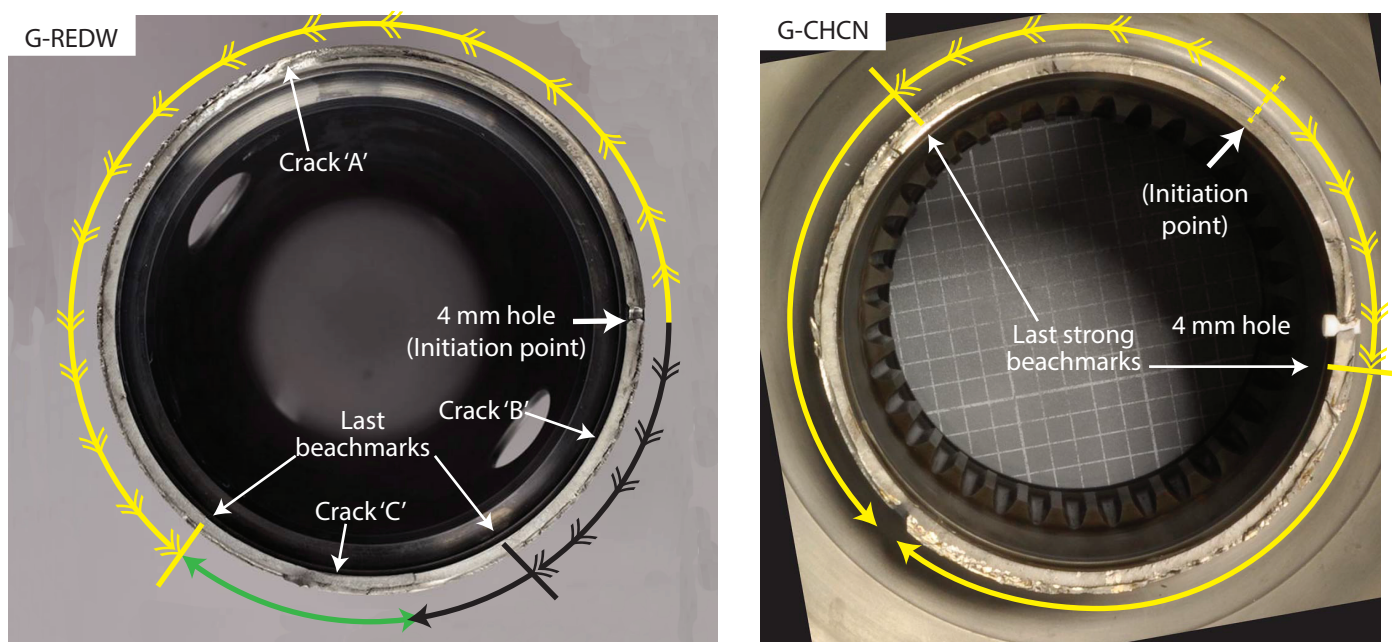
**Figure 4**

Location of beachmarks on G-REDW and G-CHCN

The fracture surfaces of the shafts on G-REDW and G-CHCN both displayed characteristic fatigue beachmarks, which can be formed when an event such as an engine start or significant change in torque has taken place (Figure 4). Beachmarks can be difficult to identify and can be interpreted in a number of ways.

For G-REDW the first beachmark was identified at 4 mm from the initiation point. Crack growth estimates are complicated by variations in engine torque and the changing stiffness of the shaft as the crack grows to failure. A number of different models are being considered, one of which suggests that the time for the crack to grow from the first beachmark to failure could be as low as 20 engine<sup>4</sup> hours. From the recorded data this corresponds to approximately 15 flying<sup>5</sup> hours. Another model has shown that the crack growth time could be as high as 31 flying hours. Detailed analysis of the beachmarks continues.

For G-CHCN, work continues to identify all the beachmarks on the fracture surface. The provisional examination and analysis indicates that the first beachmark was identified at 2 mm either side of the initiation point (giving a crack length of 4 mm). Early analysis shows that there is a possible close correlation in the crack propagation time in the shafts fitted to G-CHCN and G-REDW.
