**Air Accidents Investigation Branch**

**Report on the accident to  
Eurocopter EC225 LP Super Puma, G-REDU  
near the Eastern Trough Area Project (ETAP)  
Central Production Facility Platform  
in the North Sea  
on 18 February 2009**

Published 14 September 2011

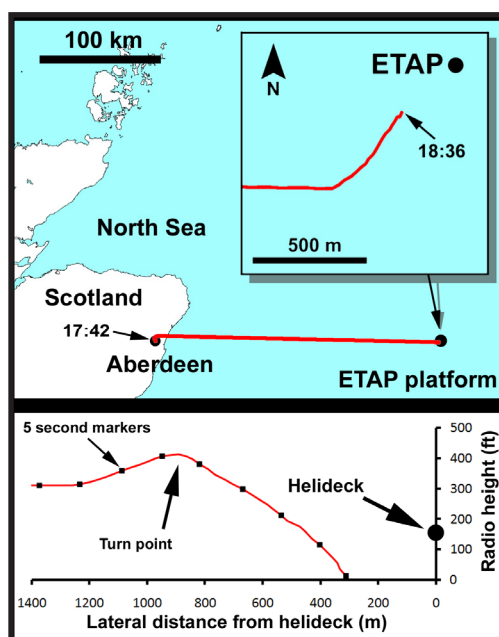
**Figure 1**

G-REDU's track to the ETAP platform and its vertical profile during the final stages of the flight

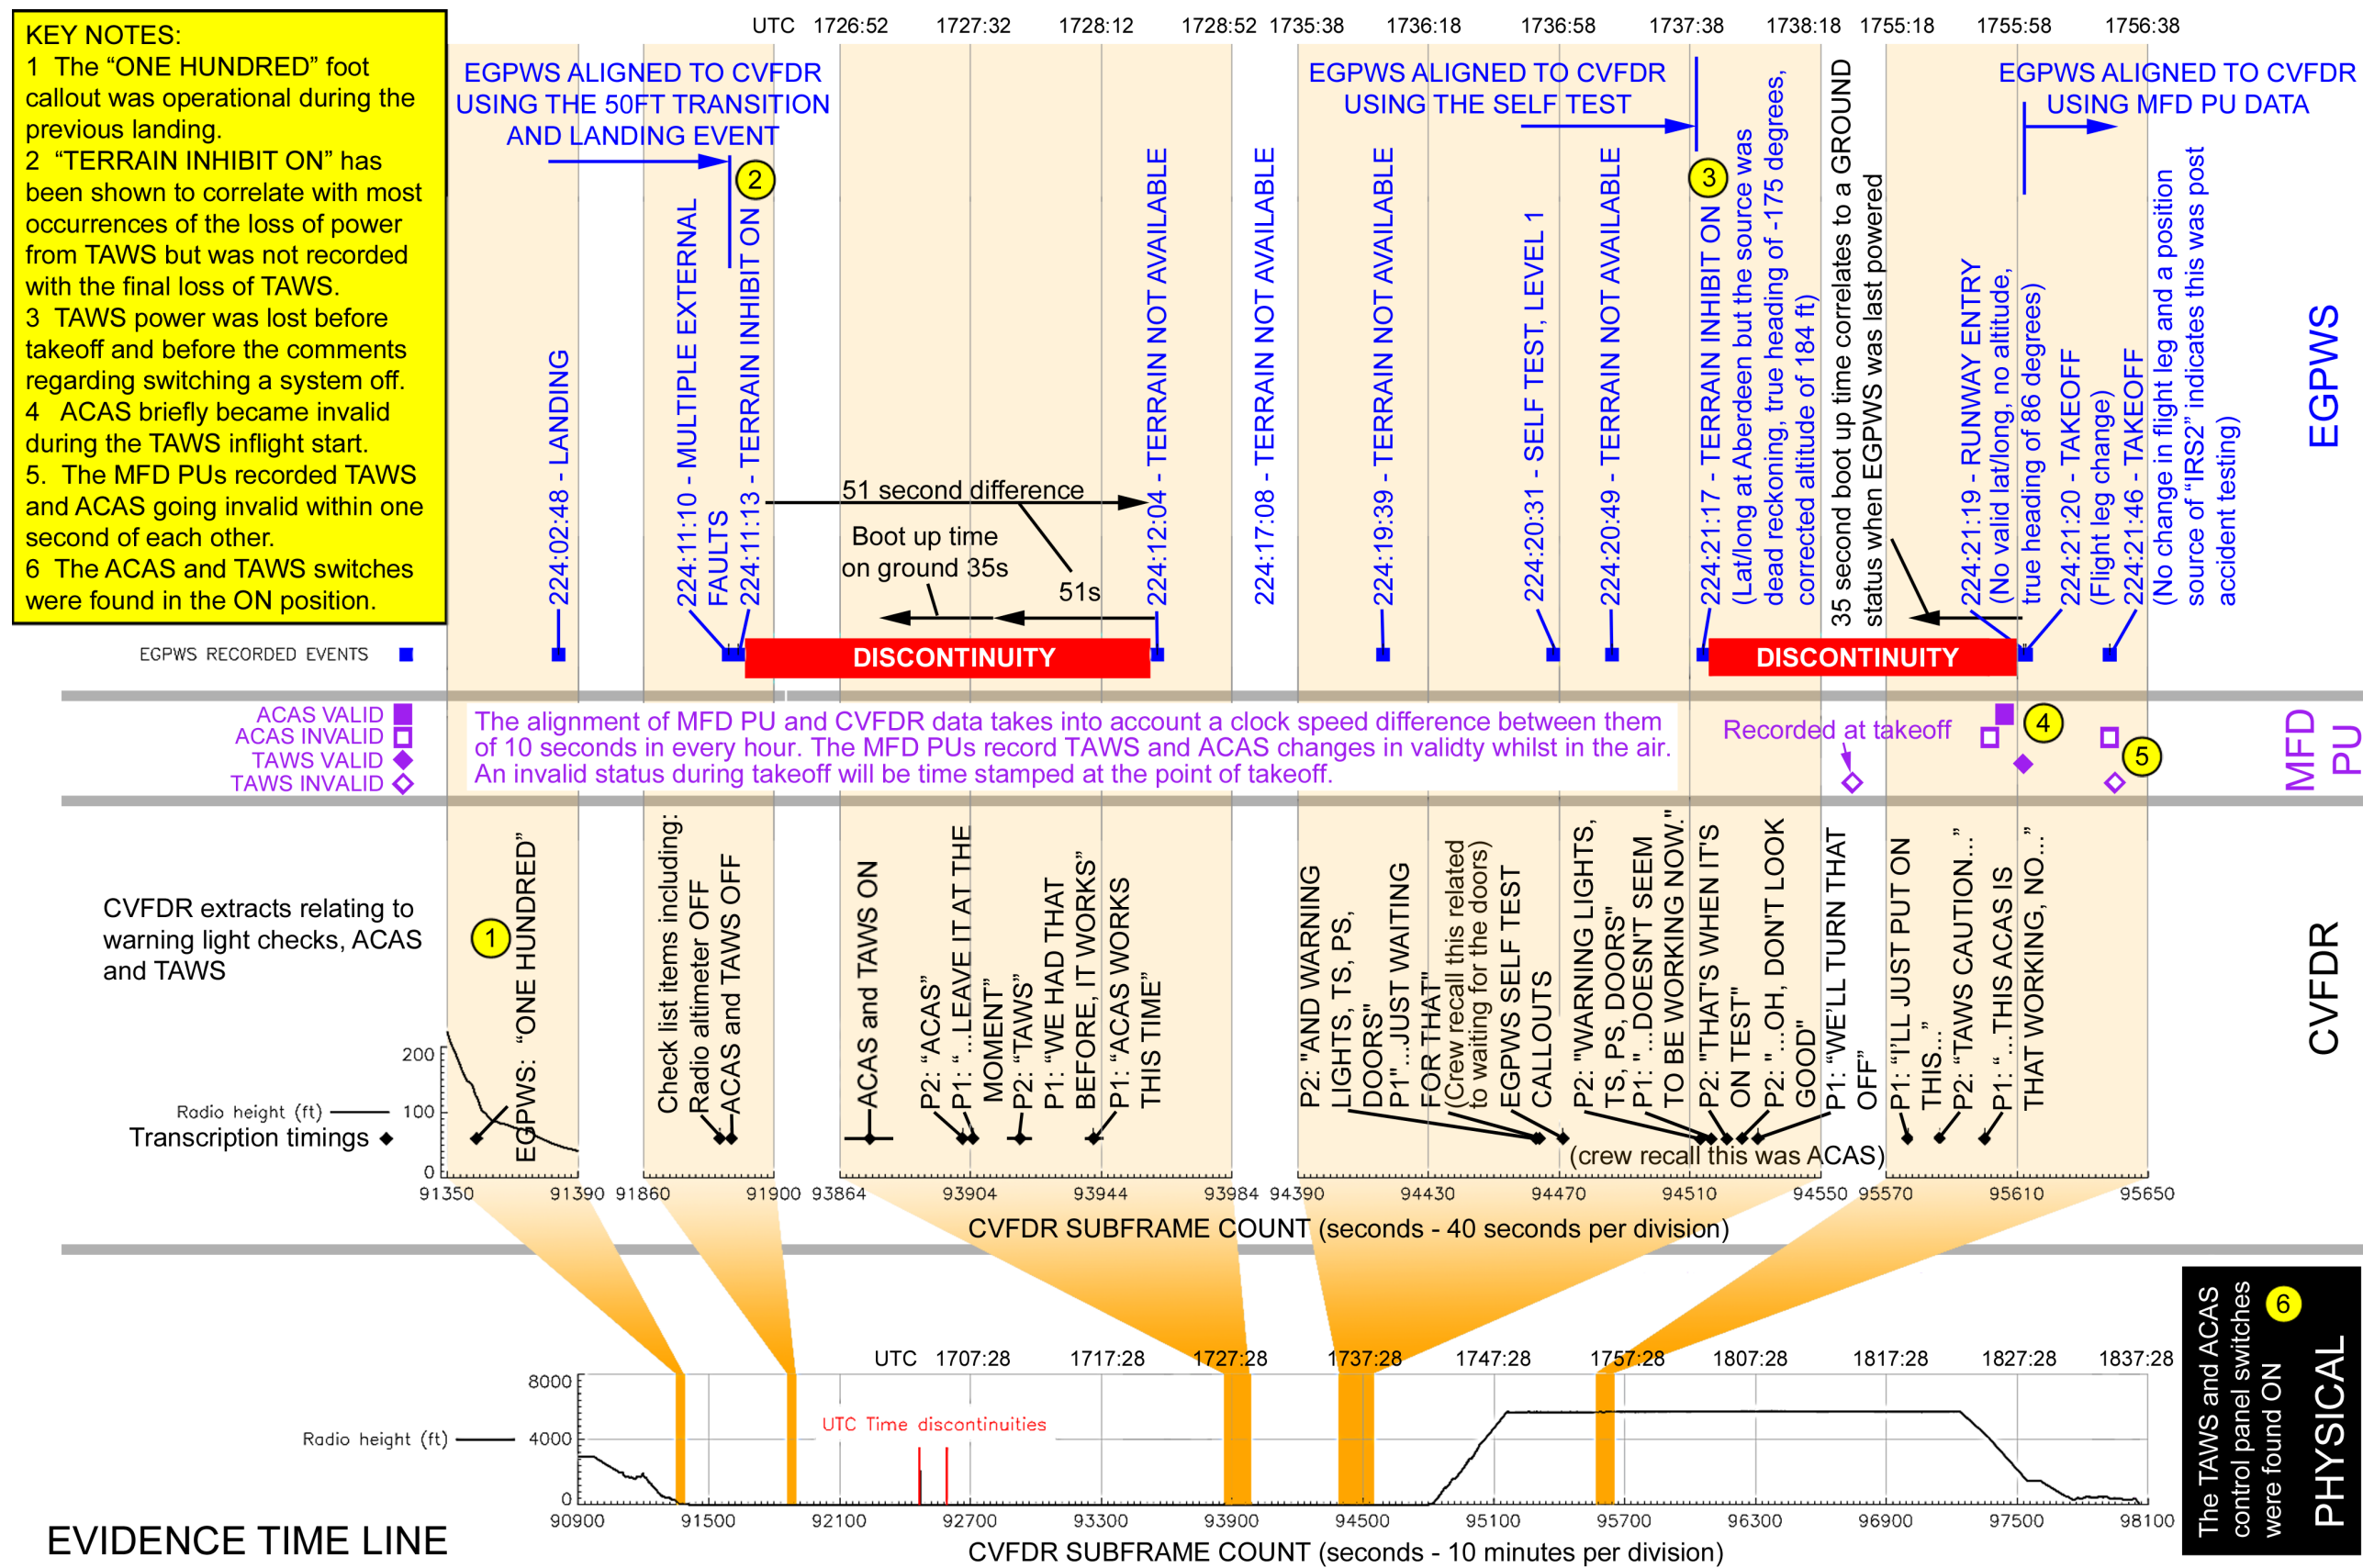
**Figure 9**  
The evidence associated with the TAWS system

Crew discussion on the ground indicated prior problems with ACAS. The MFD PU data showed periods of ACAS being invalid whilst airborne during previous flights.

The TAWS and ACAS were both switched OFF after the previous landing, and back ON again after the engines were restarted, as part of the '*POST START*' checklist. The checklist also required that both systems were tested. The crew refer to the ACAS system when they said: "WELL WE KNOW THAT DIDN'T WORK BEFORE SO WE'LL LEAVE IT AT THE MOMENT", indicating that they had problems with ACAS during the previous flight. On that occasion, the problem was overcome by switching the system to standby and then successfully back ON early in the flight. However, the pre-flight test, which included an ACAS element, was successful. The CVFDR recordings show that the TAWS test was successfully carried out later.

A problem was identified during the '*PRE-TAXI*' check before flight. At about the same time, the EGPWS recorded a TERRAIN INHIBIT ON event. This record is generated when the crew inhibits TAWS and on the majority of occasions that TAWS is switched off at the control panel or the TAWS circuit breaker is pulled. Later the crew stated "RIGHT WE'LL TURN THAT OFF..." The crew were certain, in their recollection, that the system they were referring to was ACAS. This implied that the loss of power was not initiated by the crew. However, at the point of the subsequent takeoff the MFD PUs recorded that ACAS was valid and that TAWS was invalid. Therefore, the MFD PU and EGPWS data provides evidence that TAWS was not powered and the CVFDR timing suggests that this was independent of crew action. However, the system is designed such that the combination of TAWS not being powered and not switched OFF at the control panel results in status indications on the CWP and on the PFD. The CVFDR recordings did not capture any mention of this and the crew's recollection was that that the captions were clear. The crew recalled that ACAS was the problem and the commander thought that ACAS was switched OFF using the ON/OFF switch. The crew's recollection that they switched the ACAS OFF disagreed with the MFD PU ACAS validity records. Either the recollection was mistaken or the systems did not respond appropriately to the switch selection.

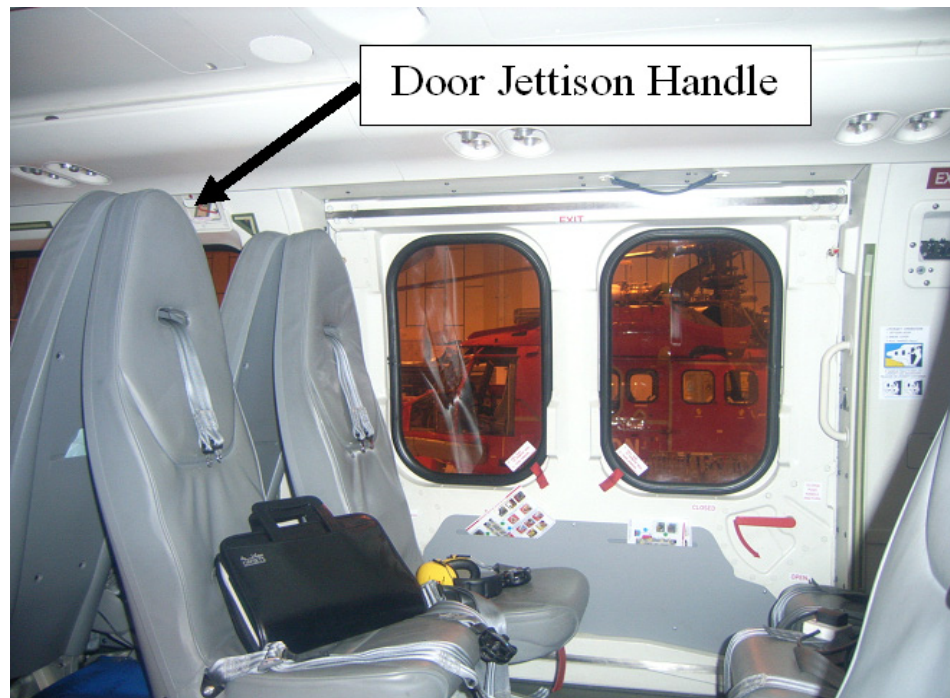
**Figure 12**

Most of the passengers did not experience any problems with the exits. However, those who were sitting beside the right cabin door were unable to locate that door's jettison handle. They opened the cabin door using the normal method and, in so doing, blocked the right forward cabin window exits (see Figure 12).

Position of right cabin door internal jettison handle

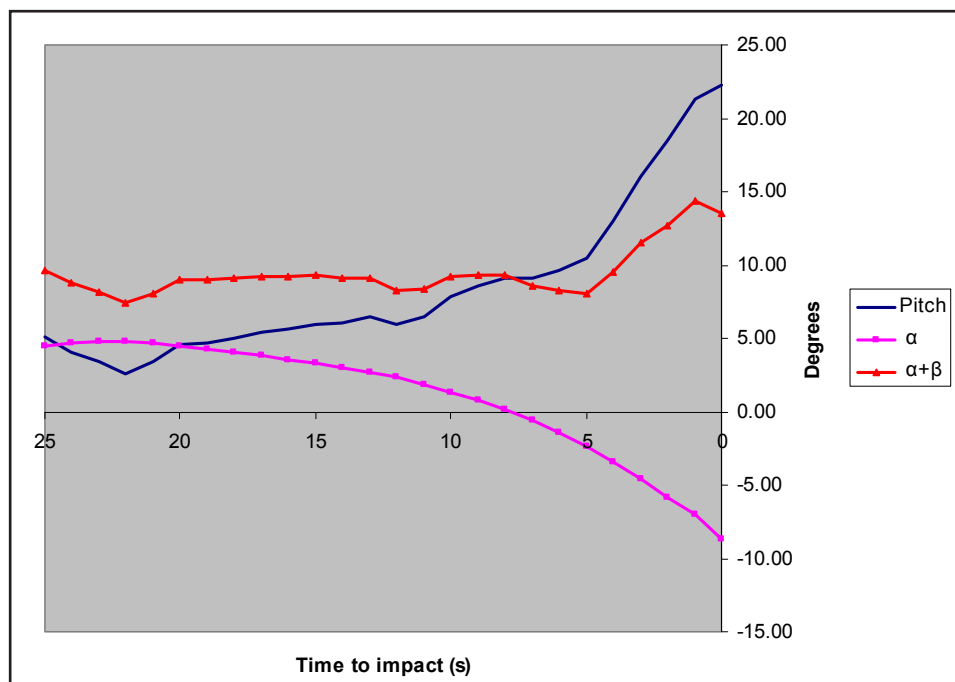
Figure 15

In Figure 15, the angle  $\alpha$  is the angle subtended at the pilot's eye between the line of sight to the horizon and the line of sight to the helideck. Angle  $\beta$  is the helicopter's pitch attitude relative to the horizon. Angle  $\alpha+\beta$  is the apparent position of the helideck relative to the airframe.

Without a visible horizon or good surface texture cues, the apparent position of the platform would have led to the perception that the approach was normal but becoming high and fast in the final 5 seconds before impact. This accords with the commander's impressions. See Figure 16.

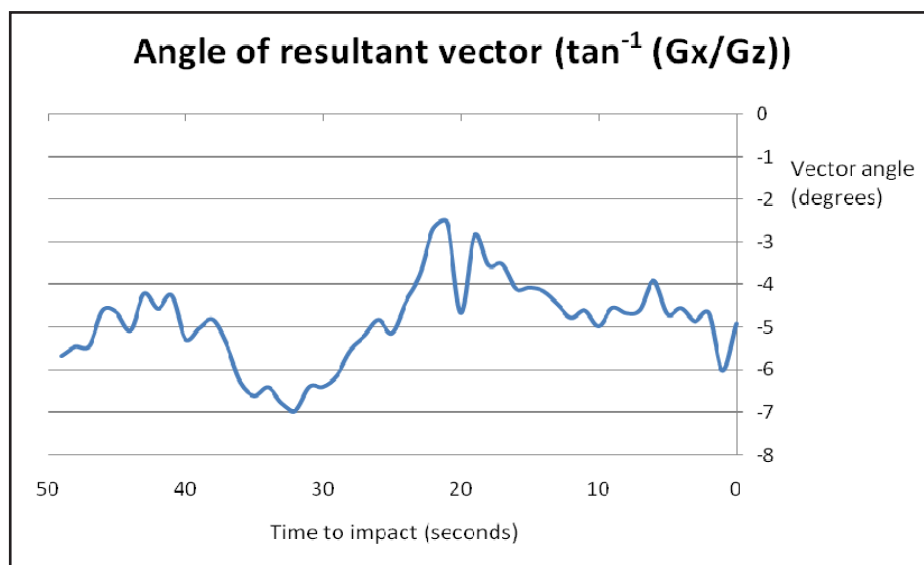
**Figure 17**

This is illustrated in Figure 17 which shows the direction of the resultant force vector derived from the recorded longitudinal ( $G_x$ ) and aircraft normal ( $G_z$ ) accelerations during the final 50 seconds of the flight. The graph shows no significant difference in the direction of the resultant force between the first 10 seconds of the record, when the aircraft was in level flight, and the final 10 seconds, during which the pitch attitude of the aircraft was increasing to a peak of  $22.5^\circ$  nose up. In the absence of adequate visual references, this force vector can be misperceived as the direction of the gravitational vertical and, in consequence, form the frame of reference that determines the apparent location of the platform.

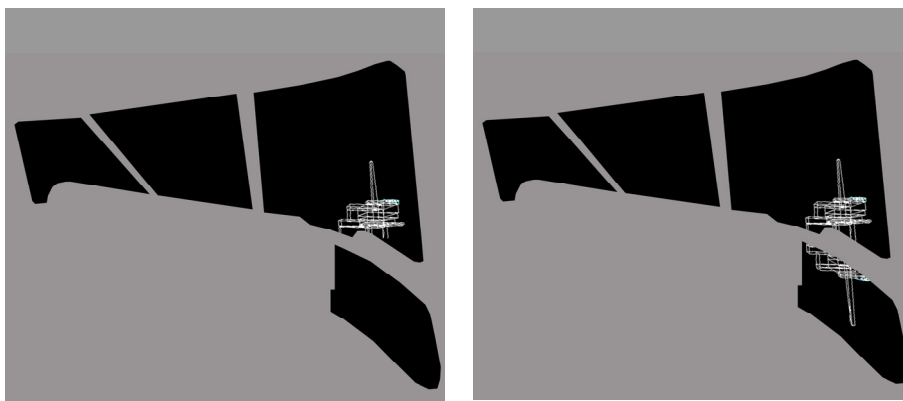
**Figure 18**

In Appendix C it is suggested that the appearance of the platform and its reflection on the surface of the sea, diffused by the fog/reduced visibility, could have been confusing. Orientation and position cues that might have been gleaned from details in the sight-picture were degraded and the platform could have appeared nearer and lower than it actually was.

The platform as it would have appeared to the commander just before impact without the reflection and with the reflection. The diagram is drawn to scale using the manufacturers Cockpit View Diagram

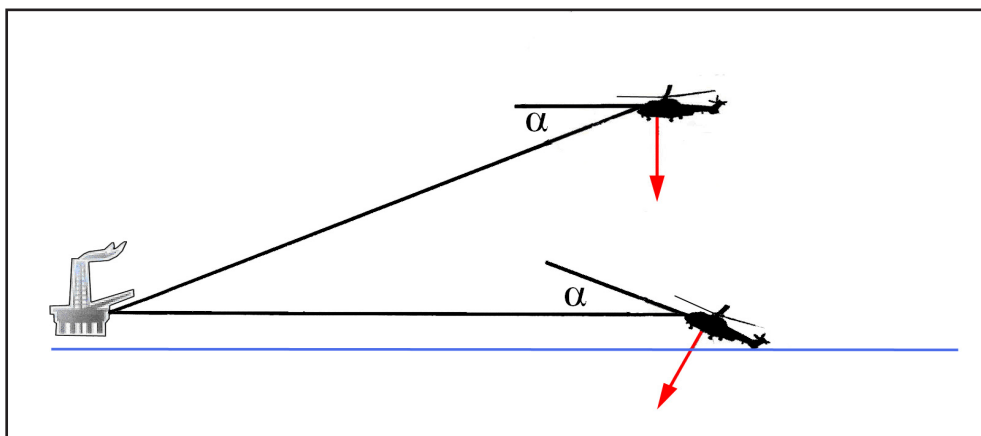
Figure 6

The oculogravic illusion. Because the force vector generated by the lift of the main rotor remains vertical with respect to the aircraft despite increasing pitch up, the aircraft feels to the occupants as it would if it were still in level flight. This misperception leads to error in the spatial localisation of isolated objects in the field of view.

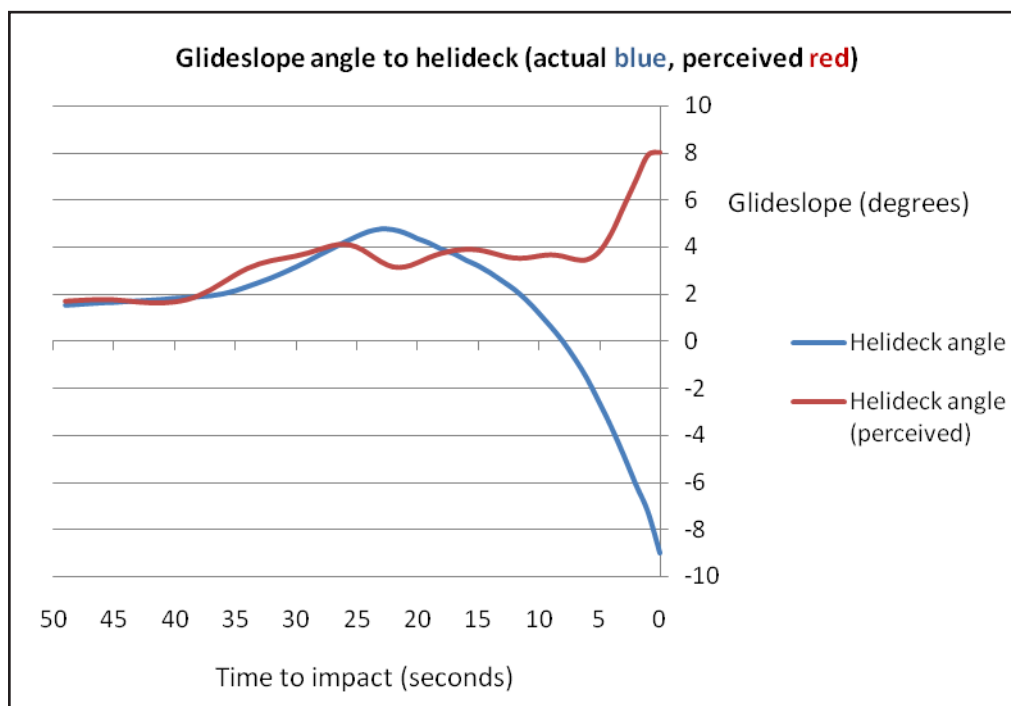
Figure 7

Comparison between the actual and likely perceived glideslope to the helideck. From 8s before impact the aircraft was below the level of the helideck but might have been perceived as between 4 to 8 degrees above it.

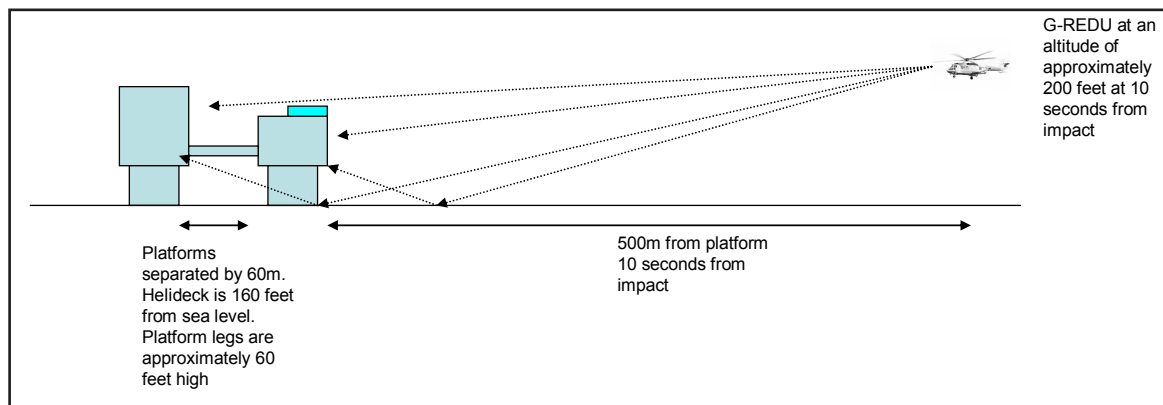
**Figure 1**

A schematic showing the potential view for G-REDU 10 seconds from impact. Above the direct view of the helideck would be the lights from the processing block. Under the helideck would be the lights from the accommodation block, the reflection from the processing block and then the reflection from the accommodation block. In fog these reflections would be diffuse and would only contain gross detail.

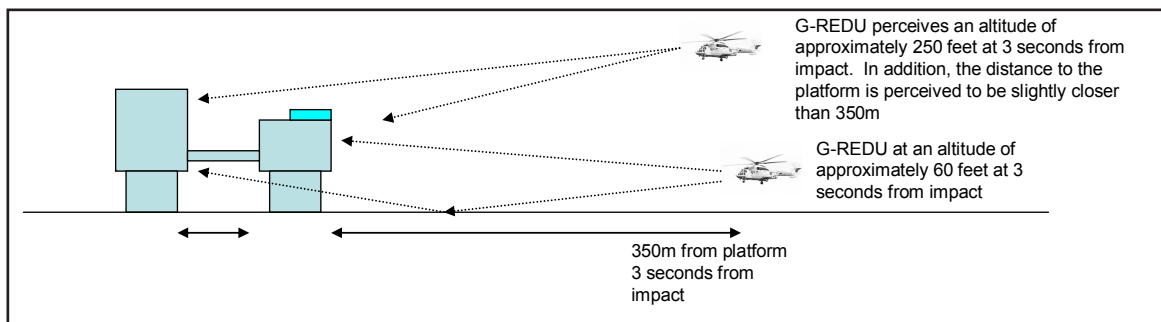
**Figure 2**

The schematic from figure 1 redrawn for 3 seconds to impact. Again, the view from G-REDU would include a direct view of the accommodation block and a reflection from the processing block, and the presence of fog would have resulted in an elongated diffuse light source. If G-REDU had been at an altitude of 250 ft and a range of 300m then the view of the platform would have been composed of a direct view of the processing block with a direct view of the accommodation block underneath. It is postulated that the two elongated blur patterns could appear similar.
