## Introduction

# Aircraft Protection, during Washing and Painting

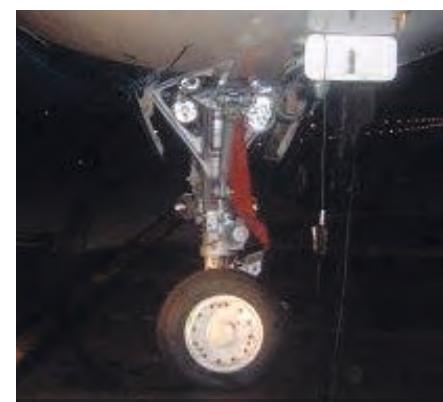
An A320 performed a landing with the Nose Landing Gear (NLG) in a position of about 90° from the aircraft centreline (fig. 1). The aircraft landed safely and stopped on the runway. The NLG was damaged.

Inspection of parts confirmed traces of water in the Nose Wheel Steering (NWS) feedback sensors and water ingress inside the NLG turning tube.

During the flight, the water froze and blocked the sensors. The sensors could therefore no longer provide the correct feedback on the NLG position. The Brake System Control Unit (BSCU) tried to align the NWS to the aircraft centreline. In absence of a correct feedback signal, the NWS was rotated further until the steering system was detected as faulty. The hydraulic supply to the steering system was shut-off, but the NWS was already at an almost 90° position from the centreline and could not be re-centred mechanically.

Figure 1  
Water ingress in the NLG tube caused a A320 to land with a NLG at 90 ° from the centreline

Further investigation on the maintenance history revealed that the aircraft had a scheduled maintenance check just few flights prior to the reported event. During the check, the maintenance provider performed aircraft external cleaning using a high pressure jet device. Consequently, water entered into the NLG and feedback sensors through a vent hole located at the top of the NLG.

Pay special attention to the instructions and cautions requesting to use protective devices as required in the AMM procedures for external cleaning of the aircraft.

In particular, do not use high pressure jets or vapour for cleaning. This type of equipment can force water and moisture into the parts and cause damage to them.

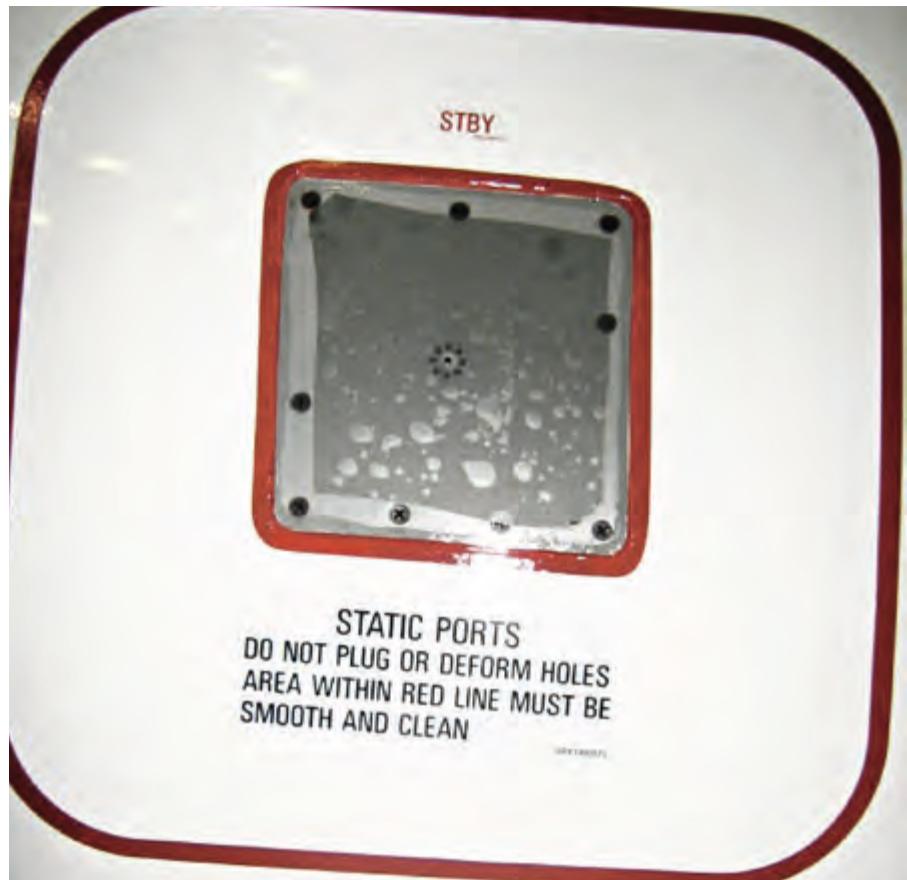
**Figure 2**  
A clear plastic film over the static ports was left on the aircraft when it was handed back to the operator

was returned into service, that there was a clear plastic film over one of the static ports that was almost impossible to detect visually (fig. 2, 3 & 4).

If the clear plastic film had not been discovered and removed, it would have caused incorrect indications on the related cockpit instruments

Inadequate protections were applied during aircraft painting in such a way that they were difficult to see from the ground. As a result, they were not removed after the painting job was done.

The transparent plastic was only noticed because of the presence of air bubbles under the film.

Follow the AMM and SRM instructions for stripping, paint removal, cleaning and painting as summarised below:

- The "Warning" notice highlights that adhesive tapes must not be applied on the probes, ducts, and sensors (static, pitot, TAT, AoA). Only specified tools should be used to seal the aircraft, which will ensure:
