LEVEL BUST

Japanese Near Miss

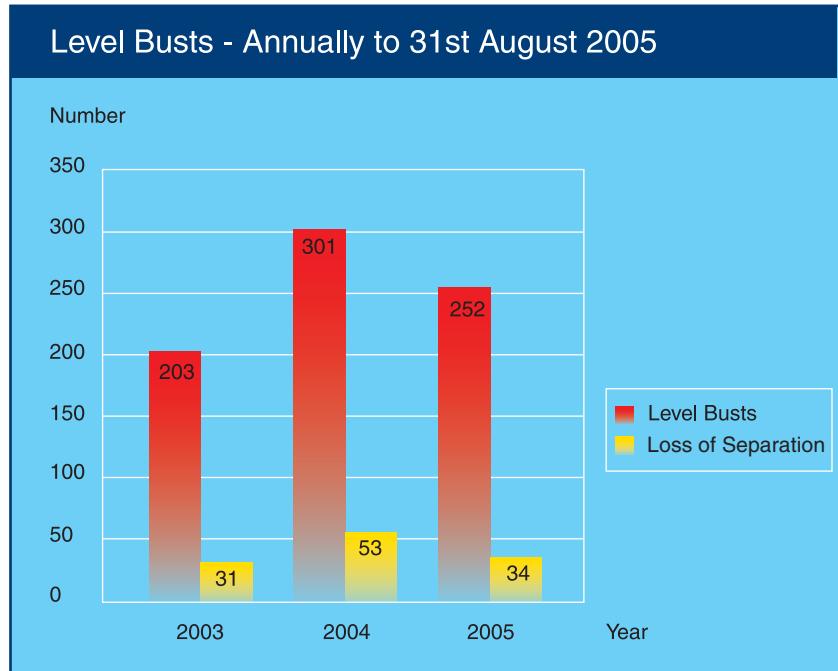
The chart below is taken from the UK CAA "Level Best" web-site⁶. It depicts the number of level bust incidents reported annually to UK CAA. At first

sight, it seems that the number of level busts is falling, but unfortunately, that is not the case, for the data for 2005 represents only the first 6 months of that year. In fact, there was a 40% increase in the number of incidents reported in 2005 compared with the same period for 2004, and a 100% increase compared with the same period in 2003.

In spite of the first impression given, this chart does not necessarily indicate that the number of level busts is rising. But it does demonstrate the success of efforts made in encouraging pilots and ATCOs to report level busts, even if no loss of separation resulted, even if no one else knew about them.
