**PART 1.1 – COVERING NOTE**

3 Oct 14

**SERVICE INQUIRY INVESTIGATION INTO AN INCIDENT INVOLVING VOYAGER ZZ333  
ON 9 FEB 14**

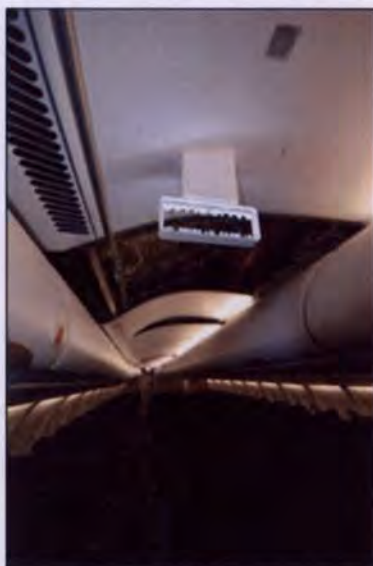
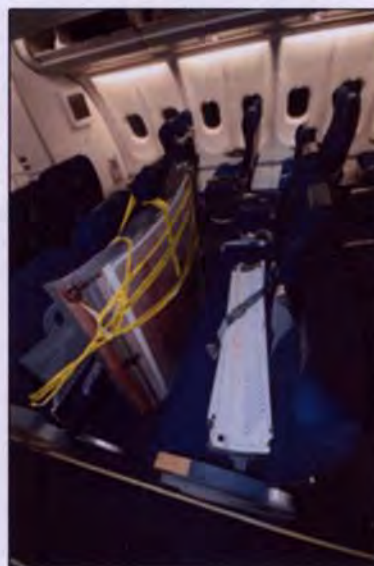
1.3.26 The damage to the aircraft comprised: 50 in-flight entertainment sockets broken or headphone pins sheared inside; seven ceiling panels dented; five florescent light tubes broken; five hand rails damaged; two seat belt brackets bent and one emergency exit sign broken (adjacent to door 2R). Initially, the rear facing lens of the exit sign at door 2R was missing (Figure 1), but it was subsequently found and put back in place for landing. Its cracked frame was sufficiently stable to accept and hold the replaced lens in order that the emergency function was not compromised for the landing.

**Figure 1: Internal damage to ZZ333.**

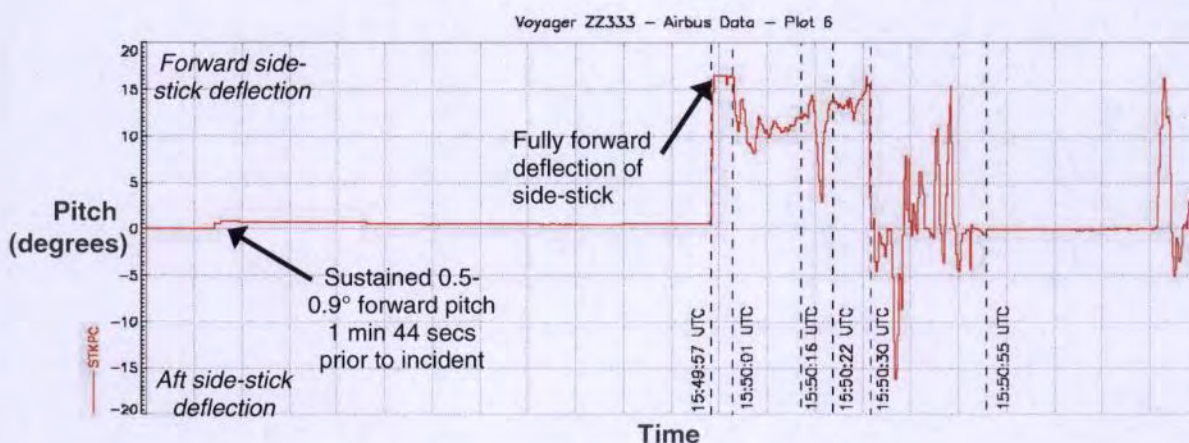
1.4.2 Evidence gathered from the aircraft's Digital Flight Data Recorder (DFDR) showed that a full pitch-down command had been initiated from the Captain's side-stick, which caused the autopilot to disconnect and the aircraft to enter a dive. The evidence also showed that the pitch-down command was not the result of a technical malfunctioning of the side-stick, the control surfaces, the autopilot, the flight control computers, or the aircraft's weight and balance. Neither was the pitch-down command the result of turbulence. A detailed examination of the aircraft indicated that there were no pertinent technical faults throughout the flight.

**Figure 1: DFDR extract showing Captain's side-stick pitch commands.**

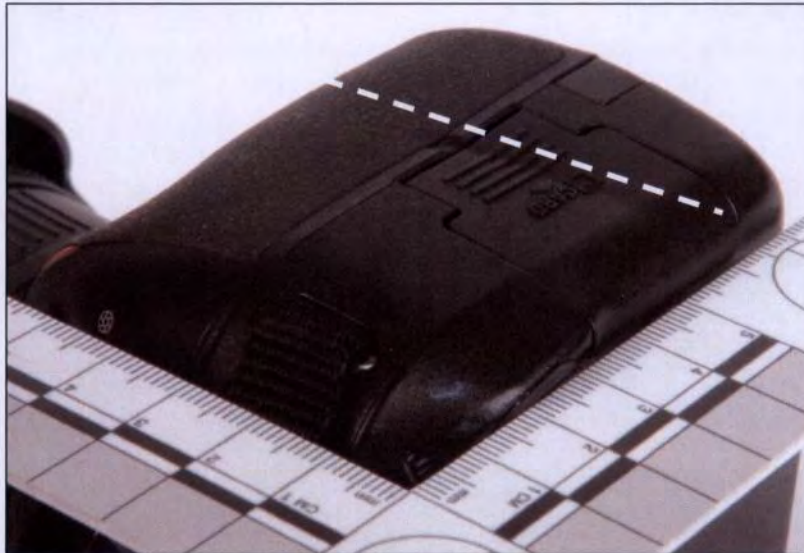
**Figure 6: Location and orientation of large dent in camera (dotted line).**

1.4.27 The camera was found to have a large linear dent on its right hand side (Figure 6). The dent extended from the softer hand grip region towards the front of the camera, across a thin part of the main body frame, and across the memory card flap.

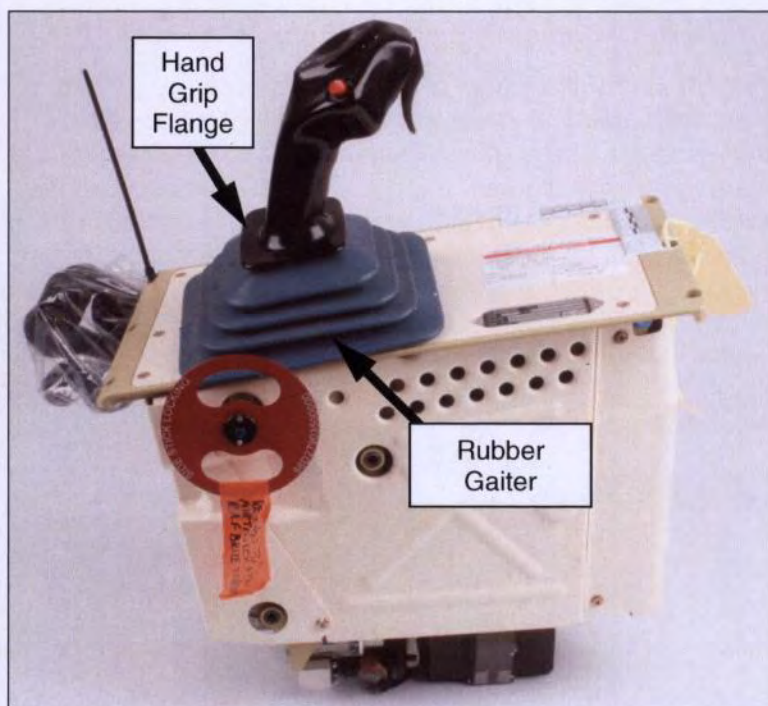
**Figure 7: Side-stick unit as received by Panel.**

1.4.28 The profile of the large dent was mapped forensically using surface profilometry and compared with the hand grip flange (Figure 7) at the base of the side-stick. The dent in the camera was found to be consistent with having been caused by the flange of the side-stick. Furthermore, chemical analysis indicated that trace amounts of materials present in a swab from the camera indentation were consistent with the material type of the side-stick. The rubber gaiter at the

base of the side-stick was examined using binocular microscopy, revealing two distinct perforations. The perforations were assessed to be the result of the gaiter material being pushed against the edges of the lower side-stick flange from the outside. When considered alongside other smaller witness marks on the camera, it was assessed as highly likely that the camera had experienced a significant compression against the base of the side-stick at some point during the flight. Specifically, it was assessed that the damage was consistent with the side-stick being pulled back forcefully against the body of the camera.

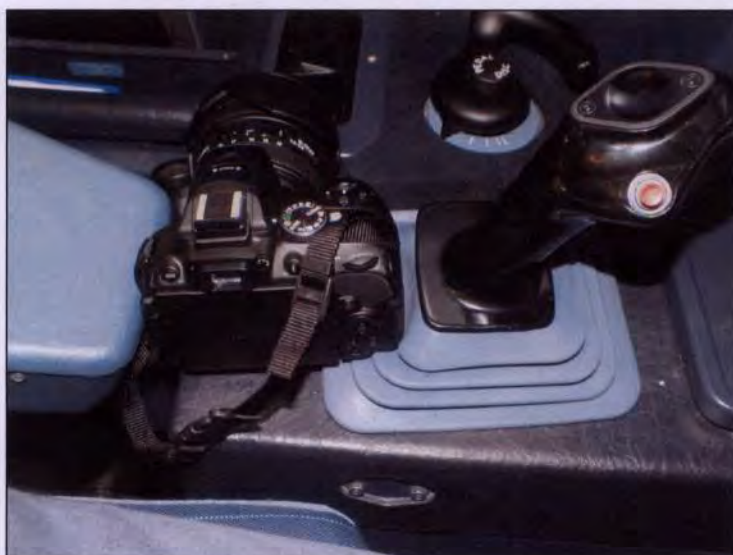
**Figure 8: Re-construction of Captain's camera behind side-stick.**

1.4.29 Using the Voyager simulator, the Panel reconstructed an arrangement of the armrest, the camera and the side-stick to assess the possibility of causing flight-control interference (Figure 8). The armrest was adjusted to the specific parameters used by the Captain on the flight in order to re-create the angle that was present during the event. Although the setting was within limits, it created an unusual angle, resulting in a particularly steep downward incline from back to front. The camera was placed in the gap between the armrest and the side-stick, with the damaged side presented towards the grip flange at the base of the side-stick. The seat motor was moved forward until the camera was gently flush against the base of the side-stick.

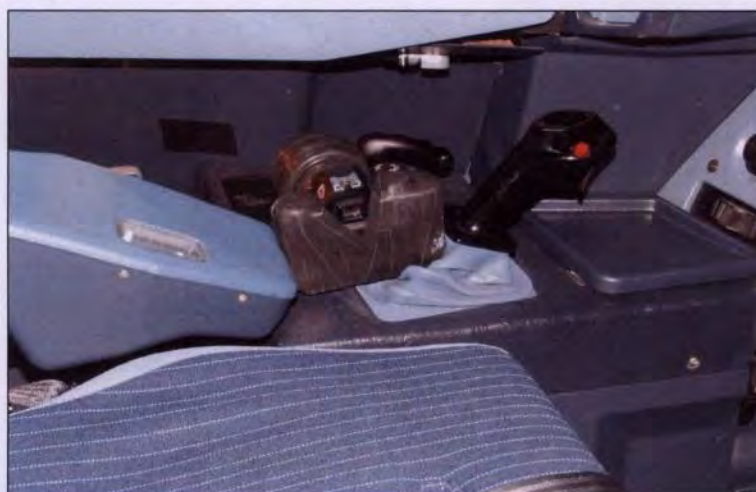
**Figure 9: Side-stick locked in fully forward position (substitute camera).**

1.4.30 The seat motor was operated in a forwards direction as heard at the onset of the pitch-down event. The effect was to push and hold the side-stick fully forward in a manner consistent with the pitch-down command seen on the DFDR (Figure 9). The motion resulted in the grip flange becoming aligned with a location exactly consistent with the dent in the camera. The re-construction took no more than a few seconds to set up.

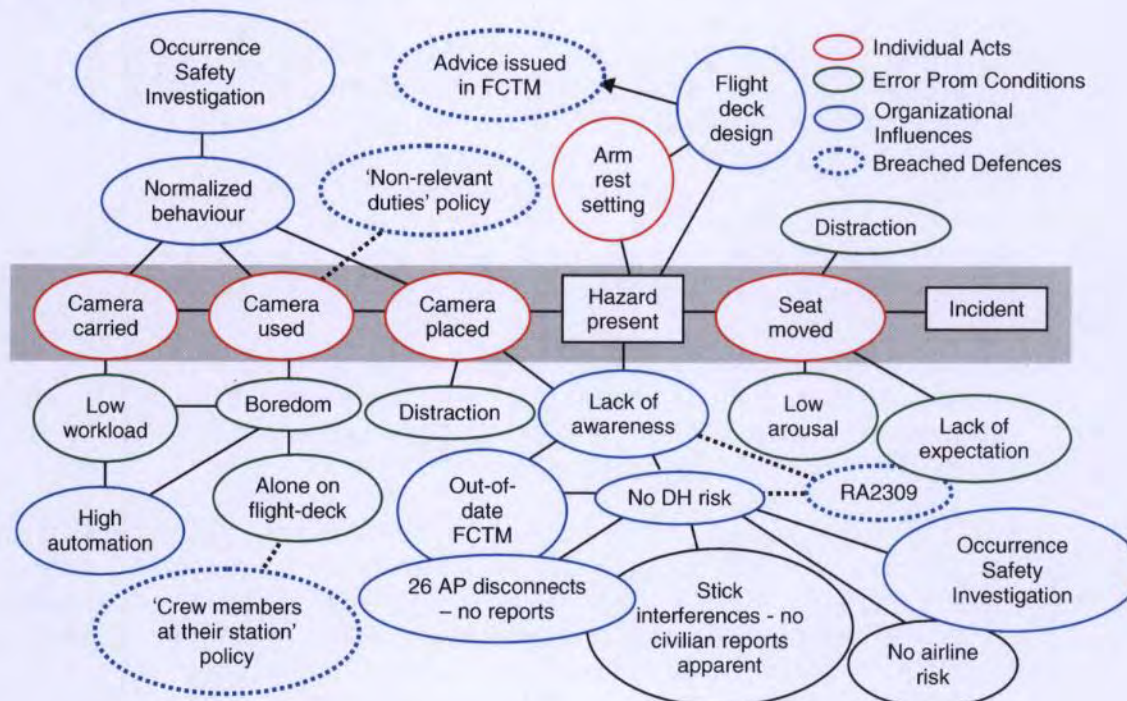
Figure 10: Diagram of key factors leading to pitch-down command.

1.4.35 **Carriage of the camera.** The carriage of the camera had a direct bearing on the incident, in as much as it was the object responsible for the side-stick interference. As such, the Panel concluded that **the carriage of the camera on the flight deck was a contributory factor**. This however, was influenced by a number of associated factors.

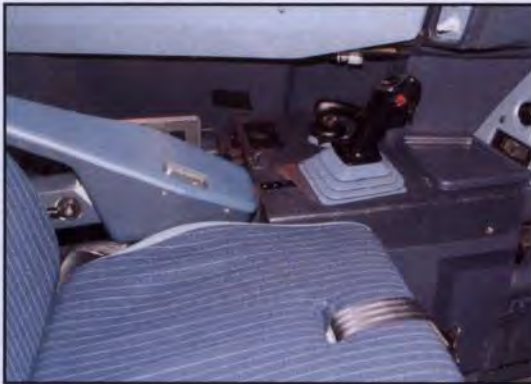
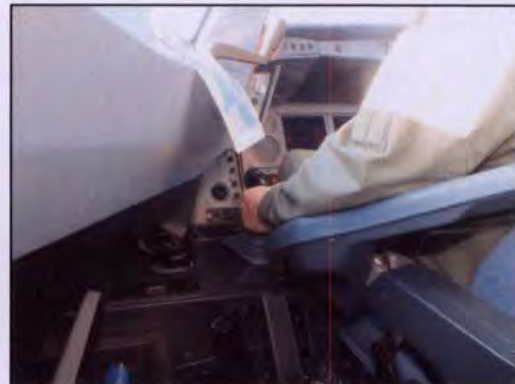
stick, increased the risk of the item becoming jammed. Moving the seat forward against a camera of a similar size to the Captain's with the armrest at different settings (to those in Figure 15) did not result in the side-stick being held forward. **The armrest setting was a contributory factor.**

Figure 15: Captain's seat and armrest configuration.

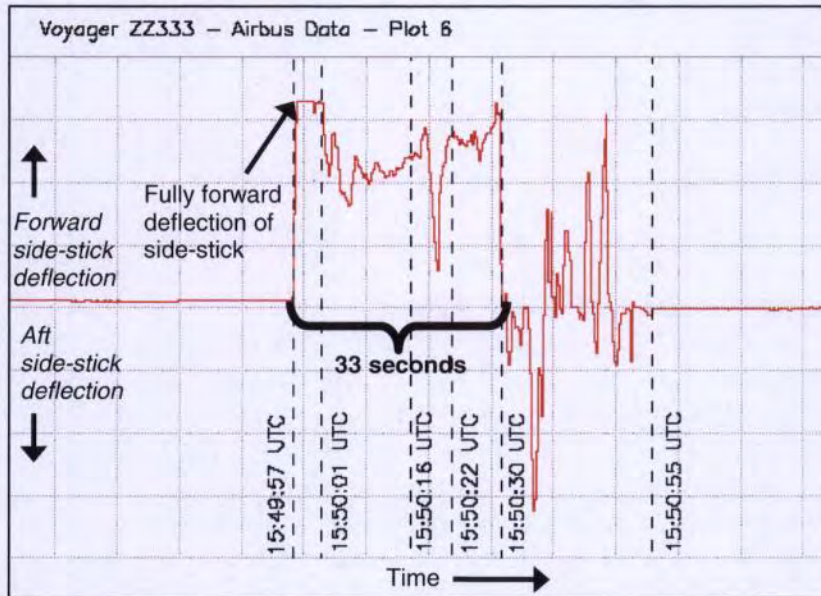
1.4.43 The interference with the side-stick persisted for a total of 33 seconds before the camera became free (illustrated by the bracket in Figure 16). The recovery from the pitch-down command was analysed in three phases: first, the initial response on the flight deck; second, the response of the aircraft; and third, the clearing of the side-stick obstruction.

Figure 16: ZZ333 DFDR trace of Captain's side-stick in pitch.

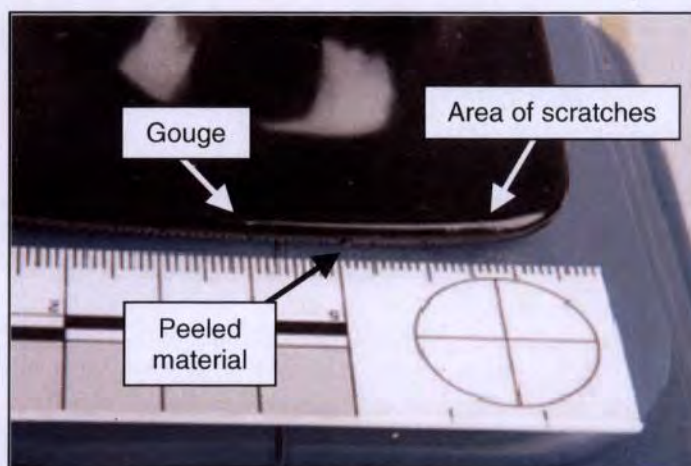
hard edge had been pressed into the flange and dragged sideways, peeling away small chunks of material (Figure 22).

**Figure 22: Witness marks on rear right-hand area of side-stick.**
