# **AIRCRAFT ACCIDENT REPORT 1/2014**

**Report on the accident to  
Airbus A330-343, G-VSXY  
London Gatwick Airport  
16 April 2012**

**Air Accidents Investigation Branch**

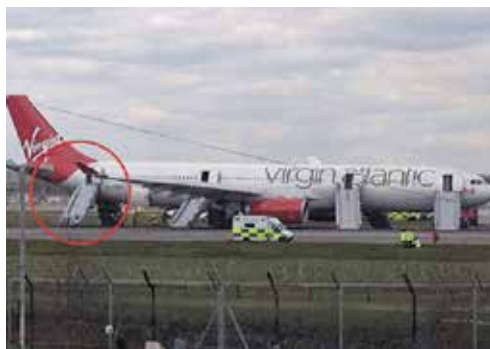
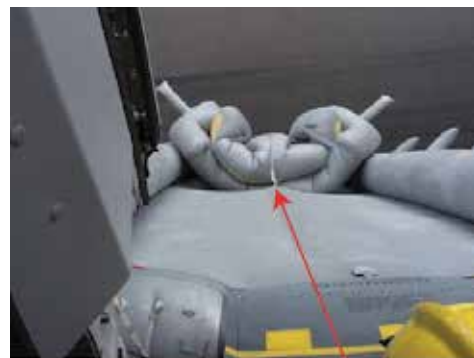
**Figures 11a and 11b**

A review of video evidence of the aircraft evacuation showed that the slide-raft inflation commenced normally after the R4 door had been opened. However the primary restraint appeared to release earlier than normal and the slide-raft did not fully inflate. The deployment sequence stopped at the secondary restraint. Figures 11a and 11b show the condition of the R4 slide following the evacuation.

Unbroken  
secondary  
restraint

The R4 slide-raft (P/N 7A1508-125, S/N AA5588) was examined at the manufacturer's facility. All subassembly parts were found correctly assembled and all mechanical restraints were installed at the correct locations. The secondary restraint was unbroken. Minor damage and abrasions were evident on some subassembly components and some small perforations on the inflatable assembly were noted. However these were considered to be consistent with the slide having been moved across the ground, after removal from the aircraft.

No anomalies which could have contributed to the partial inflation of the slide-raft were found with the inflation system components.

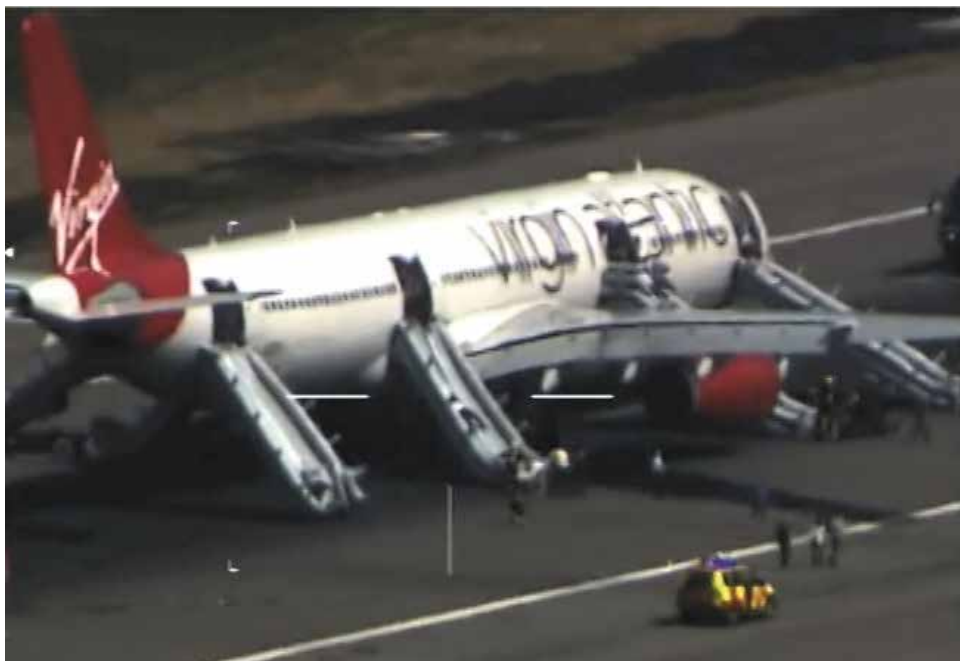
**Figure 13**

The videos showed that the flow of people from the left doors (Figure 12) was much quicker than from the right (Figure 13). On the right side a number of people sat down in the doorway before descending the slide; some people fell to the ground at the bottom of the slide and others slowed their own evacuation because they were carrying hand baggage (Figure 14). The video also showed members of the RFFS standing at the bottom of the slide at Door 3R directly in line with the escape path.

Still image from video showing right side approximately 30 seconds after evacuation commenced

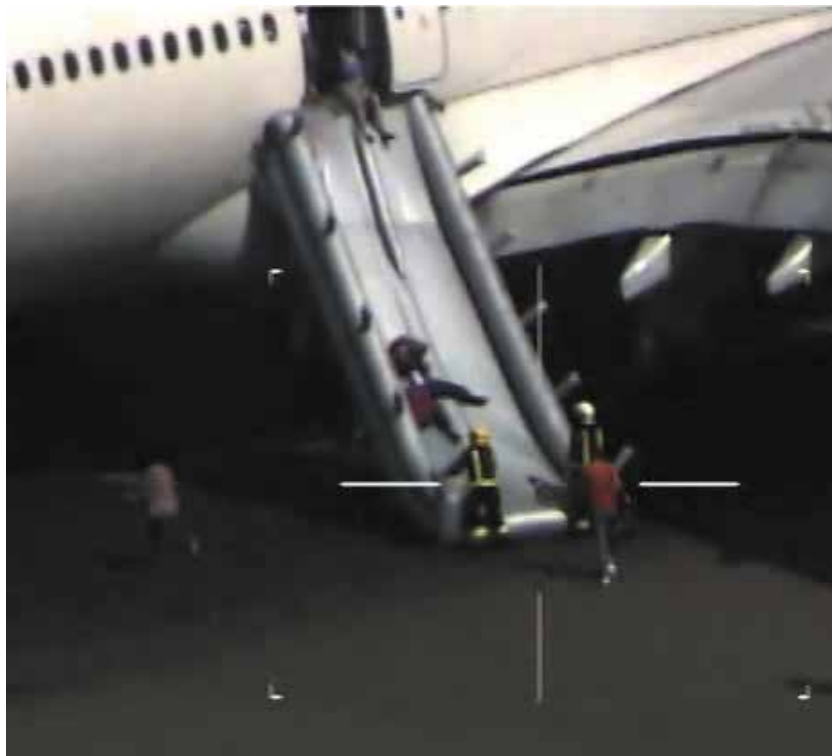
**Figure 14**

Door 3R showing passengers with hand baggage, sitting to use the slide and members of the RFFS waiting to assist

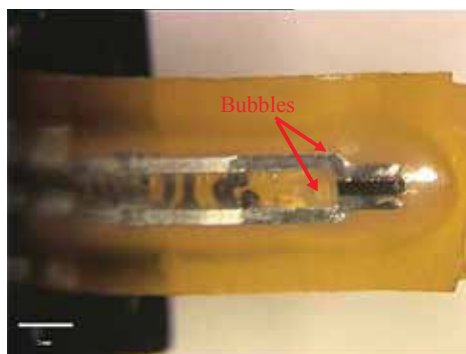
**Figure 15a**

Optical inspections of the T1 and T2 temperature sensors from both measurement boards revealed the presence of bubbles in the insulating envelopes of the thermistors (Figure 15a). A crack in the Kapton tape was also evident very close to the active area of the T1 thermistor from 10WH. The crack was located close to a wrinkle in the tape (Figure 15b).

Bubbles in T1 thermistor from 9WH

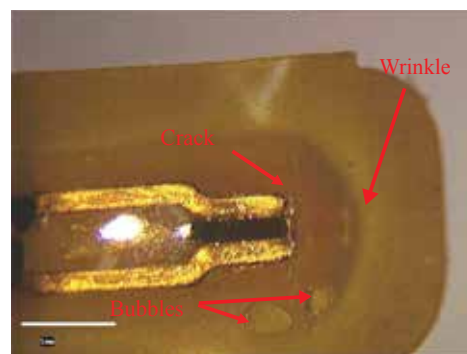
**Figure 15b**

Bubbles and crack in T1 thermistor from 10WH

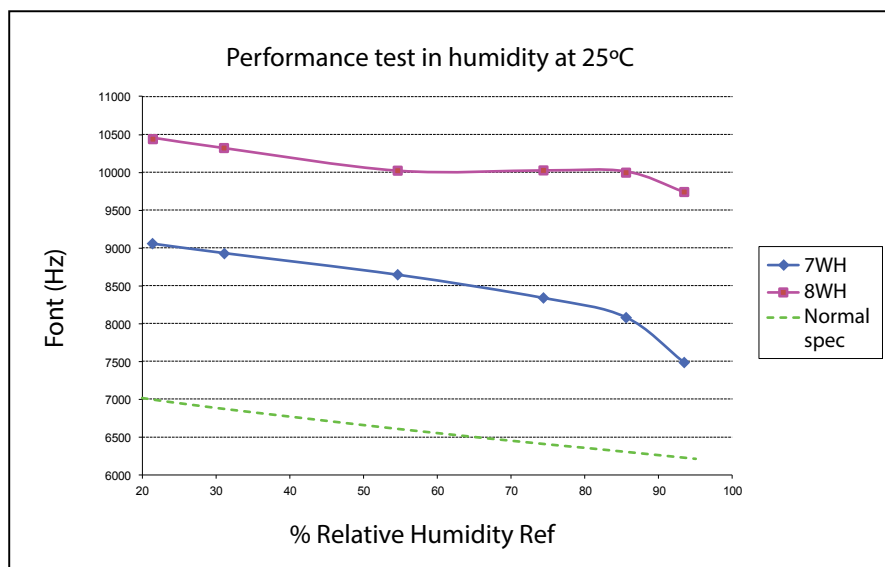
**Figure 16**

The performance test confirmed that while the sensors reacted to varying levels of humidity by altering the output signal, the frequency response curve was offset from the nominal values by approximately 2,000 Hz for 7WH and by approximately 3,000 Hz for 8WH. The profile of the response curve was also noticeably different at high humidity levels. Such high frequency outputs are indicative of lower than actual humidity readings by the sensors.

Frequency output for 7WH and 8WH vs Relative Humidity
