# Investigation Report

Type of Occurrence:	Accident
Date:	24 January 2005
Location:	Düsseldorf
Aircraft:	Airplane
Manufacturer / Model:	Boeing / 747-212B
Injuries to Persons:	No injuries
Damage:	Aircraft severely damaged
Other Damage:	Aerodrome equipment
Information Source:	Investigation by BFU
State File Number:	BFU AX001-05

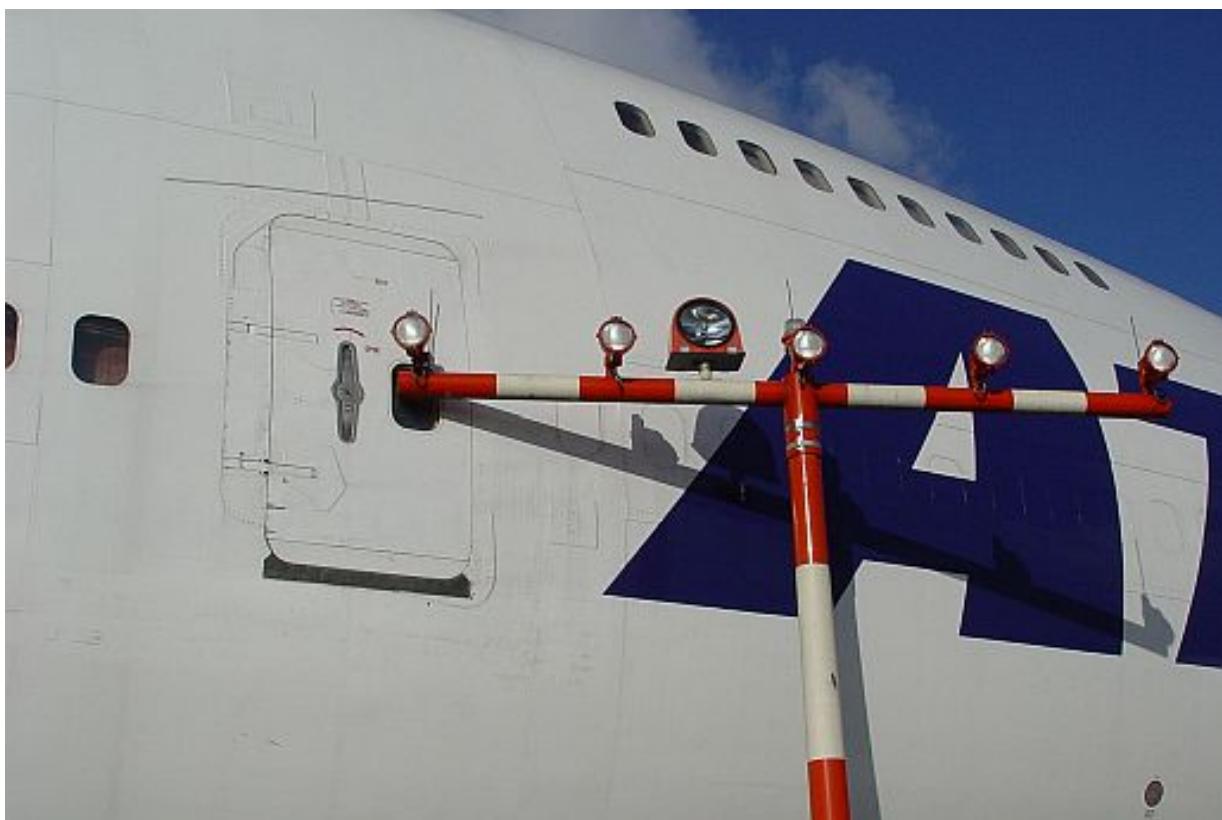
Three stanchions of the approach lighting of runway 05R were severed. A fourth stanchion of the approach lighting had been turned by about 60° around the yaw axis and blocked the airplane's door 1L.

Blocked door L1

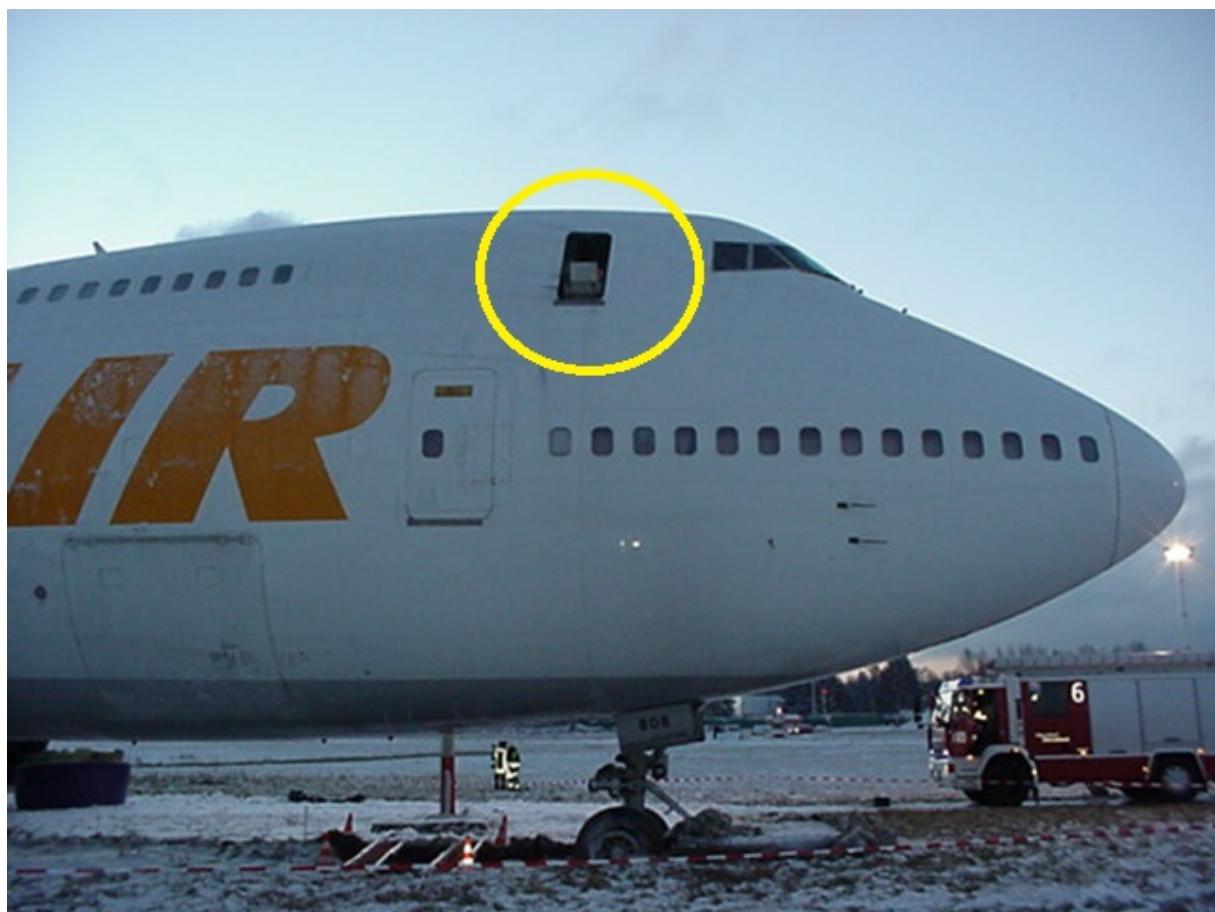
Open crew service door

The crew service door on the upper floor of the right fuselage was open and pushed aside (opposite the flight direction). The platform including the escape slide mounted on top was in the position operation ready and directly in front of the doorway.

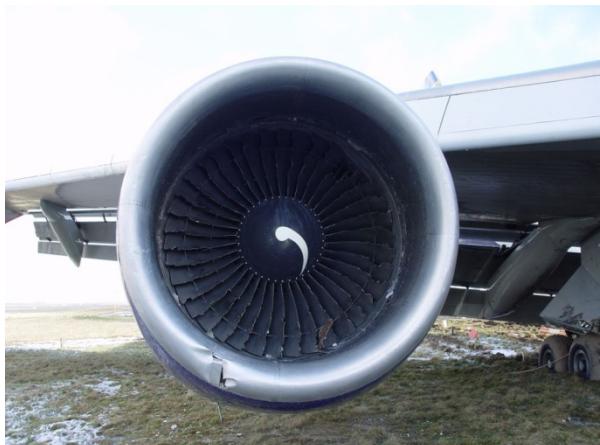
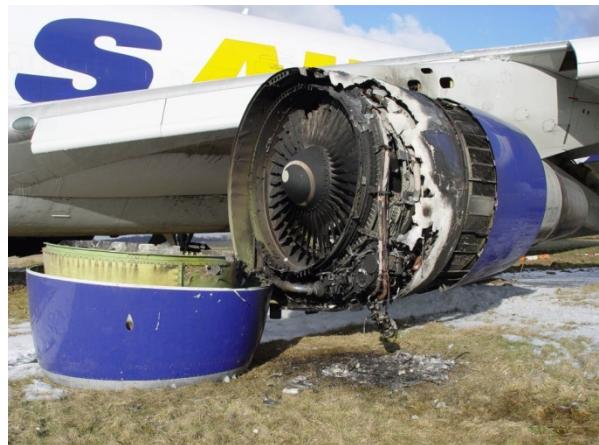
The air intake of engine 1 showed damages in the 5 o'clock position. The entire air intake of engine 2 up to the fan was severed and was lying in front of the engine. Fire had destroyed the left engine fairing in the area of the fan and the low pressure compressor. The thrust reverser doors were in the open position. The air intake of engine 3 was damaged in the 7 o'clock position; the thrust reverser doors were in the open

position. The engine air intake of engine 4 showed damages in the 5 o'clock position. The fan blades of the engines 2, 3, and 4 were also damaged.

Parts of the ILS antennas were found in the engines. Fuselage and wings showed damages which were also a result of collisions with the antenna array.

Damages on engines 2 an 3

- The collision of engines 2 and 3 with the localizer antenna caused engine failure and fire.
- The tower controller alerted the fire brigade immediately.

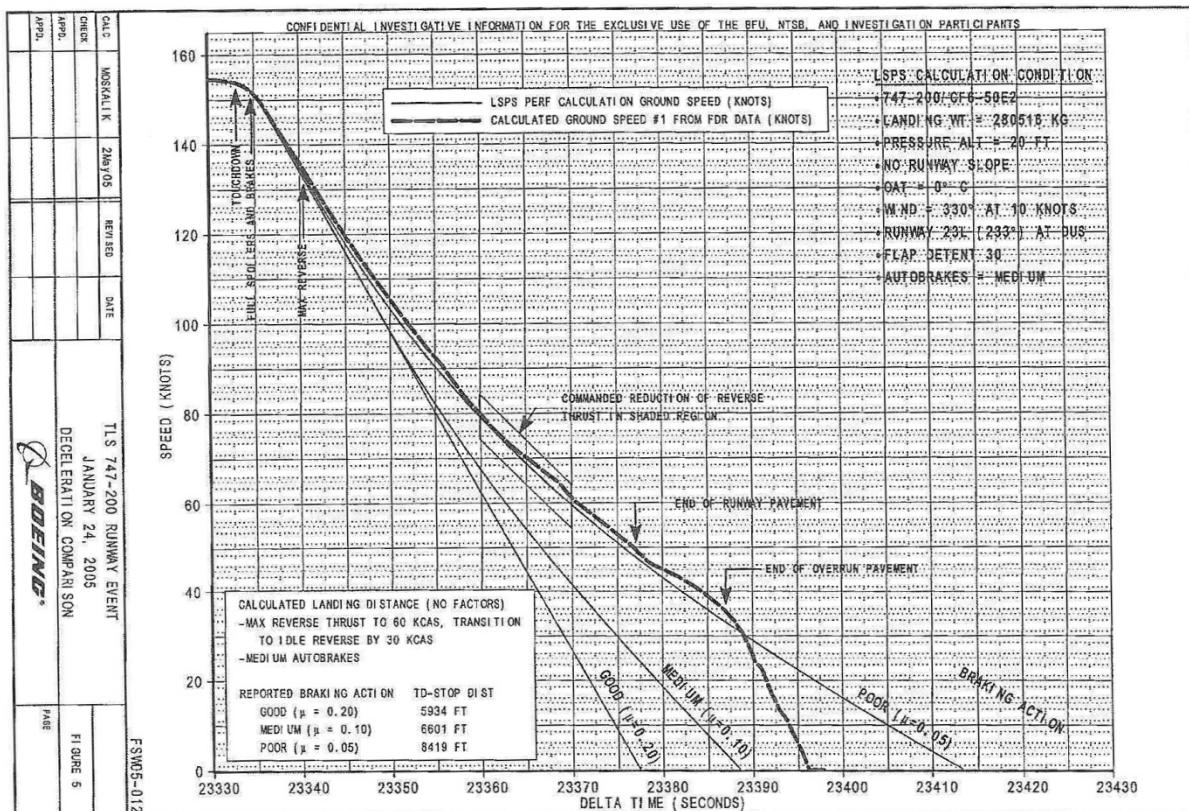
The aircraft manufacturer analysed the FDR data and calculated that the airplane had touched down between 1,100 ft and 1,600 ft beyond the displaced threshold. According to the FDR at touch-down the normal load factor reached 1.2. Three seconds after touch-down the longitudinal deceleration reached 0.17 g. According to Boeing this correlates with the target value for the deceleration with the auto brake setting medium (6 ft/s<sup>2</sup> or 0.186 g). Within the next 35 seconds deceleration gradually decreased and then reached 0.08 g. At a speed of about 85 kt the thrust was set to reverse idle and then to maximum thrust again. After which the deceleration fluctuated between 0.1 g and 0.05 g.

Boeing conducted a performance evaluation of the FDR data of the landing with the help of Boeing's Low Speed Performance System (LSPS) program. As a result a runway braking coefficient was determined which corresponds with the braking action poor or worse. Under these conditions the LSPS program calculated that the airplane would have needed 8,419 ft (2,566 m) to stop.

Deceleration comparison

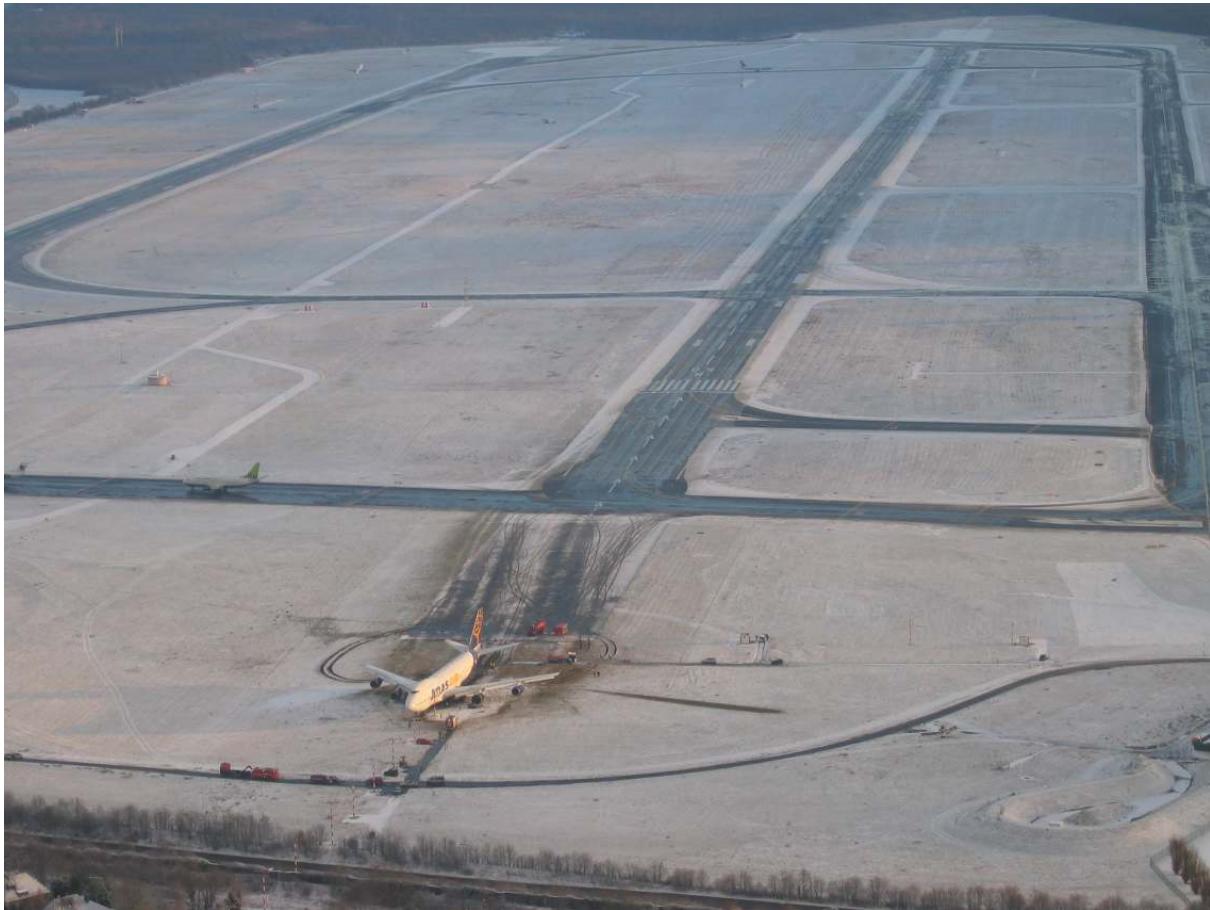
Accident site overview
