# Report

Serious incident on **16 August 2008**  
on **take-off from Paris Charles de Gaulle Airport (95)**  
to the **Boeing 737-800**  
registered **SU-BPZ**  
operated by **AMC Airlines**

**BEA**

Bureau d'Enquêtes et d'Analyses  
pour la sécurité de l'aviation civile

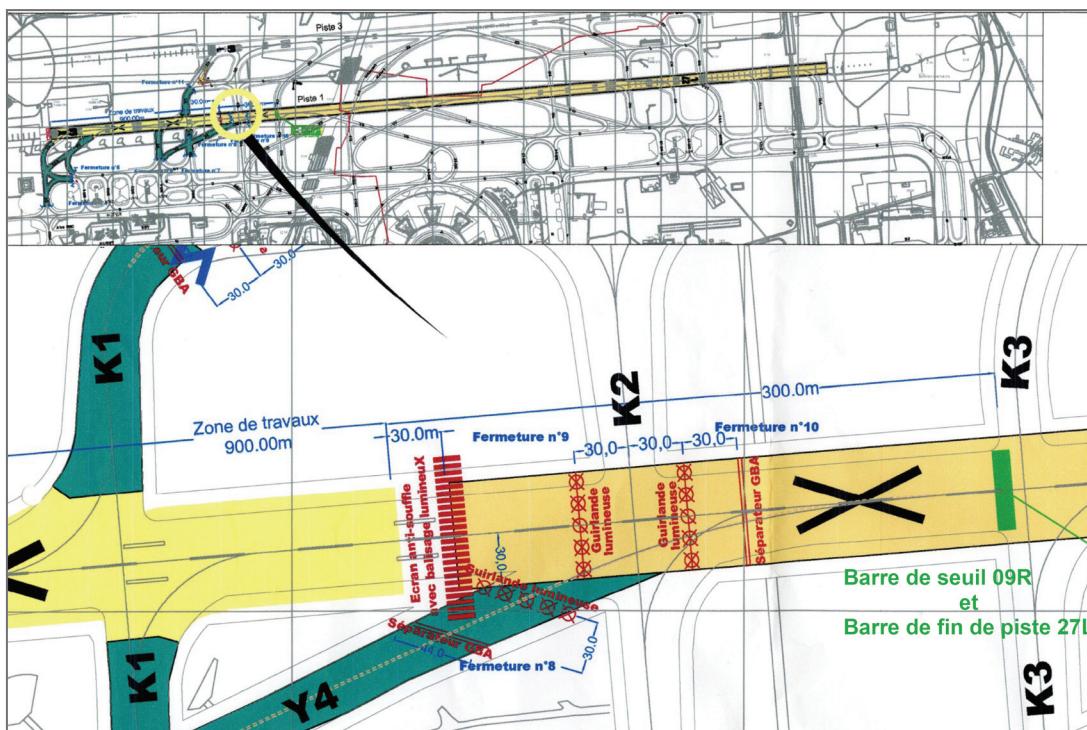
Plan by ADP for the taxi and runway closures

The two plans that follow were supplied by ADP. On the first, the workers' traffic zone, 36 m wide, arranged between the extended RESA and the works zone, is incorrectly positioned.

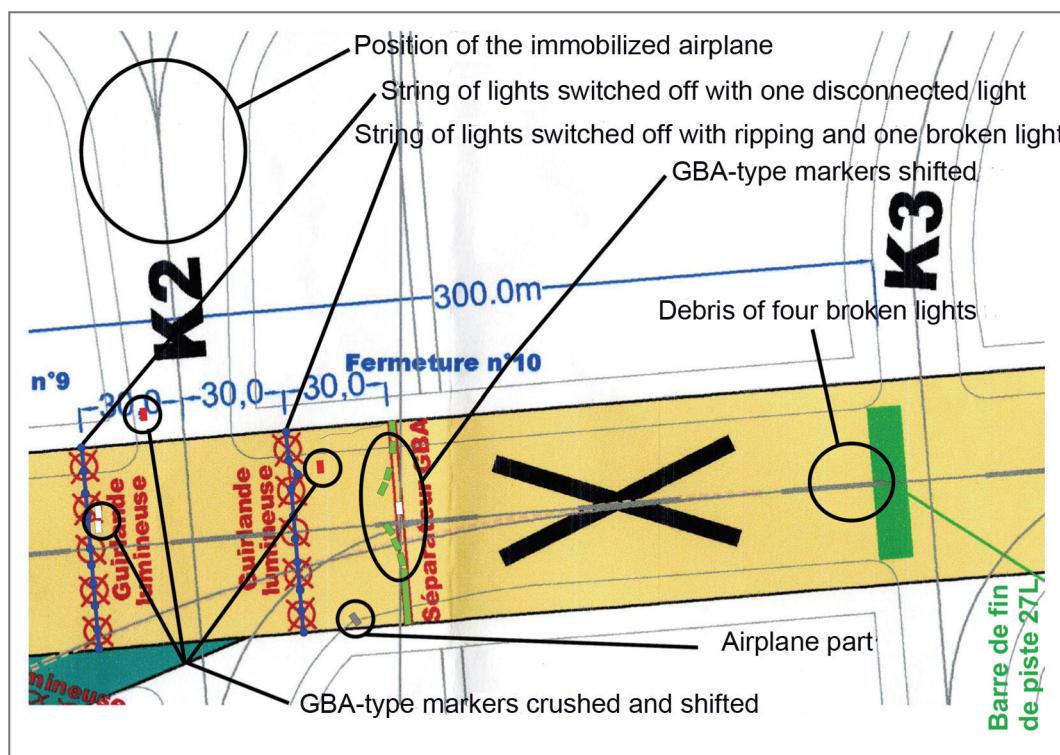
Two PCR coordinators visited the site at 02 h 37 on the 17 August, in order to clear the debris blocking track K2. ATC had been informed by flight BIE250 which should have used this taxiway (see diagram below).

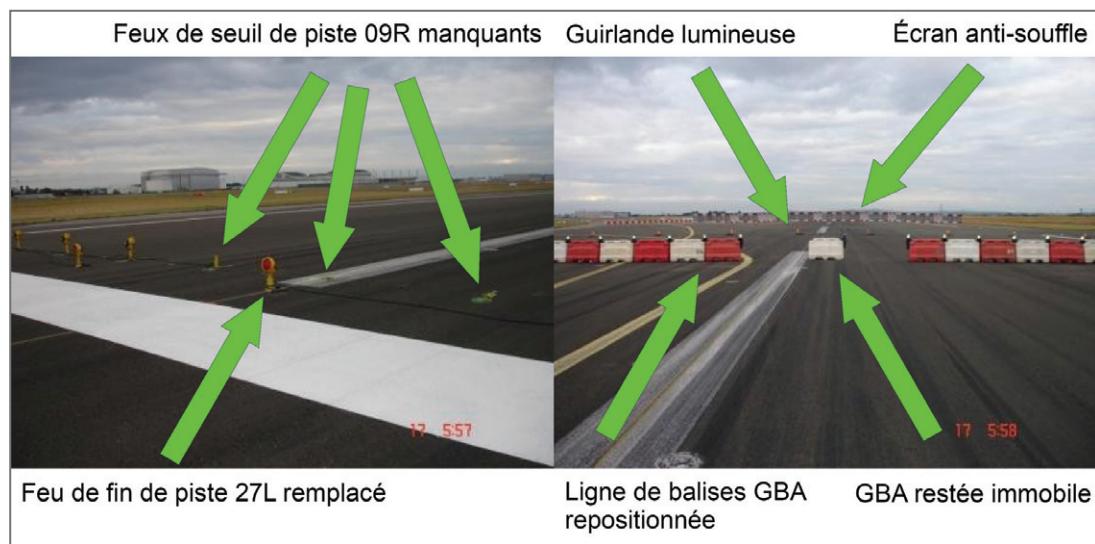
The agents found two crushed white-coloured GBA's in the runway centreline on track K2 next to the lights situated furthest west. Switched off, it had not been displaced and a light had been disconnected without any sign of impact. A third GBA, crushed and red in colour, was on the North side of track K2 and to the South of the stop barrier, in front of any crossing airplane.

Once track K2 had been cleared, the agents visited the unusable part of the runway. On the other lights, also switched off, they reported that one light had been displaced towards the east and that another had been broken and violently torn out. They also found on the runway, to the North of the centreline, a fourth GBA, crushed and red-coloured as well as the left main landing gear harness support from SU-BPZ<sup>(12)</sup> on the South boundary, two metres fifty from the lights. At the level of the GBA line, three markers had been displaced, on each side of a white marker situated near the centreline and which had not moved. The markers thus displaced formed a "funnel". Debris originating from the lights positioned at the end of the runway was found. It corresponded to the lights at the end of runway 27L nearest to the runway centreline and to the three 09R threshold lights situated closest to the centreline.

N.B: These photographs were taken some days after the event.

At 3 h 47 a team visited the site in order to replace the runway centreline end light and to line up the GBAs again. They left a space equivalent to two GBAs on either sides of the white marker that had not moved (this marker stayed positioned 0.45 m from the runway centreline). Two runway end lights situated on the far left that had not been working on the night of 16 August 2008 were also replaced.

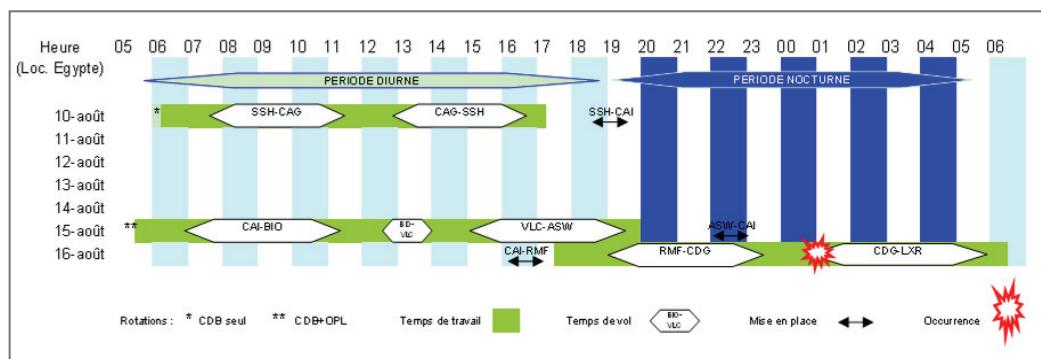
The review of the crew's activity-rest cycles the week preceding the event is summarized in the following table:

The planning for the Marsa Alam – Paris – Luxor trip, delayed until the afternoon as well as the airplane's lateness, made the pilots' activity period clash with their biorhythms in relation to the preceding week. Consequently the time the event occurred corresponded to a period in which the crew's performance was likely impaired.
