Air Accident Investigation Unit Ireland

SYNOPTIC REPORT

ACCIDENT
Airbus A320-214, EI-CVA
London Flight Information Region
7 September 2012

AAIU Report No: 2014 - 003

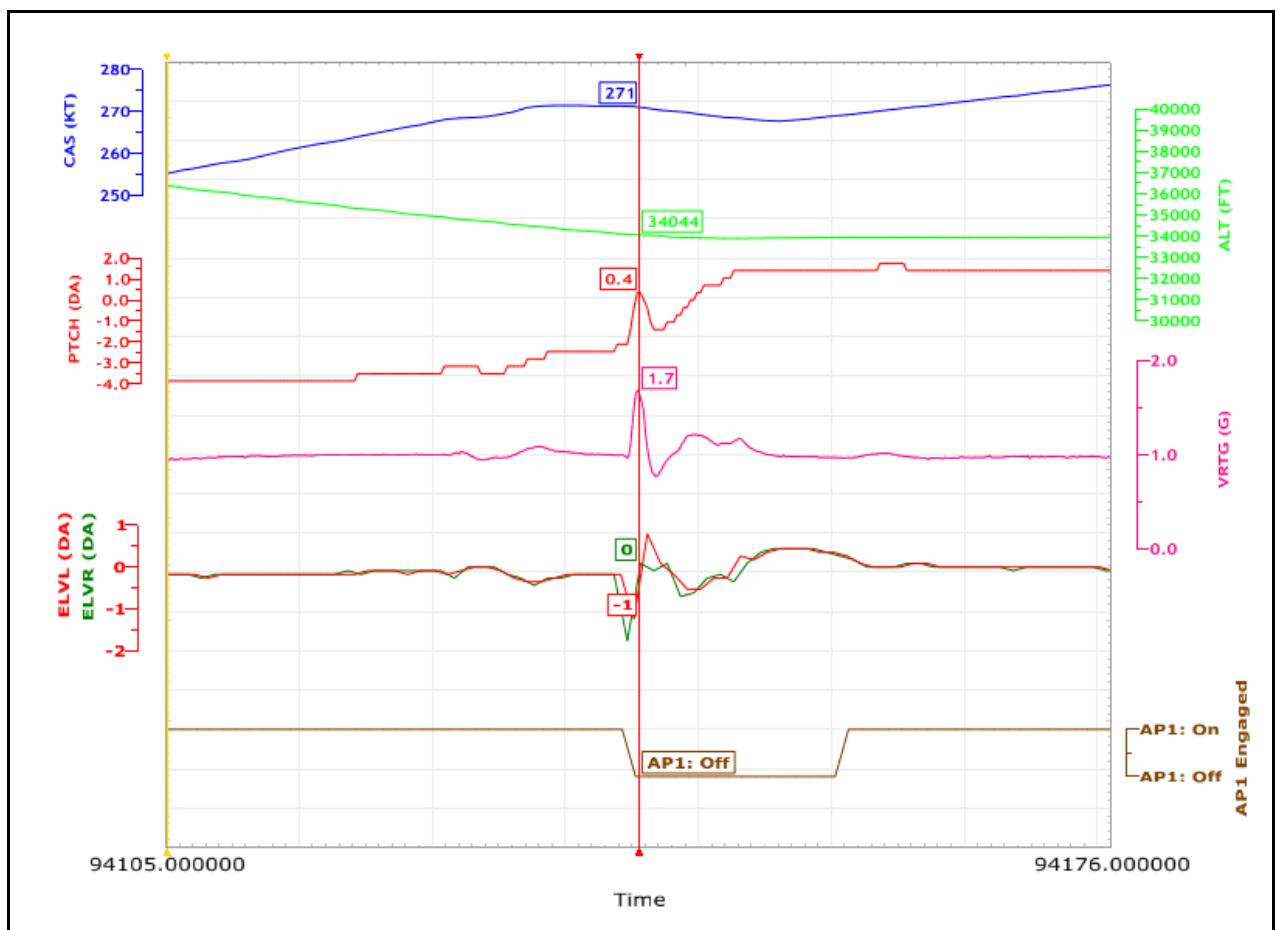
Graphic No. 1: DFDR parameters

The DFDR was obtained from the Operator and downloaded by the Investigation. The flight data recovered was of good quality. **Graphic No. 1** shows that during the occurrence the vertical acceleration (g)⁹ increased sharply from 1g to 1.7g and then decreased to approximately 0.8g over a period of 3.4 seconds. It then oscillated slightly before settling back at 1g.

There was a corresponding pitch change of +2.9°, from -2.5° to +0.4°. Although not depicted in the graphic, the vertical speed in the initial descent was approximately 4,000 ft/min. This had reduced to 2,800 ft/min when the occurrence commenced. The Commander's side stick information, as recorded on the DFDR, was not reliable or consistent with the other recorded data.

This rapid change in g forces, due to aircraft pitch changes, probably caused the CCM's injury.

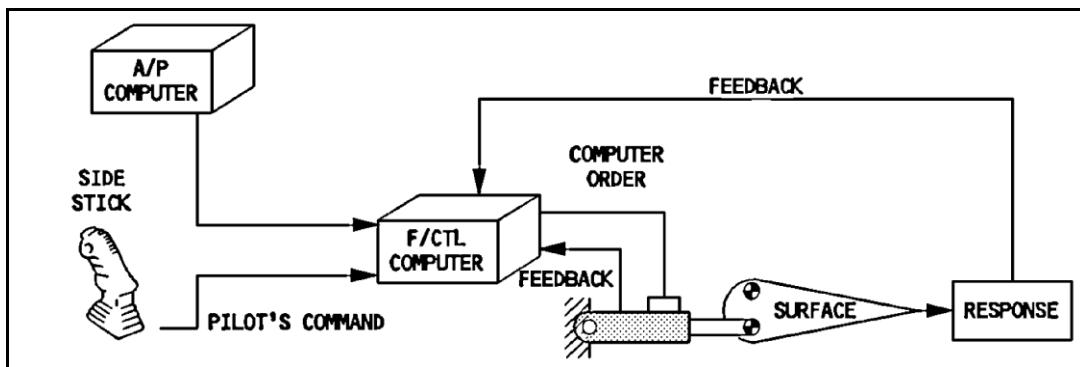
Graphic No. 2: A320 Flight Control System Architecture (A320 FCOM)

In Normal law, in which the subject aircraft was operating, control surface movements are automatically limited which inter alia keep the aircraft within certain parameters in pitch and roll. A side stick pitch input demands a proportional load factor from the flight control system and the control surfaces move accordingly. The Autoflight System automatically trims the aircraft through the elevator and trimmable horizontal stabiliser (THS) to maintain a vertical load factor of approximately 1g. Pilot input is not required to trim the aircraft in manual flight or with the autopilot engaged. The A320 Flight Control System architecture is shown schematically in **Graphic No. 2**.

Normal law protections prevent excessive pitch attitude and angle of attack. Speed and bank angle are also protected with load factor limitations provided. In a clean configuration, the A320 will maintain the load factor between +2.5g and -1g, regardless of pilot stick input. This means that full manual control stick inputs can be made without stalling, over-speeding or overstressing the aircraft, thus preventing a loss of control while allowing use of the full flight envelope.

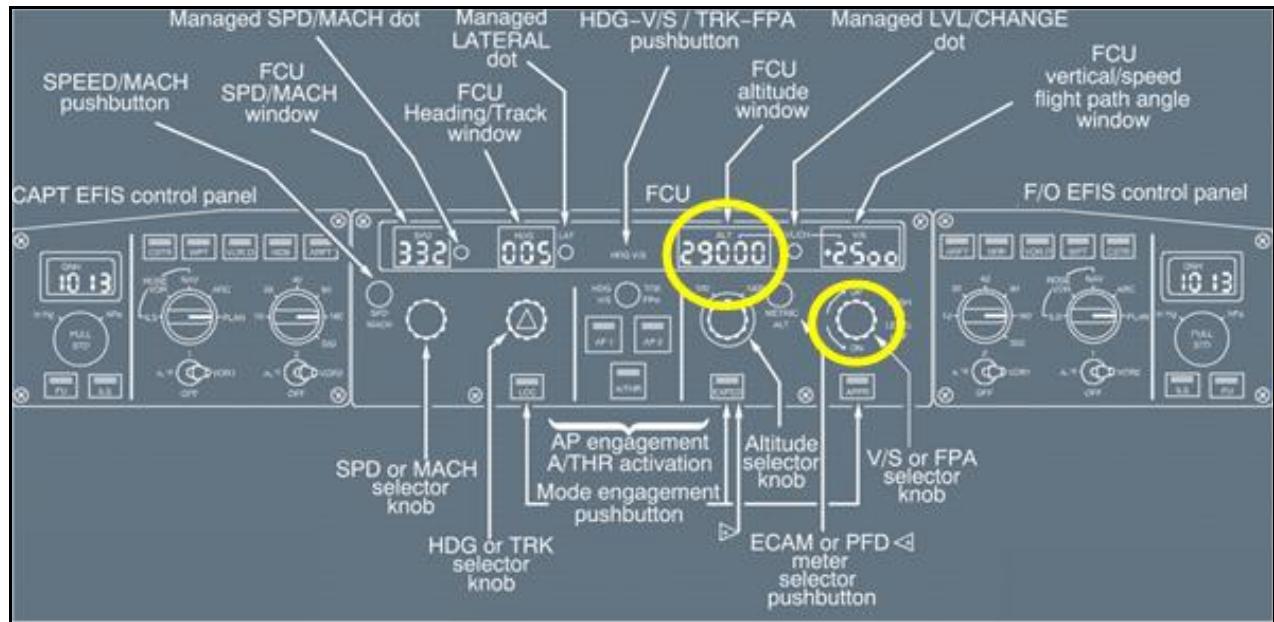
Graphic No. 3: FCU control panel showing altitude window and V/S or FPA selector (Airbus).

Direct, tactical short term inputs can be made by flight crew using the FCU control panel (**Graphic No. 3**). FCU inputs are known as selected guidance and have priority over managed guidance. Pilots use the FCU to make altitude, speed and flight path trajectory selections. In the case of a selected altitude change this appears in blue on the PFD. The FCU is also used to select autopilot and auto thrust functions.

When the flight crew pushes in the V/S or FPA¹⁷ knob, the system commands an immediate level-off by engaging the V/S or FPA mode with a target of zero.

Thus when the autopilot is engaged and an immediate level-off is desired, pressing the V/S or FPA selector knob will command the aircraft to conduct a smooth level off to zero vertical speed.
