# Report

Accident on **16 October 2012**  
at **Lorient Lann Bihoué (56) Aerodrome**  
to the **the Bombardier CRJ-700**  
registered **F-GRZE**  
operated by **Brit Air**

Bureau d'Enquêtes et d'Analyses  
pour la sécurité de l'aviation civile

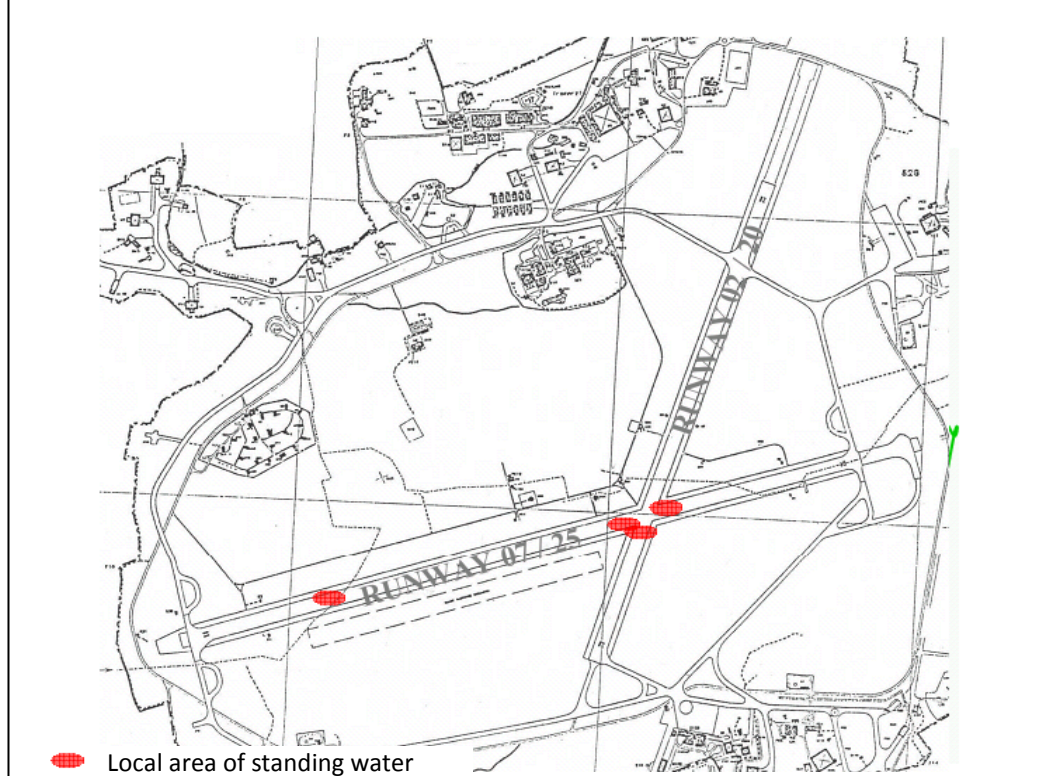
### RUNWAY PROFILE CORRECTION ZONES TO ELIMINATE RAINWATER RETENTION AND PHOTOGRAPHS OF THE RUNWAY IN RAINY WEATHER

After the accident, two fire trucks poured water on the south side of the runway over the last 1,200 m. Water retention zones were found on certain sections<sup>(16)</sup>.

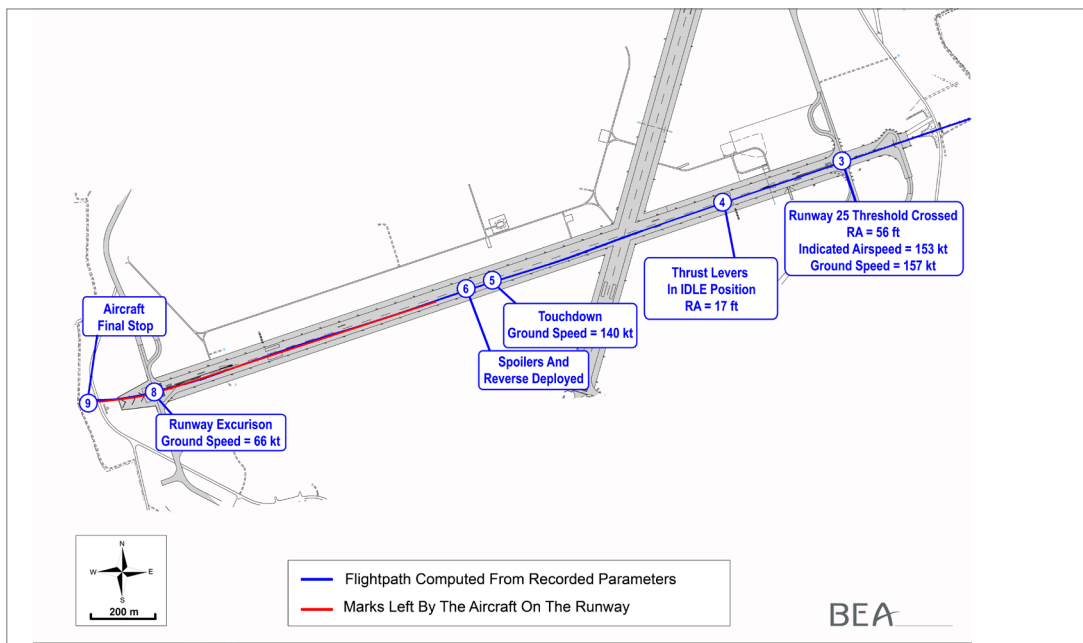
The flight path of the aeroplane was calculated from its ground speed, magnetic heading<sup>(18)</sup> and drift recorded on the FDR. It was consistent with the marks left by the aeroplane on the runway.

The positioning of the thrust levers to IDLE and touchdown of the main landing gear occurred respectively at 330 and 1.130 m from the threshold of runway 25.

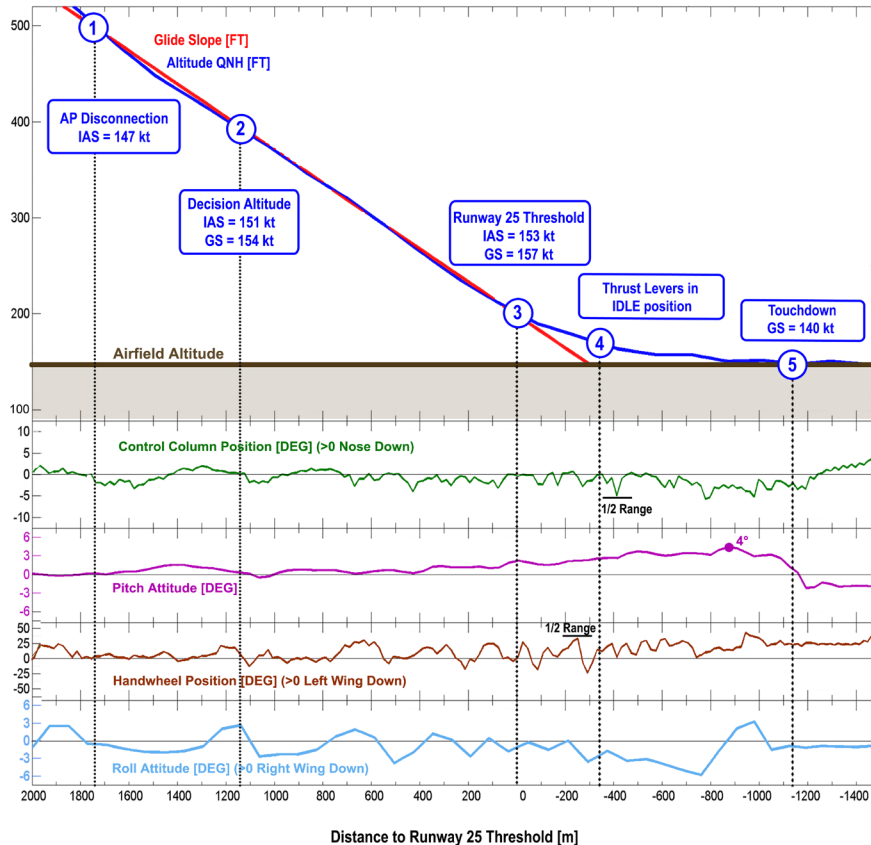
The following specific points can be noted:

- ☐ From the disengagement of the AP to 50 ft above ground level, the aircraft was on the glide path to runway 25;
- ☐ On final approach, the roll inputs were substantial (up to half of the maximum amplitude);
- ☐ The aeroplane passed the runway threshold at a height of 56 ft with 4 knots of tailwind;
- ☐ Between reducing the thrust 17 ft from the ground and touchdown, the aeroplane travelled approximately 800 m.

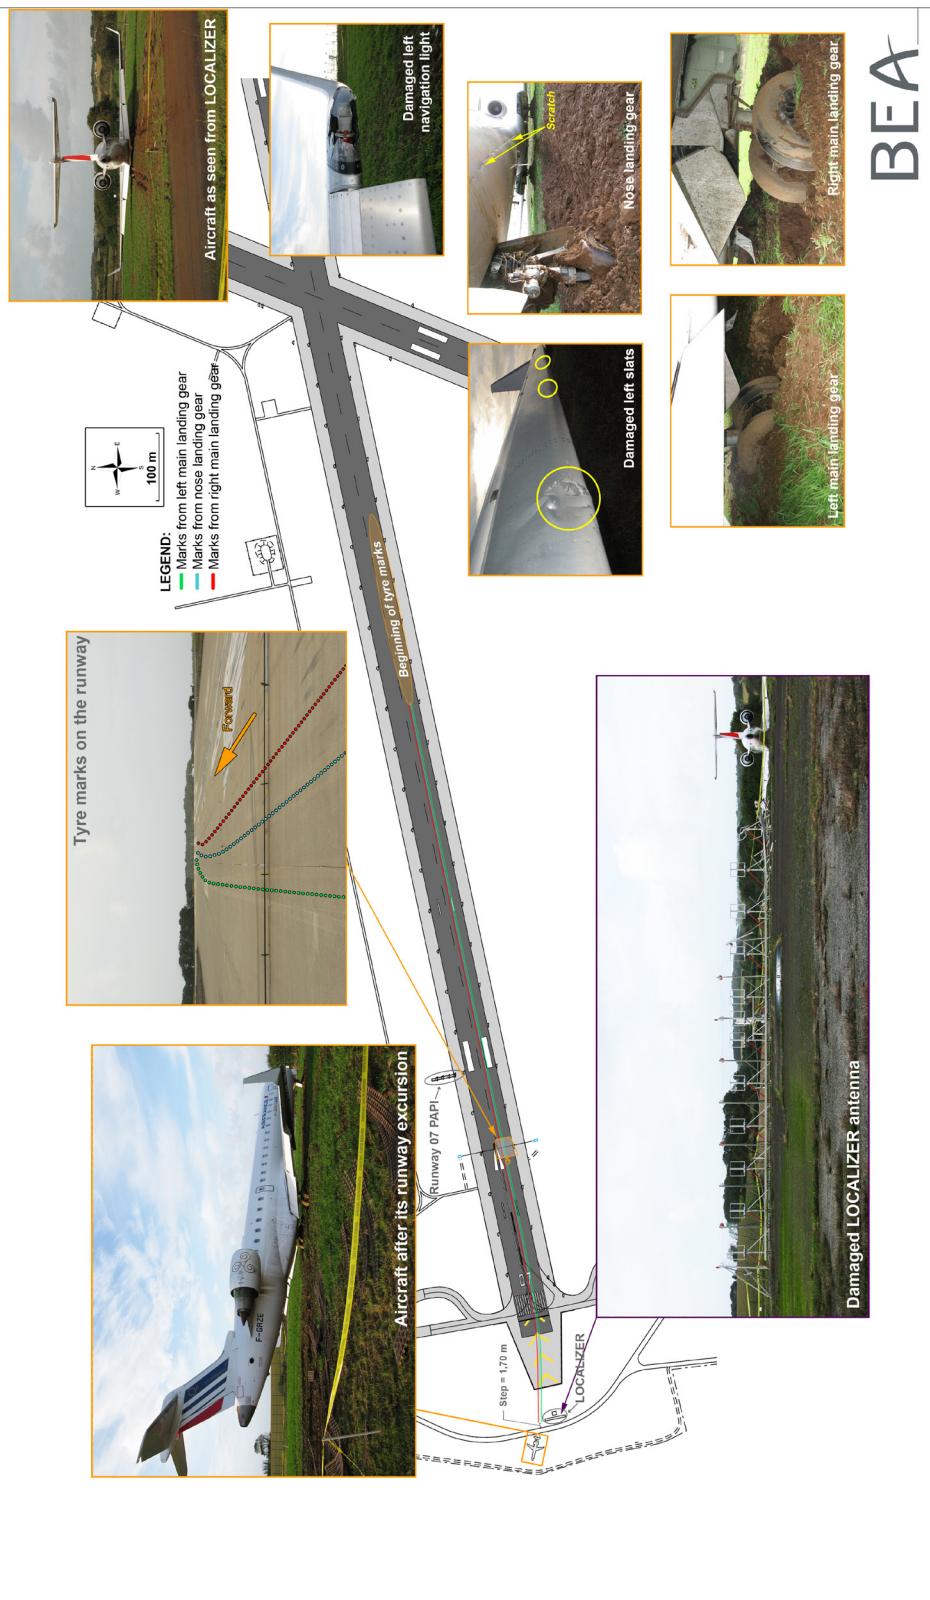
## EXTENT OF DAMAGE ON SITE

The main landing gear and the nose gear suffered significant damage requiring their replacement.

Major structural damage was found.

The LOC antennae were damaged when the aeroplane collided with them.

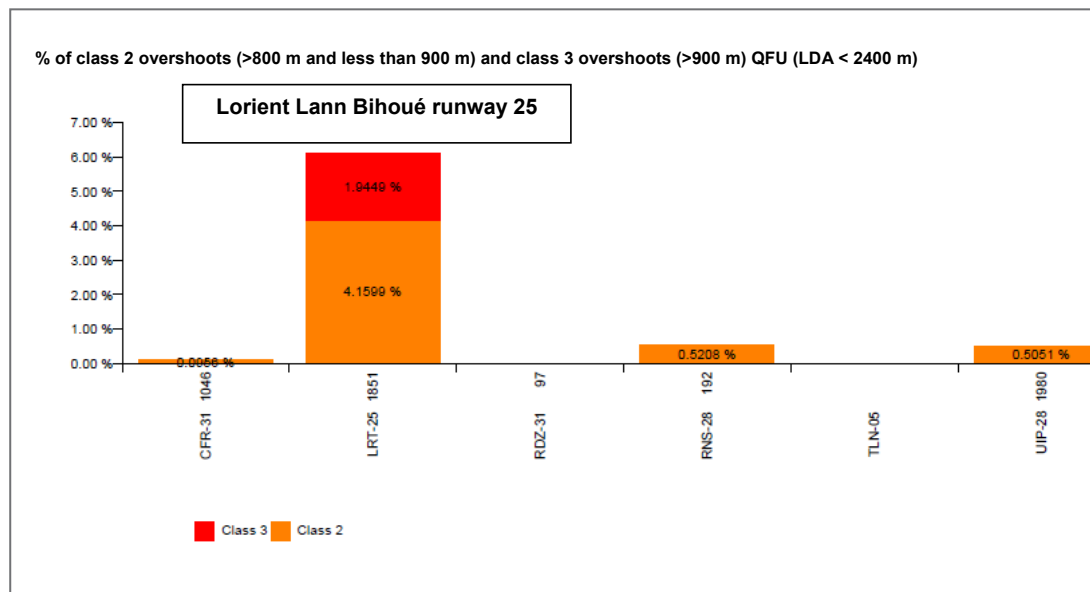
At the request of the BEA, the airline forwarded the graph for overshoots by CRJ-700 on runways where the LDA is less than 2,400 m. It shows that 551 out of 1,680 landings occurred more than 650 m from the threshold, i.e. 32.8% of the landings (see Appendix 9). In this classification, it can be seen that the largest number of overshoots occurred at Lorient Lann Bihoué.

It should also be noted that only 9.8% of the overshoots were due to unstabilised approaches (UA). The latter, therefore, do not seem to be a contributing factor.

11 of the 12 landings more than 950 m from the threshold of runway 25 at Lorient Lann Bihoué did not follow a UA.

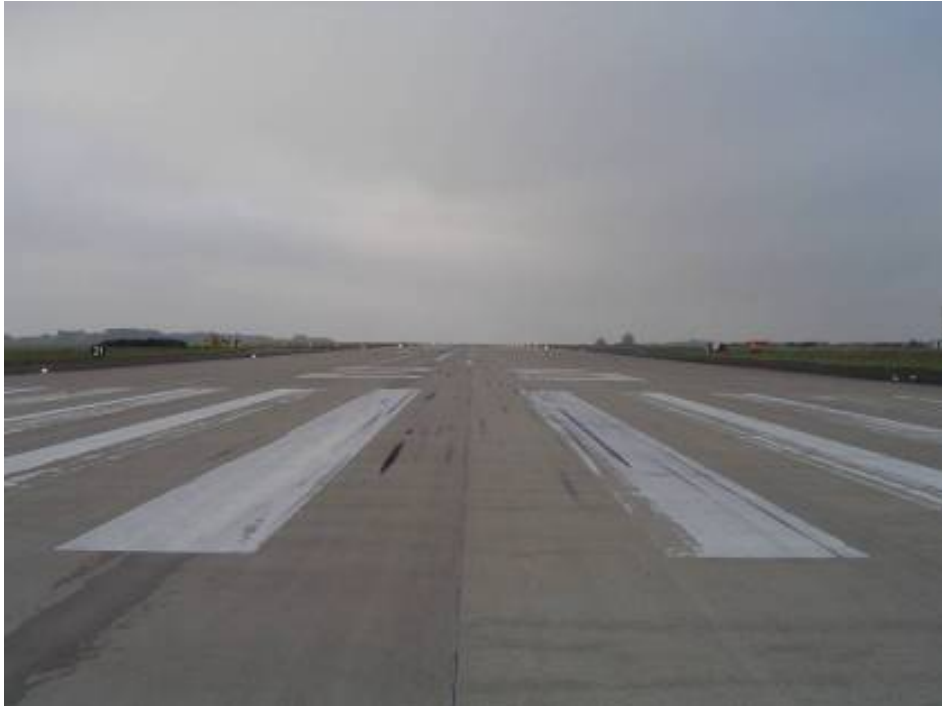
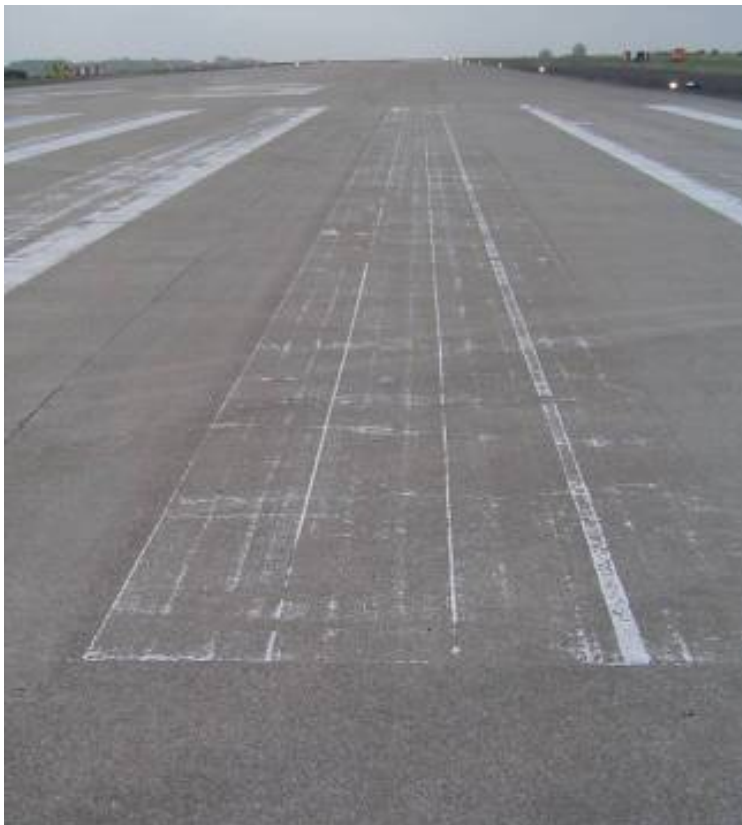
#### -Markings on the threshold of runway 25

- ❑ Deviation n°7: Presence of numerous rubber marks that mask the daytime markings and appear to alter the friction characteristics when the runway is wet.
- ❑ Deviation n°13: The daytime markings are generally in very poor condition and do not guarantee any contrast, even less so because the surface is made of concrete.
- ❑ Deviation n°14: There are no side markings on the main runway used for precision approaches.
- ❑ Deviation n°16: The markings for the touchdown zone on the main runway only measure 1.70 m wide (instead of 3 m minimum).

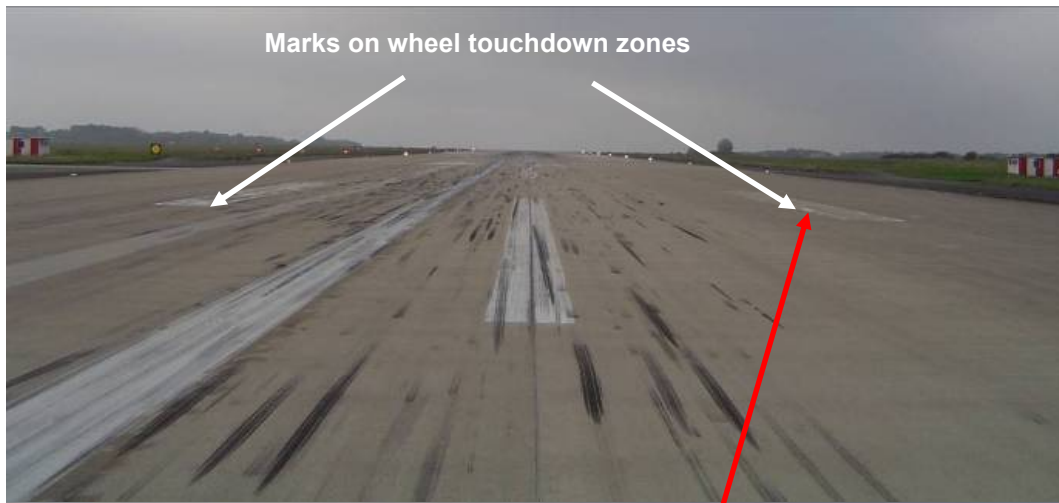
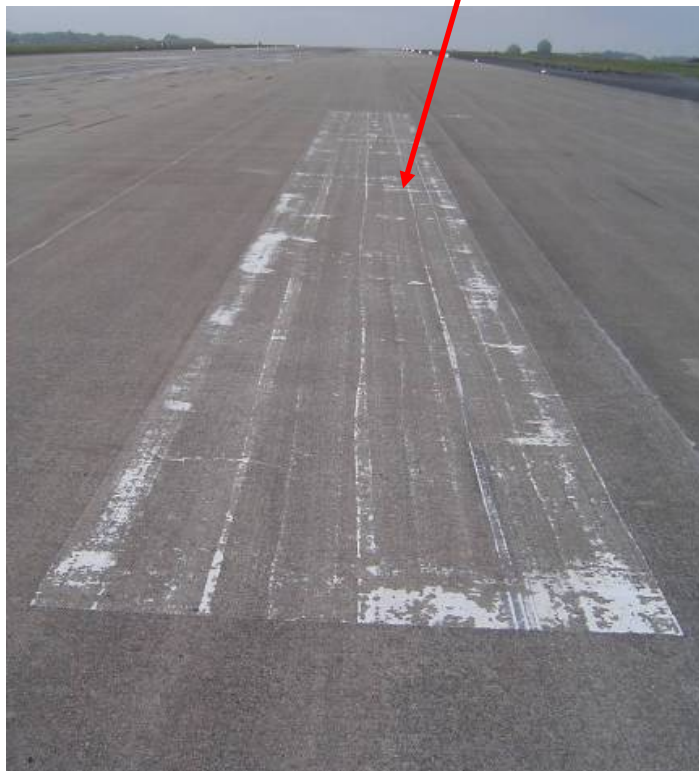
Wheel marks on touchdown zones 150 m from threshold 25

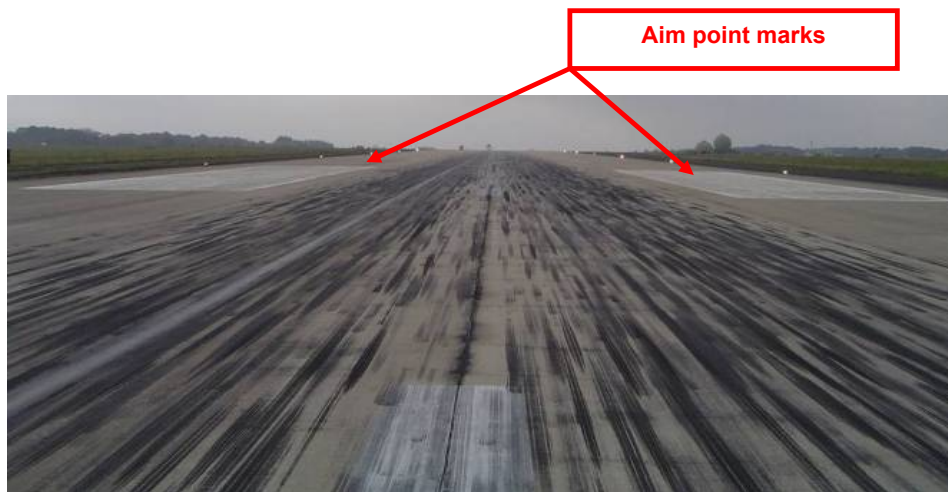
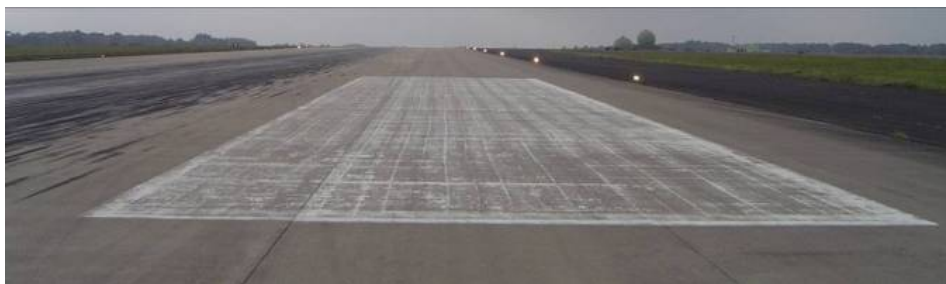
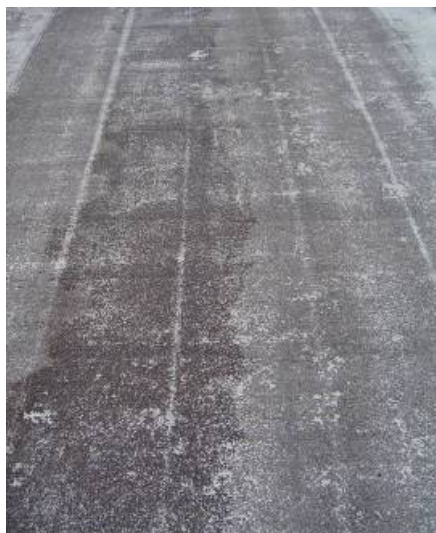
- Aim point marks and markings for the runway centreline

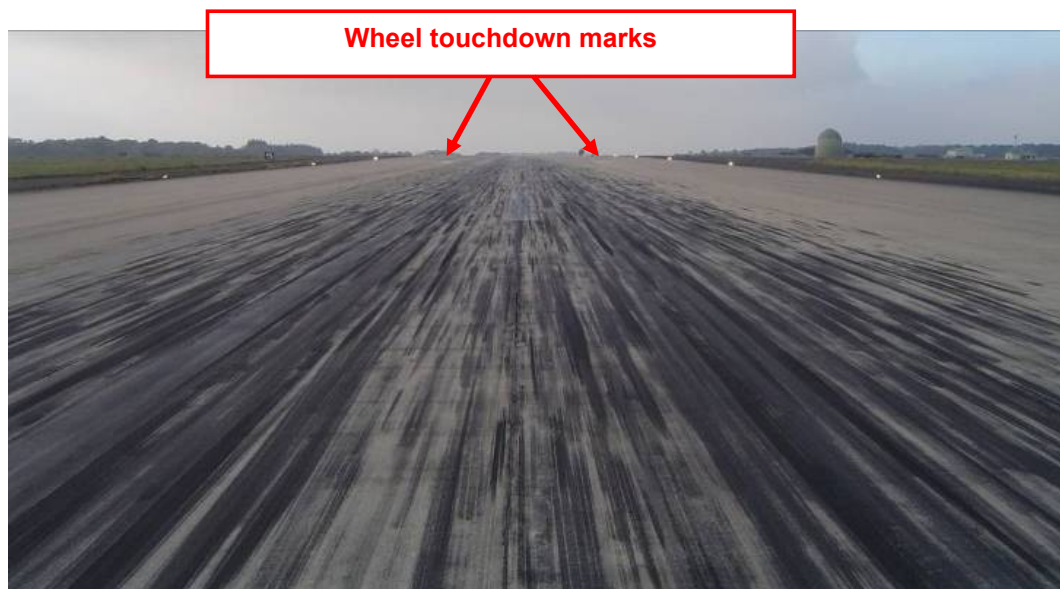
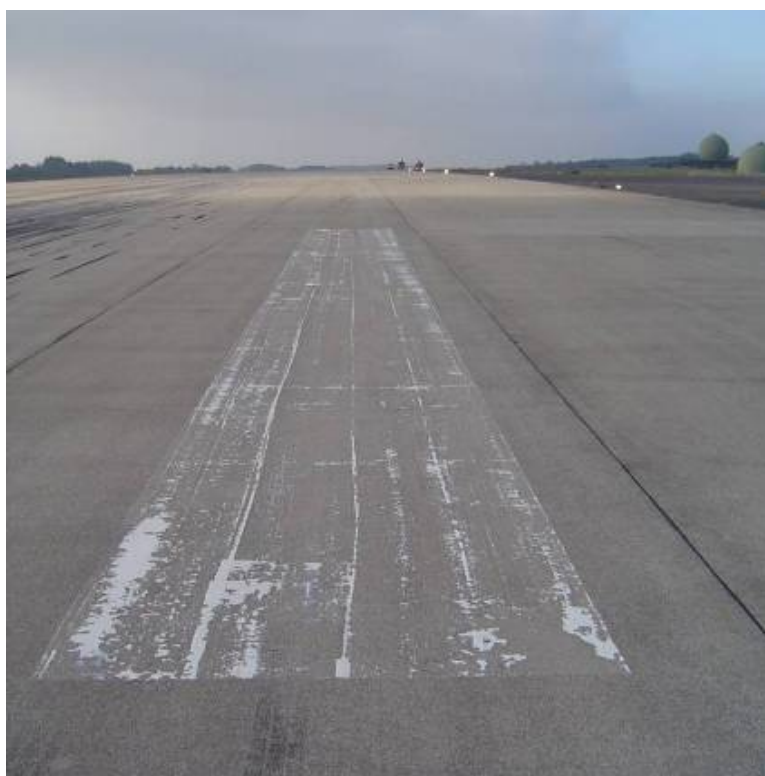
- Wheel marks on touchdown zones 600 m from threshold and runway centreline
