## Strong turbulence in cruise, momentary loss of control of the flight path by the crew

| <b>Aircraft</b> | Airbus A330-200 registered F-GZCG |
| <b>Date and time</b> | 27 February 2012 at 00 h 48 <sup>(1)</sup> |
| <b>Place</b> | In cruise at FL360 over Tanzania |

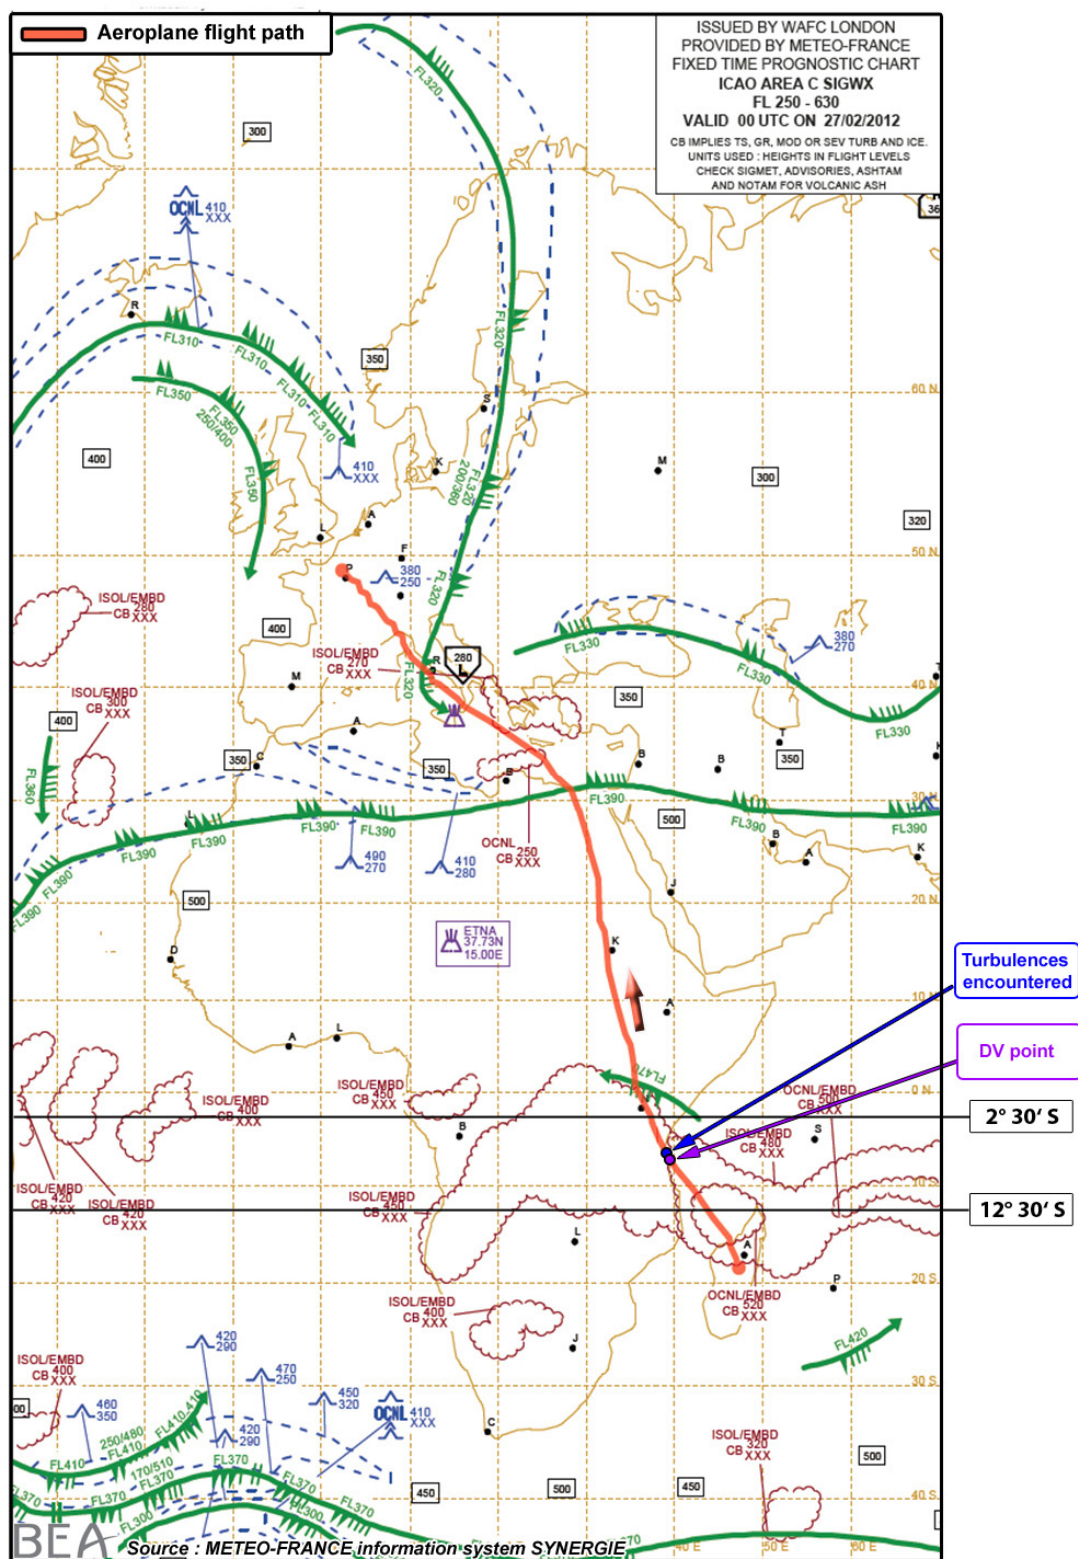
Figure 1: SIGWX chart of 00 h 00

The weather information available to the crew initially showed the presence of isolated cumulonimbus in the region where the turbulence occurred.

The 00 h 00 SIGWX chart was available in the flight dossier; the flight path specified in the flight plan was indicated on it.

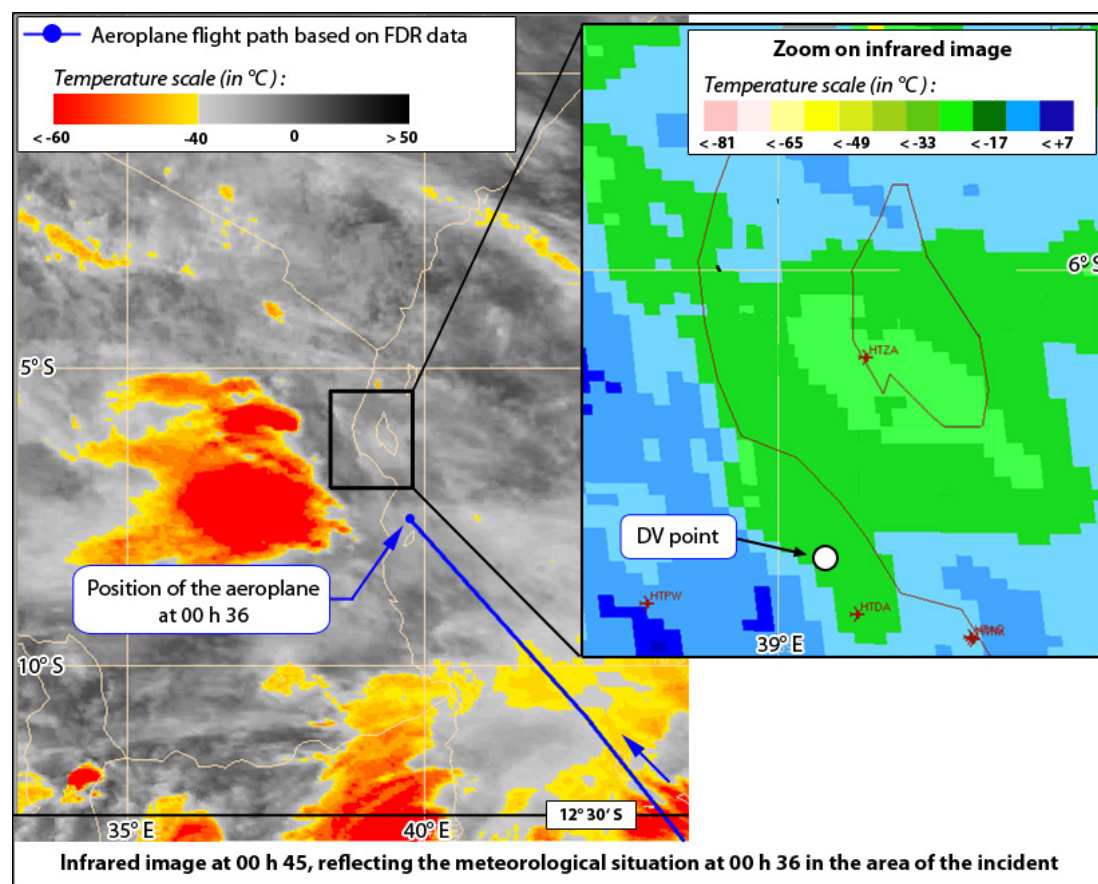
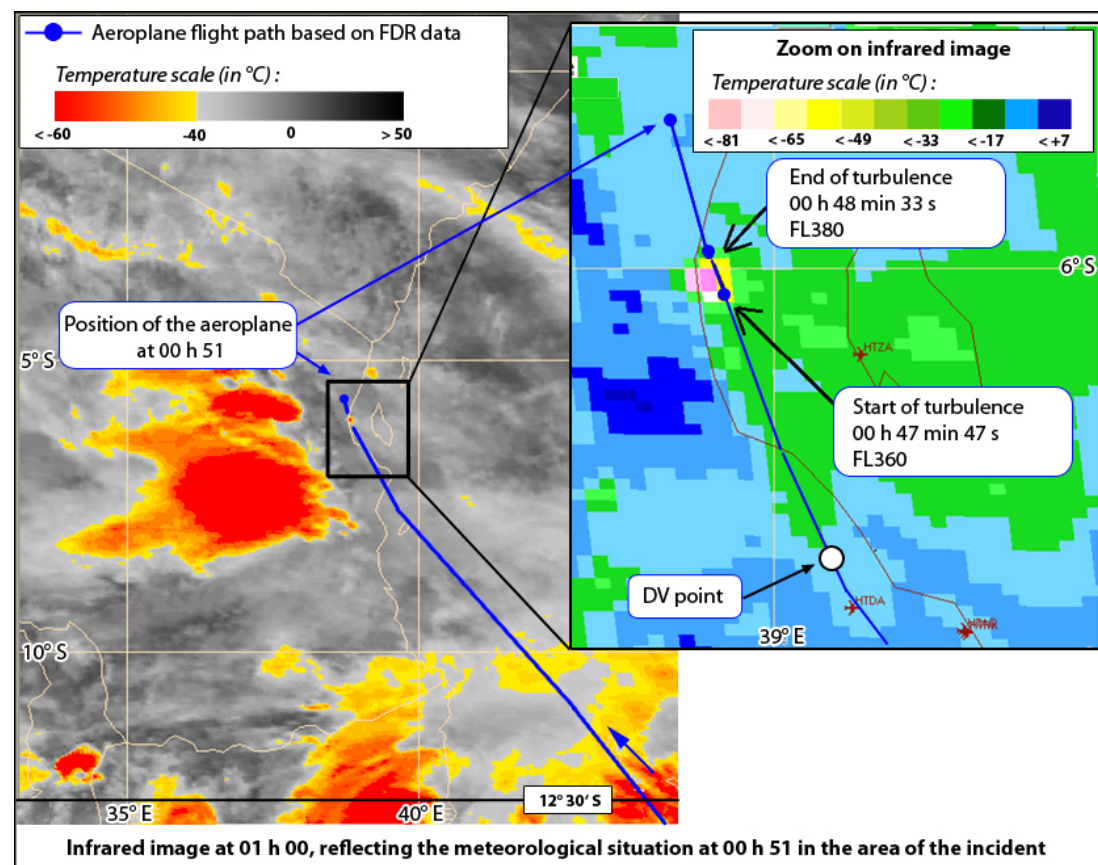
Figure 2: IR images and position of the aeroplane

On the image corresponding to the situation at 00 h 36, there is cloud cover whose top is located around FL280/300 (dark green). The cell was probably building up, but still undetectable by radar at that time. On the image corresponding to the situation at 00 h 36, cloud tops can be observed between FL360 and FL450 (pink dots). For this reason, the relatively small convective cell is not visible on the image at 00 h 45 but is easily detectable on the image at 01 h 00.

It is therefore a case of particularly rapid development of an isolated thunderstorm cell. The development of this cell into a large convective cluster within a few hours may suggest the presence of strong updraughts and severe turbulence. In addition, this rapid growth could explain the violent phenomena encountered, related to the dynamism and not to the size of the cell.

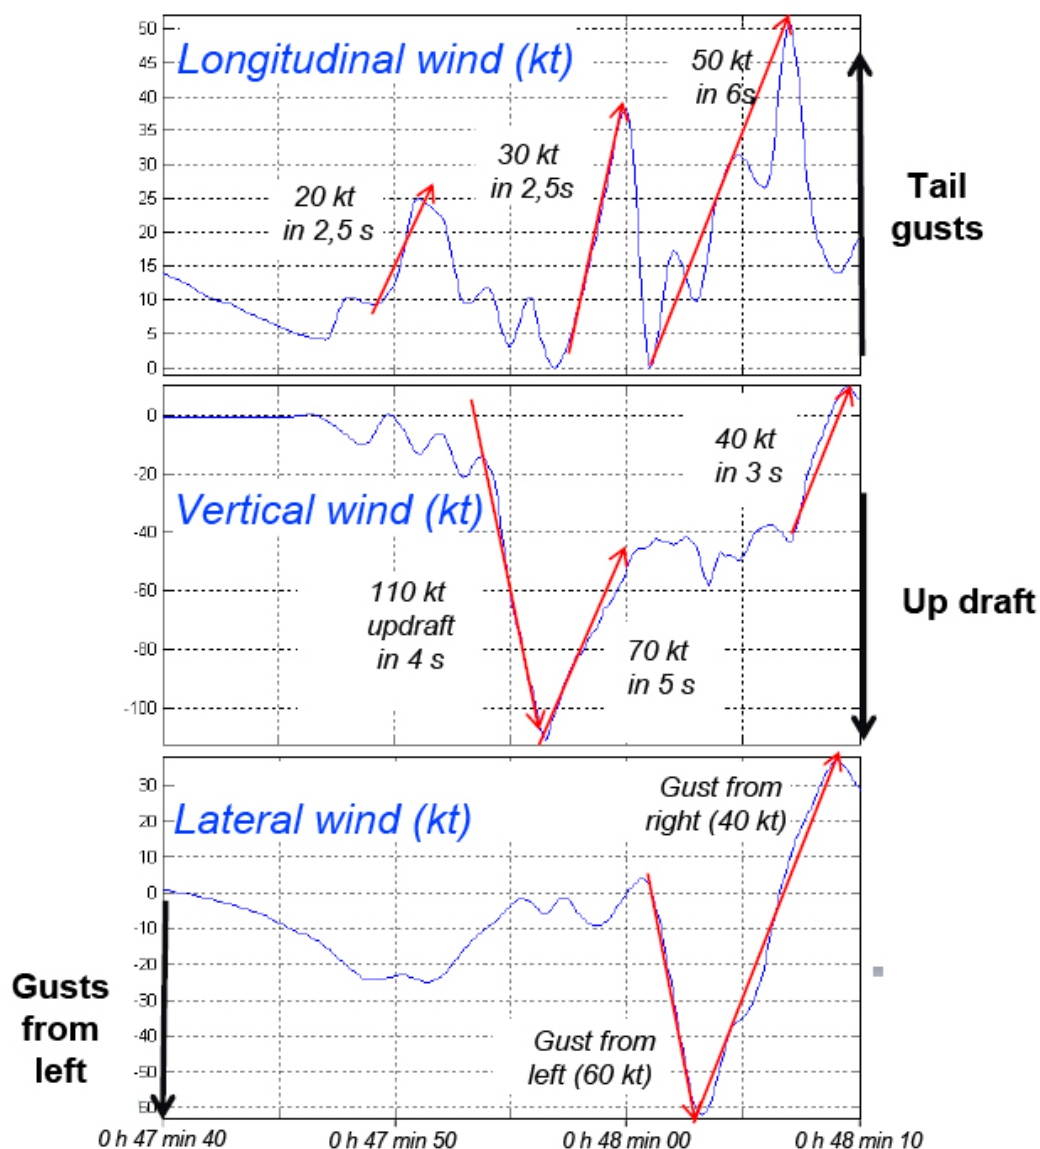
The wind components were reconstituted by the manufacturer.

The aeroplane encountered highly dynamic, intense, turbulent phenomena on all three axes.
