DATA SUMMARY

Date and time	Friday, 21 September 2012; 19:16 UTC¹	
Site	On approach to runway 06 at the Ibiza Airport (LEIB) (Spain)

Registration	EC-JIL	CS-DNP
Type and model	BOMBARDIER Inc. BD-700-1A10	DASSAULT FALCON 2000
Operator	Punto-FA, S.L.	Netjets Europe

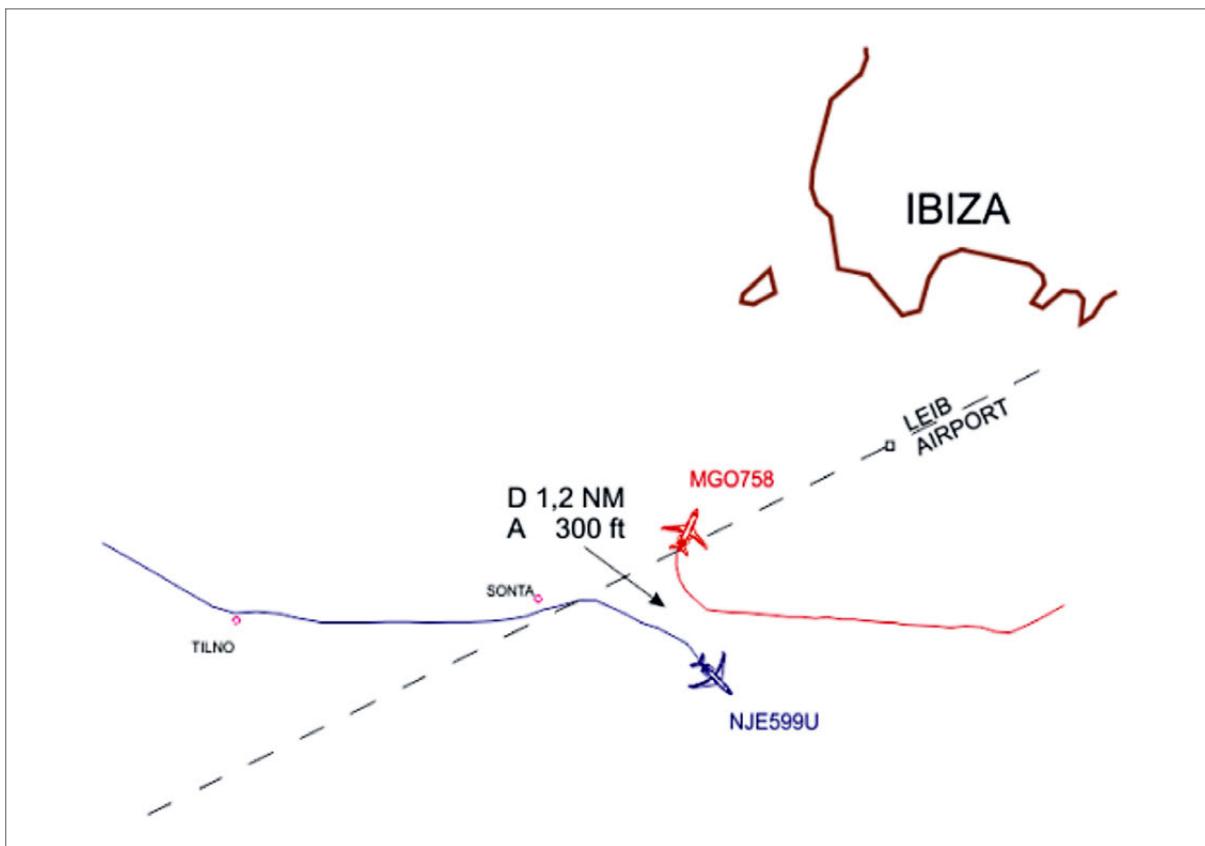
Figure 1. Aircraft flight paths

At 19:16:38, both aircraft notified ATC⁷ that they had received a TCAS RA⁸. Aircraft CS-DNP was established at 3,000 ft and had passed the runway 06 localizer, on a heading opposite that being flown by EC-JIL, which was descending to 2,500 ft as authorized. The two aircraft flew within 1.2 NM horizontally and 300 ft vertically of each other.

The incident, then, can be deemed to have been caused when the flight paths of EC-JIL and CS-DNP converged as Ibiza APP was vectoring them for the approach to runway 06 at LEIB, resulting in a violation of the prescribed minimum radar separation distances.

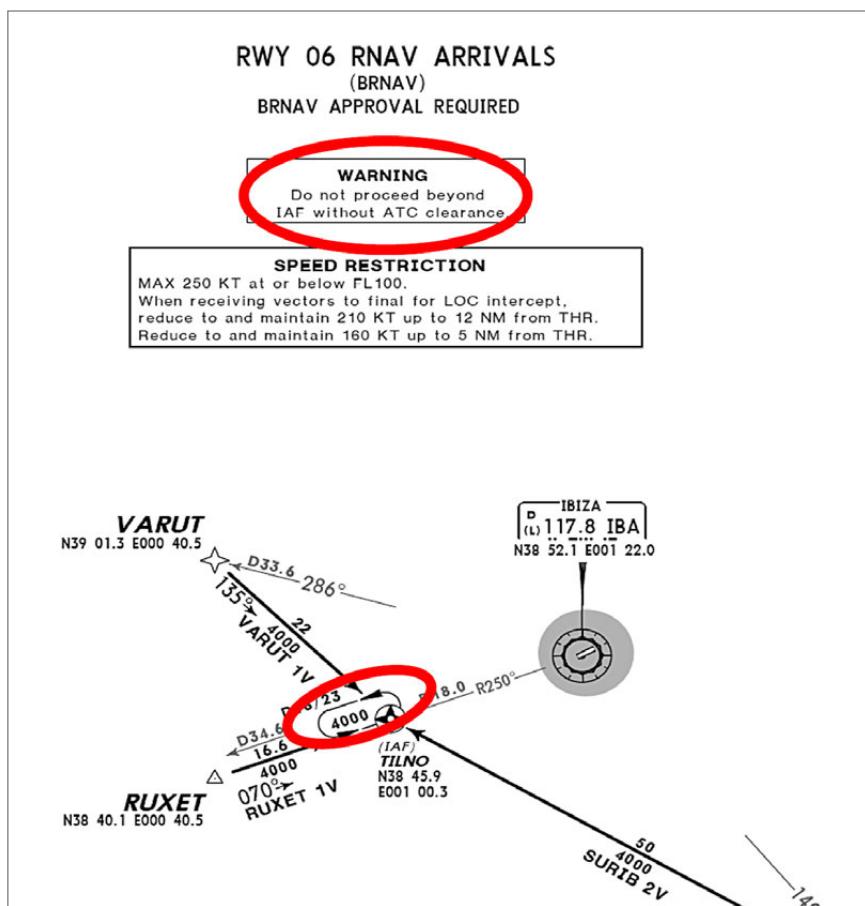
Figure 2. Portion of Jeppesen chart 10-2G

As indicated on the flight plan for aircraft CS-DNP, the standard arrival (STAR) planned for the day of the incident was STAR VARUT1V, published in the AIP Spain in chart AD2-LEIB STAR 1.2. Onboard the aircraft was the Jeppesen 10-02G chart for Ibiza, corresponding to the instrumental standard terminal arrival route for runway 06 at the Ibiza Airport. This chart warns not to proceed beyond the IAF without ATC clearance. It also lists the minimum hold altitude over IAF TILNO as 4,000 ft.

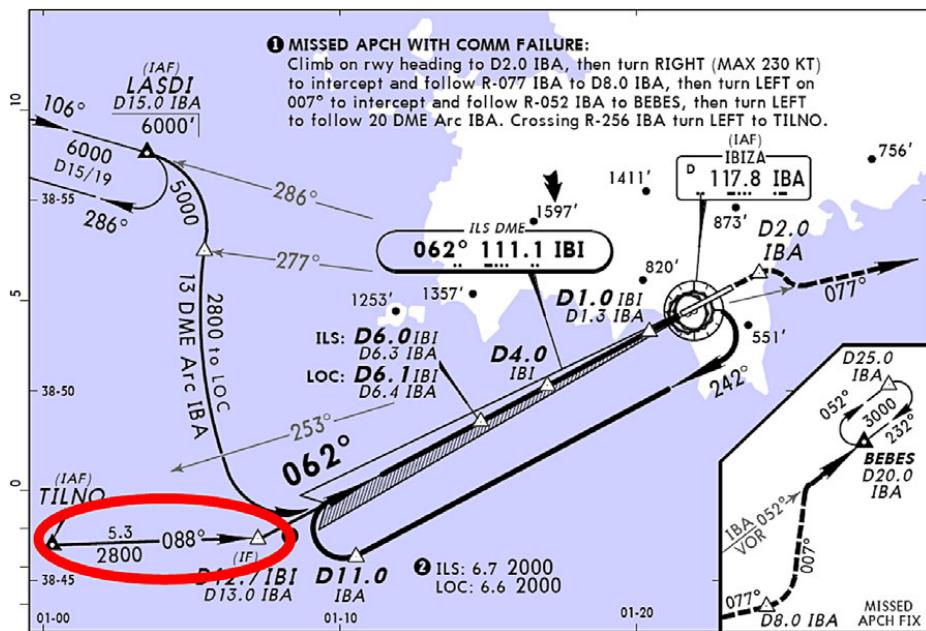
Figure 3. Portion of Jeppesen chart 11-1

The ILS instrument approach procedure for runway 06 at LEIB is published in chart AD 2-LEIB IAC/1 of the AIP Spain. Aircraft CS-DNP had onboard Jeppesen chart 11-1, corresponding to the IAC for runway 06 at Ibiza. Both charts establish the heading to fly after leaving the IAF TILNO as 088° until the intermediate fix (IF) is reached.

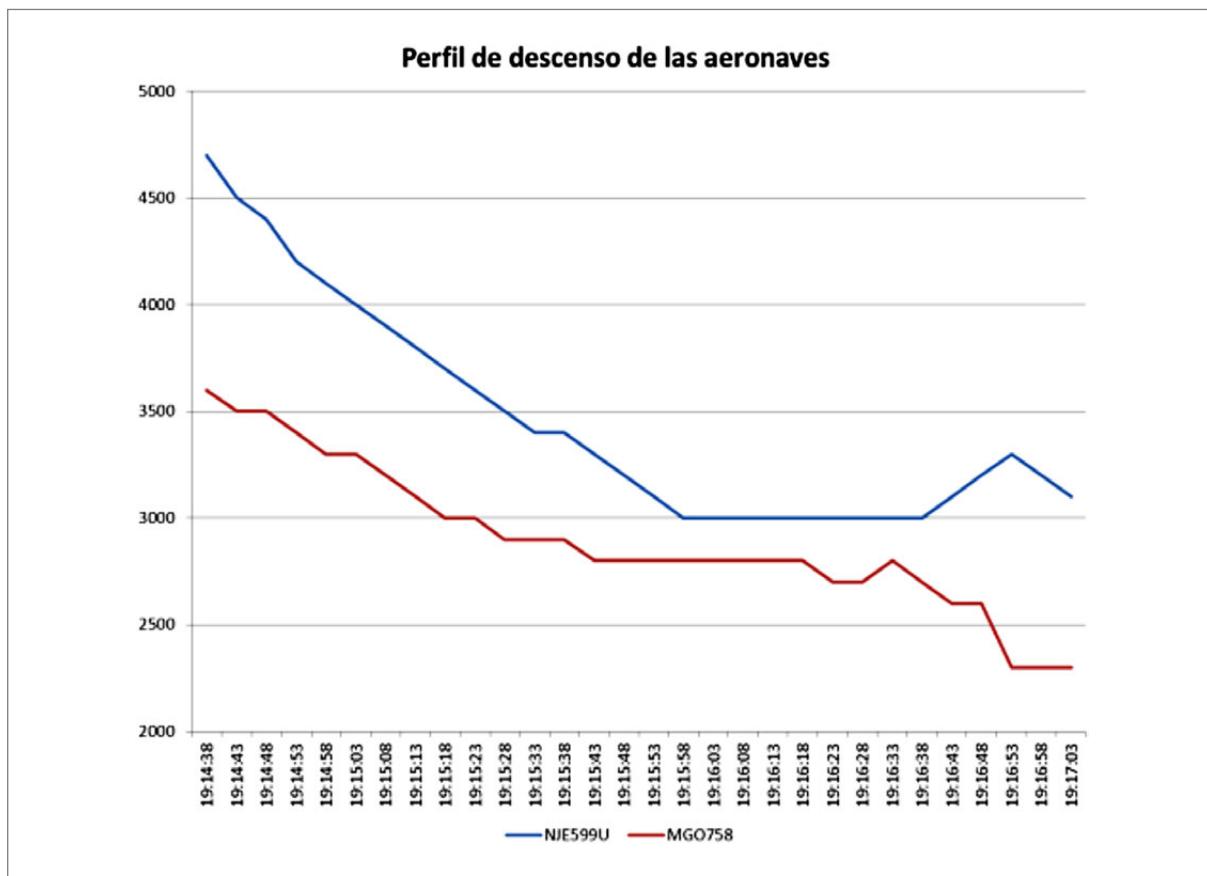
Figure 4. Descent profiles of aircraft NJE599U and MGO758

The closest point of approach was at 19:16:38, with the two aircraft closing to within 1.2 NM horizontally and 300 ft vertically of each other. Aircraft CS-DNP was at an altitude of 3,000 ft on an easterly heading while turning to HDG 160° as instructed, and aircraft EC-JIL was descending through 2,700 ft heading west.

Five seconds later, aircraft EC-JIL was turning right and descending through 2,600 ft, while aircraft CS-DNP was climbing through 3,100 ft.
