Final Report

Concerning
Airbus A321 aircraft tail strike

At Hurghada Airport

On 28th February 2013

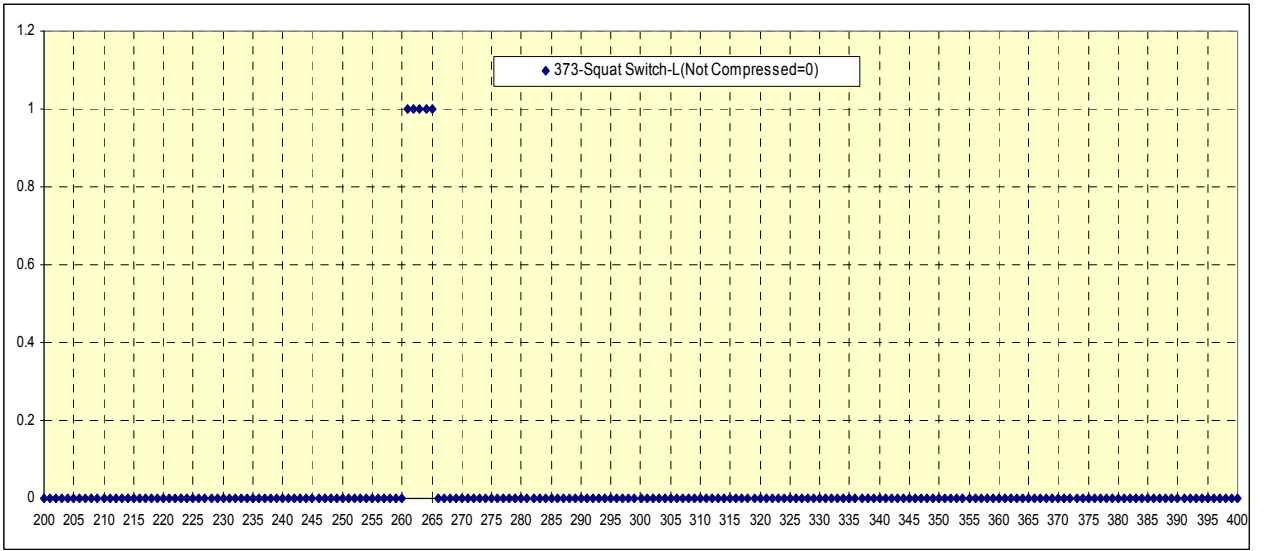
- Left L/G leg squat switch showed compressed condition (Ground) at 261 seconds ((83771 FDR frame number) and stayed on the ground for 5 seconds (from time 261 to time 265)
- Nose L/G leg squat switch did not show any compressed condition during the event, meaning that the nose L/G almost did not touch the ground.
- Right L/G leg squat switch showed compressed condition (Ground) at 258 seconds ((83768 FDR frame number), the L/G showed air again at 259 for one second, then showed ground again at 260 seconds and stayed on the ground for 6 seconds (from time 260 to time 265)

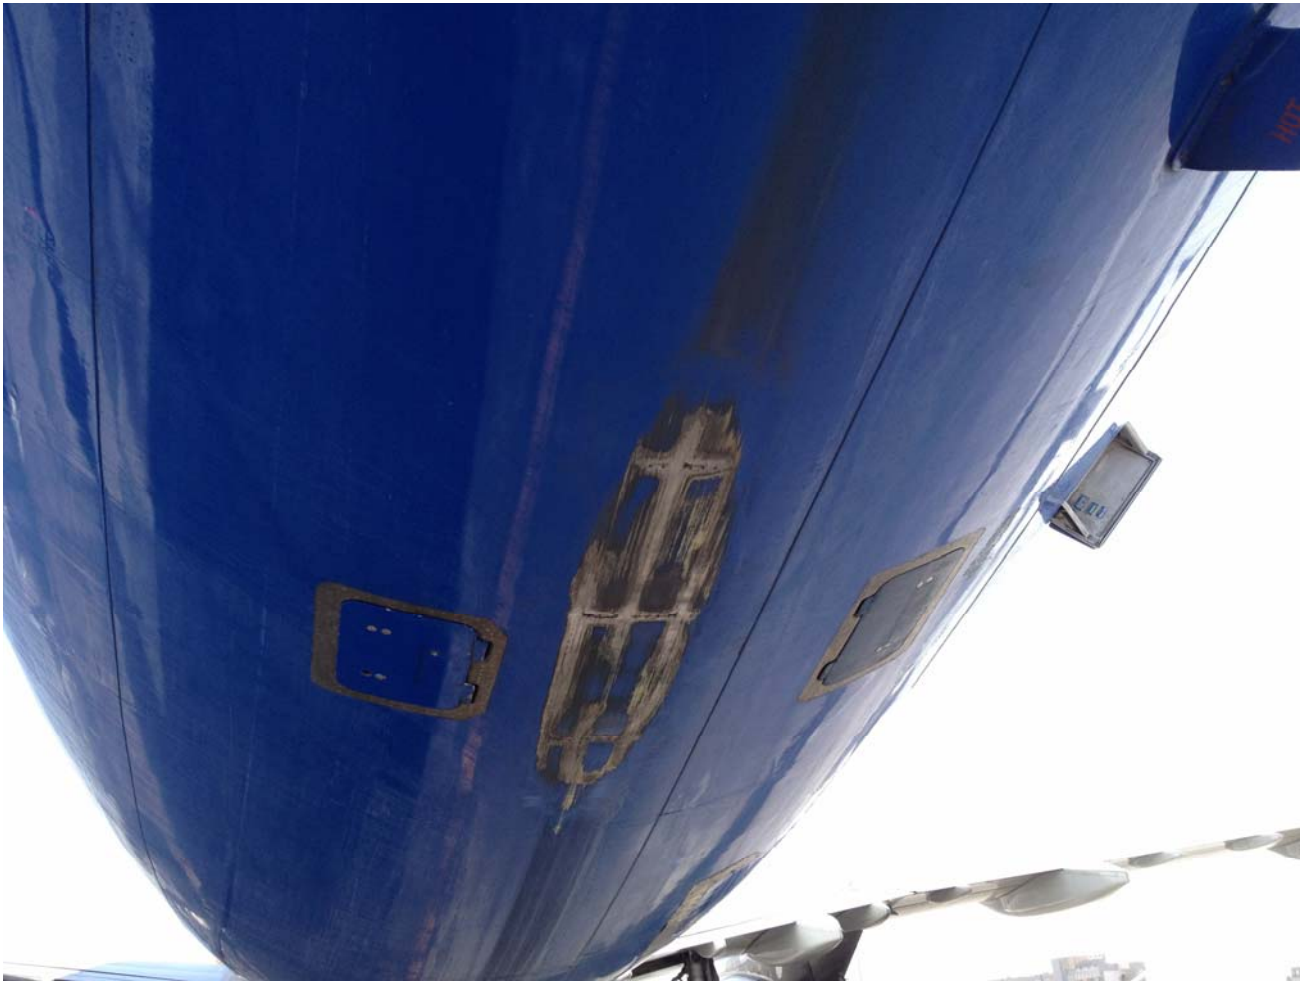
Photo #1

Examination of the aircraft revealed that the lower aft side of the fuselage just right side of the A/C centerline suffered a structural damage as a result of the tail strike and the impact with the ground. (Refer to photos showing A/C damage)
