**THE DANISH
ACCIDENT INVESTIGATION BOARD**
The Aviation Unit

FINAL REPORT

HCLJ510-2012-155

Accident to Learjet 24D
Registration D-CMMM
Bornholm/Roenne Airport, (EKRN), Denmark
15 September 2012

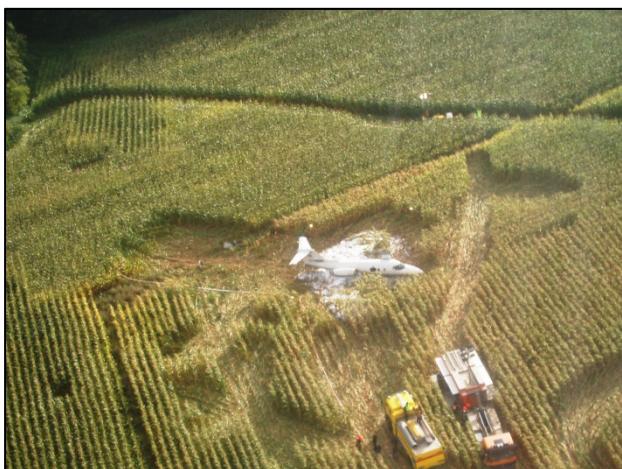
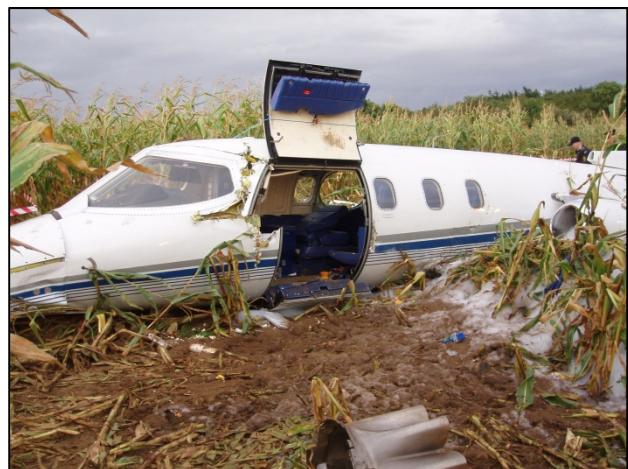
The aircraft impacted terrain (a field of sweet corn) at 55 03 19.21 N 14 47 15.63 E (1040 meters east of the threshold to runway 29) in a wings-level attitude. The height of the sweet corn crop was approximately 3 meters.

The wreckage trail track had a direction of approximately 300 degrees magnetic. The wreckage and the wreckage trail pattern observed were consistent with a low forward airspeed and a steep descent (stall). The wreckage trail was approximately 19 meters long by 16 meters wide.

At impact, the main landing gear struts went through the upper wing skin. Both the main and the nose landing gear separated from the aircraft. The fuselage and the wings were severely damaged. Both engine mounts were bent and broken.

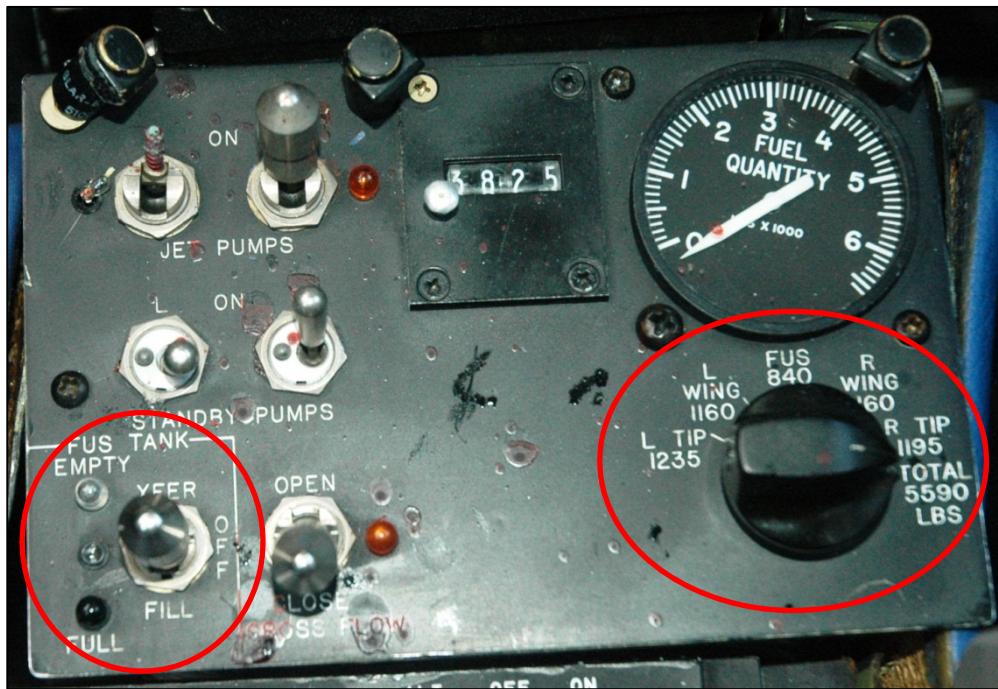
2. Fuselage tank switch and fuel quantity selector switch

After recovering the aircraft to hangar facilities, a quantity of 160 liters of fuel was drained from the fuselage tank. The fuel transfer valve and the fuel cross flow valve were found in closed position, which was consistent with the position of the fuselage tank transfer toggle switch (off). If selected to transfer both the fuel cross flow valve and the fuel transfer valve open and allow fuel from the fuselage tank to the wing tanks.

At a critical moment, it is possible that the fuel quantity selector switch in the total position might mentally have blocked the pilot's perception of the onboard fuel distribution leading to inappropriate fuel management and decision-making.

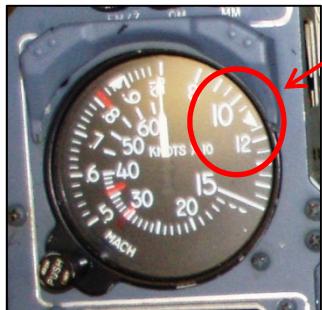
3. Airspeed indicator at the left instrument panel

The speed bug setting was 110 knots, which was equivalent to the speed bug setting at the right instrument panel.

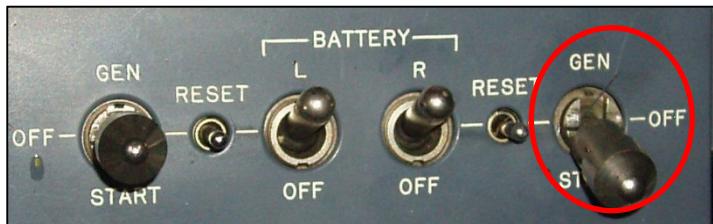
4. Starter/generator switches (toggle switches)

The right starter/generator switch was found in start position.

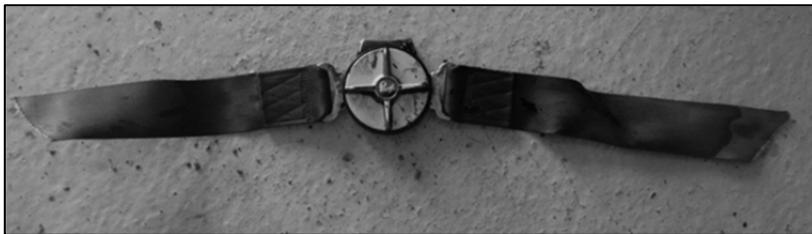
The pilot's hip belt (see below) was cut by the firefighting services personnel. The two shoulder harness straps were not attached to the hip belt locking mechanism.

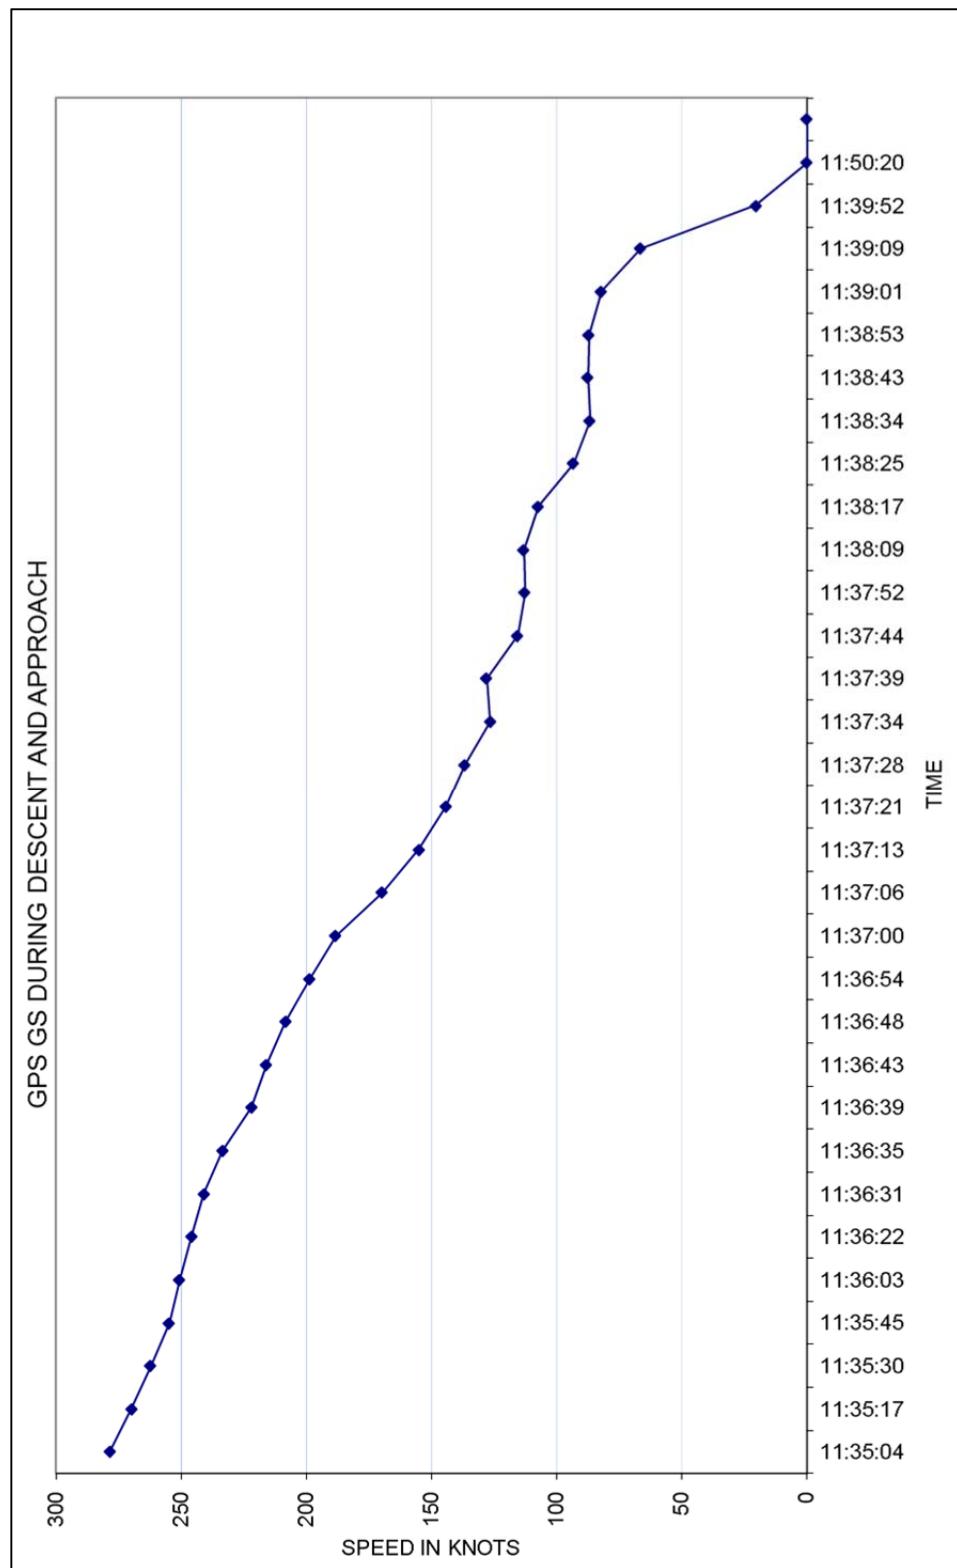
Appendix 3 - GPS groundspeed (GS) readout

While descending inbound EKRN, the airspeed was decreasing. See appendix 3 and appendix 4.

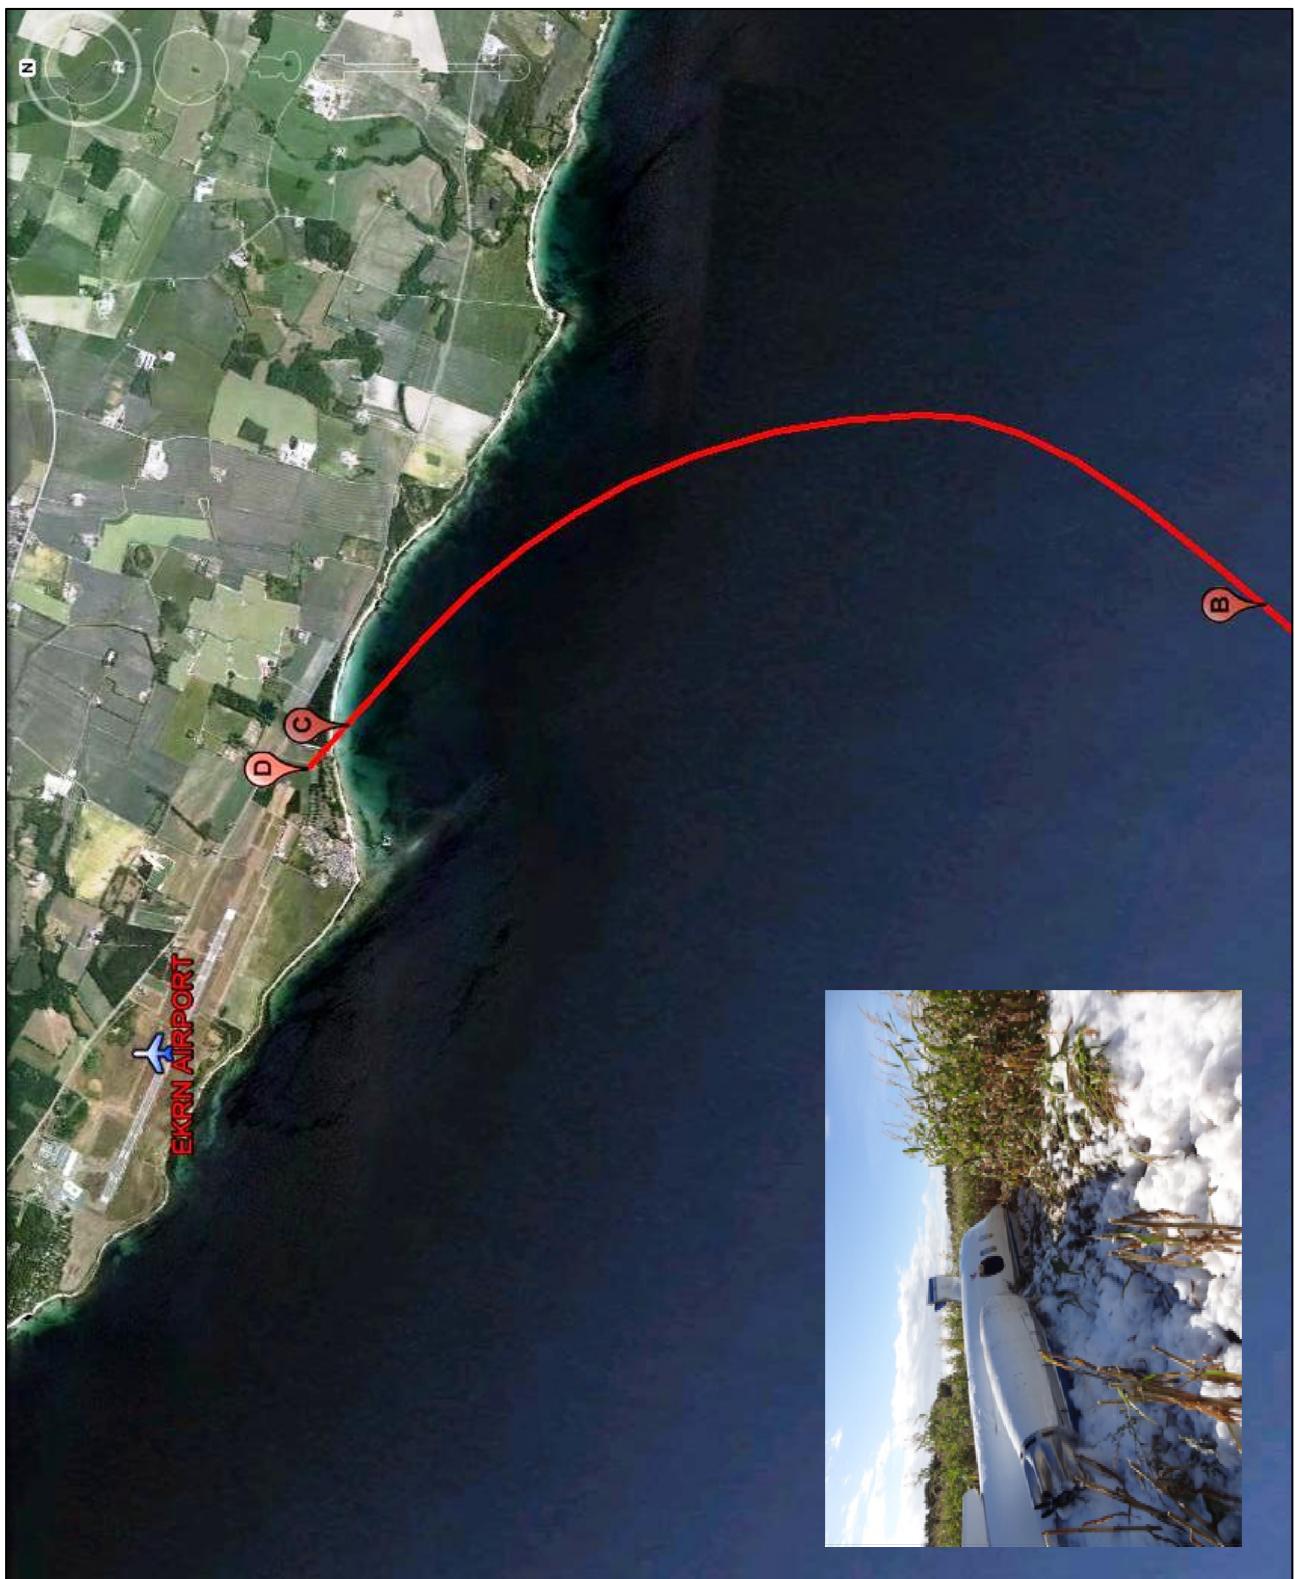
Appendix 5 - GPS readout (approach)

At 11:37:08 hrs, the pilot reported to Roenne Tower that the aircraft was turning final for runway 29. The aircraft was cleared to land. The wind conditions were reported to be 280° 19 knots maximum 29 knots. See appendix 5 - marking B.

At 11:39:18 hrs, the pilot three times declared an emergency. See appendix 5 - marking C.

The aircraft entered a stall and impacted terrain in a field of sweet corn. See appendix 5 - marking D.

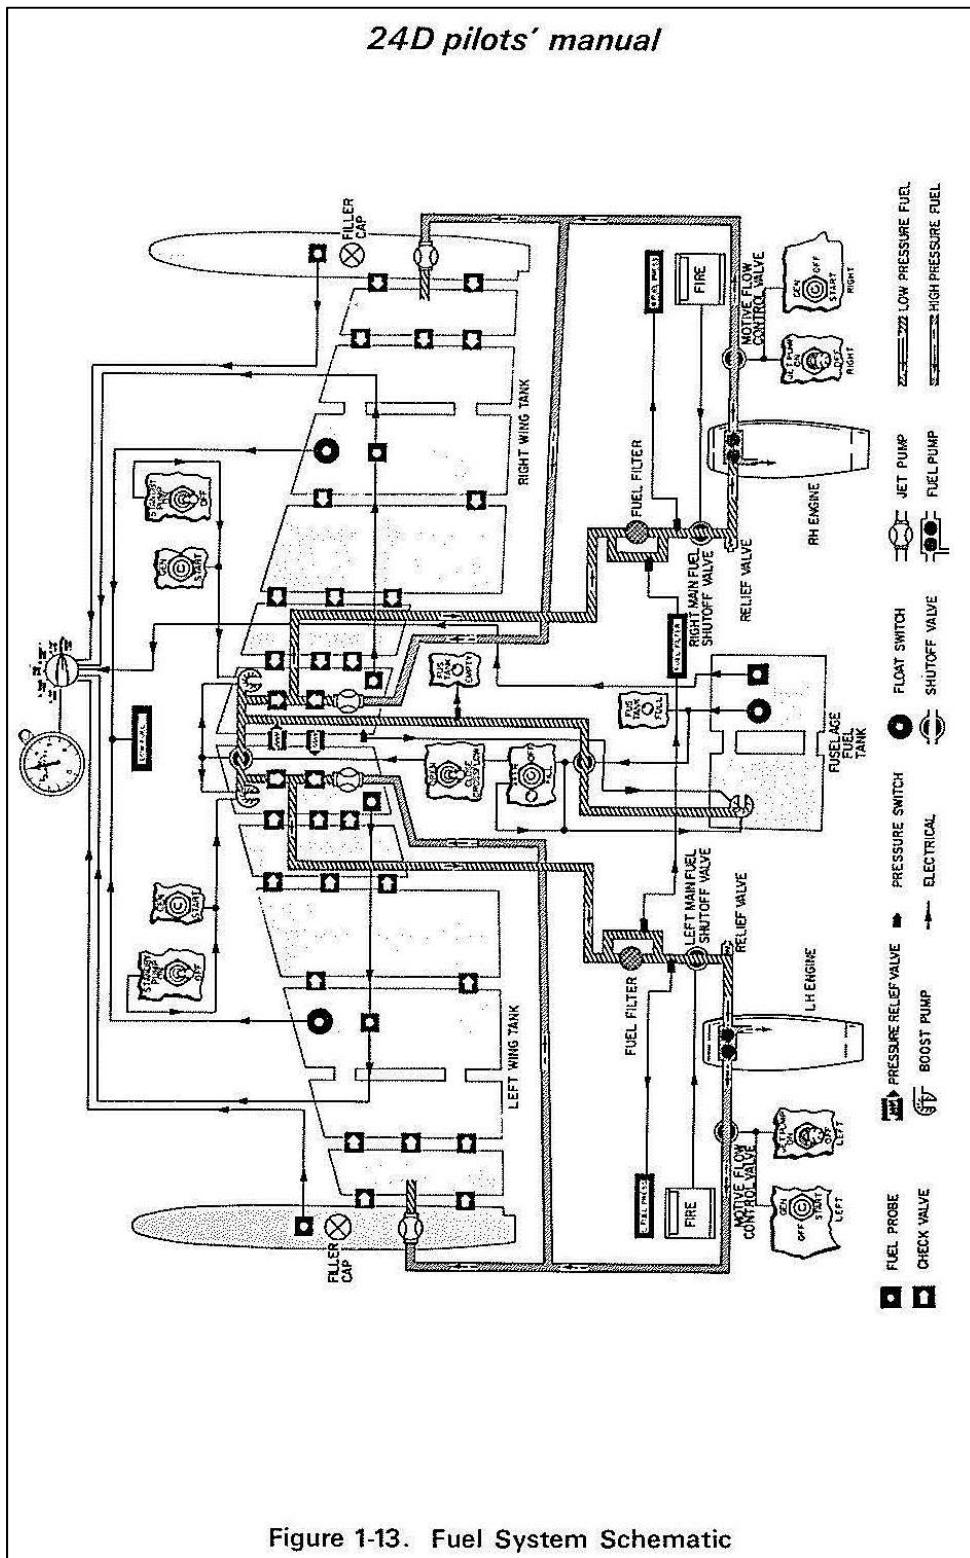
Appendix 6 - Fuel system

The engines were supplied with fuel from the wing tanks only. In order to use the fuel from the fuselage tank, the fuel had to be transferred into the wing tanks.

However, the AIB DK concludes that usable fuel in the fuselage tank was not transferred into the wing tanks. On approach to EKRN, empty wing tanks led to fuel starvation of both engines.

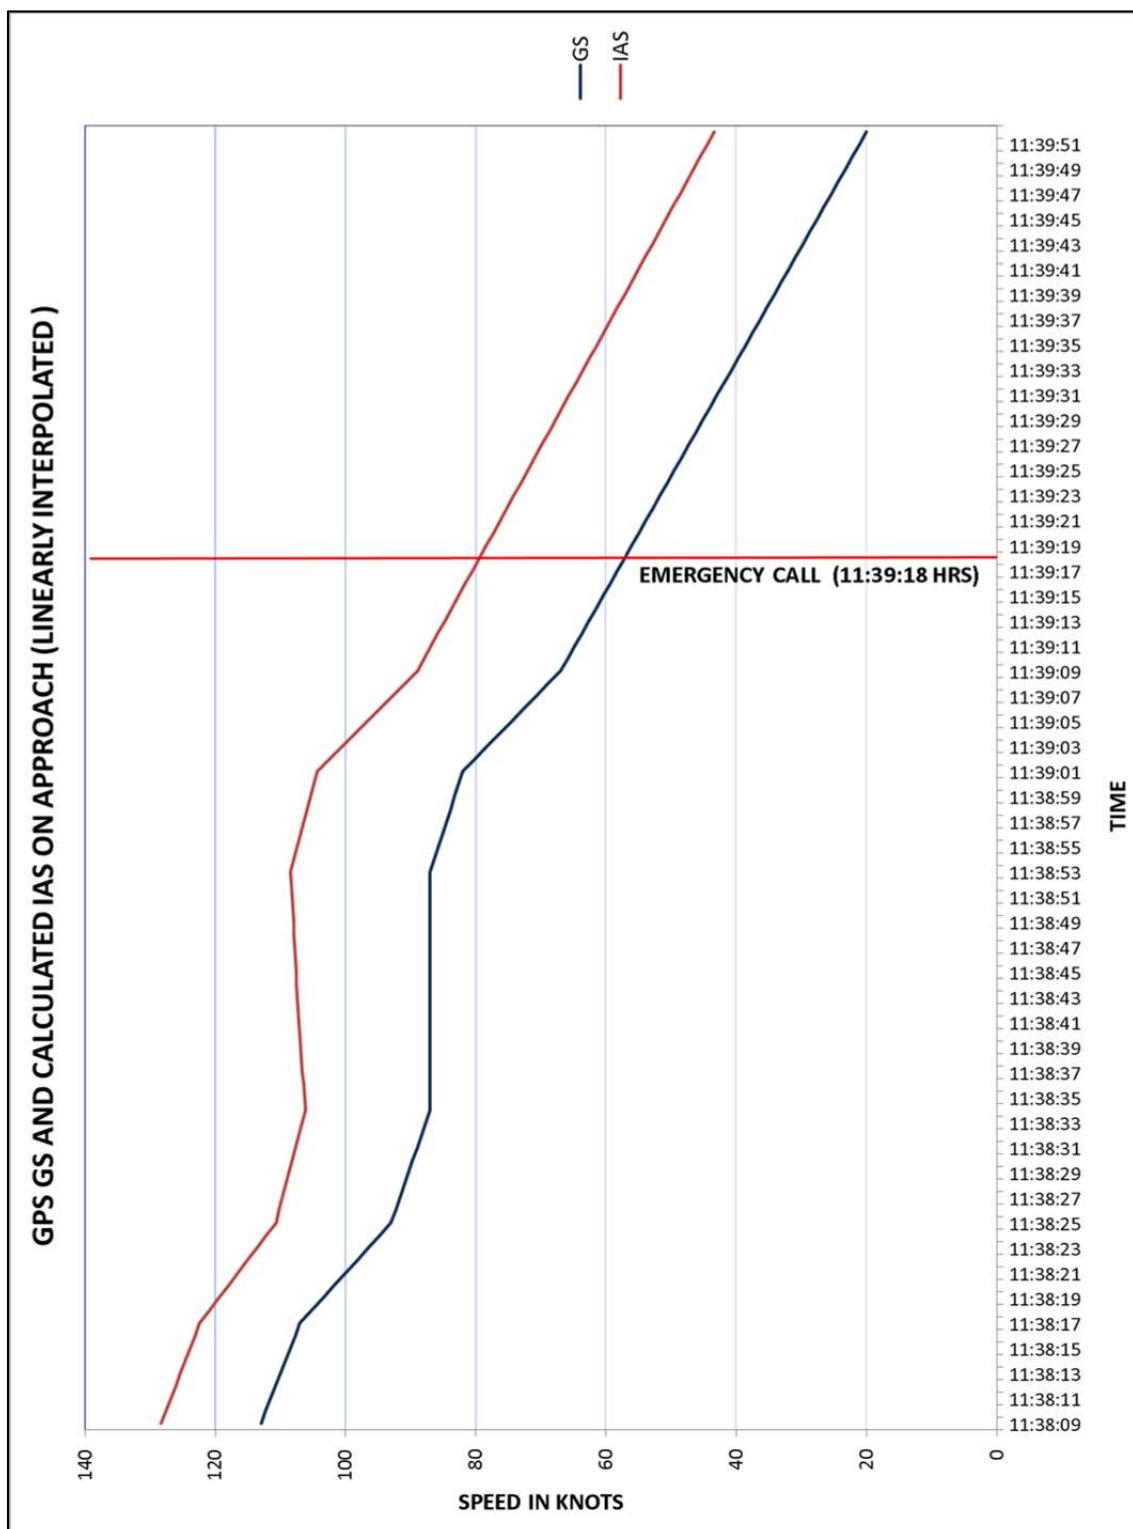
Appendix 7 - GPS GS and calculated IAS on approach (linearly interpolated)

When established on bug speed (approximately 110 knots IAS), the pilot most likely added power to remain stabilized and both engines suffered from fuel starvation. Pilot handling of the dual engine flame out (possible attempt to restart the right hand engine) caused a gradual speed drop.

The gradual speed drop led to activation of the stall warning system - column shaker (approximately 80 knots IAS equal to 75 knots IAS (stall speed) + 7%)). A further speed drop highly probable caused a commanded nose down attitude to the pitch servo – column pusher (76 knots IAS). The activation of the stall warning system and the pilot emergency call seemed to occur almost simultaneously (rf. appendix 7).
