Report

**Accident on 25 April 2010
at Nadi (Fiji)
to the Beechcraft B200
registered F-OIAN
operated by Air Alizé**

Electrical failure during approach, landing with gear retracted, lateral runway excursion

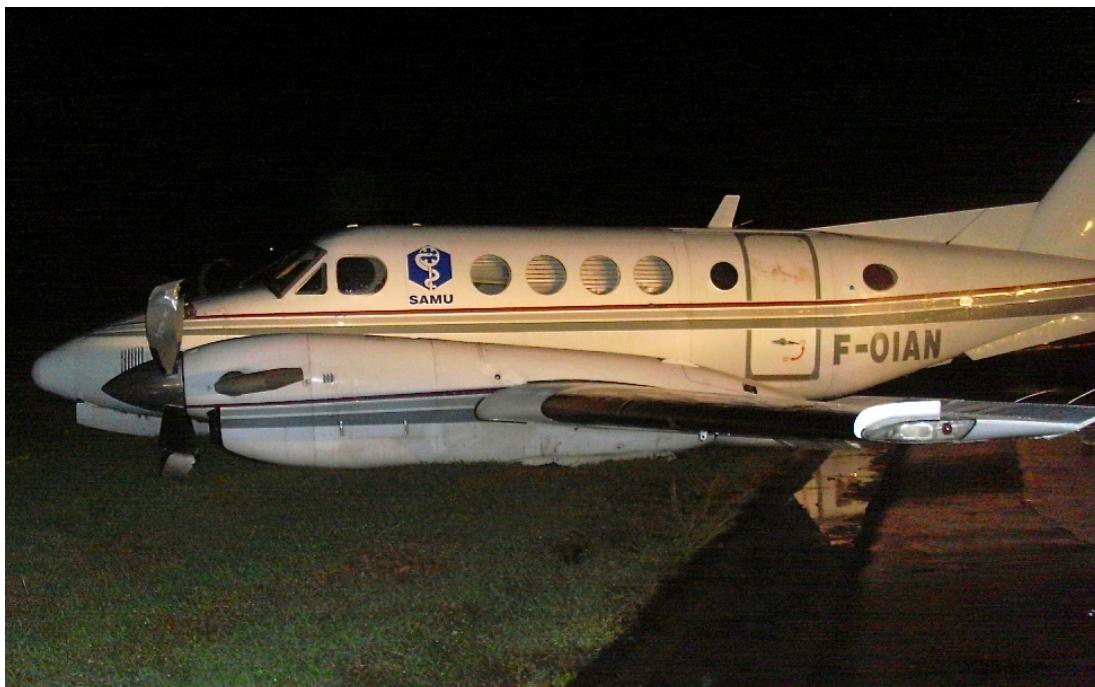
The PNF stated that during the landing, the aeroplane landed normally, then the landing gear collapsed and the propellers hit the surface of the runway. The aeroplane exited the runway to the right and came to a stop leaning on the fuselage. The landing gear was found to be retracted, although the landing gear doors were open.

The propeller blades left marks on the surface of the runway and a runway perimeter light (the 25th on the right, starting from the approach end of runway 2) was destroyed.

Position of the aeroplane in relation to the runway

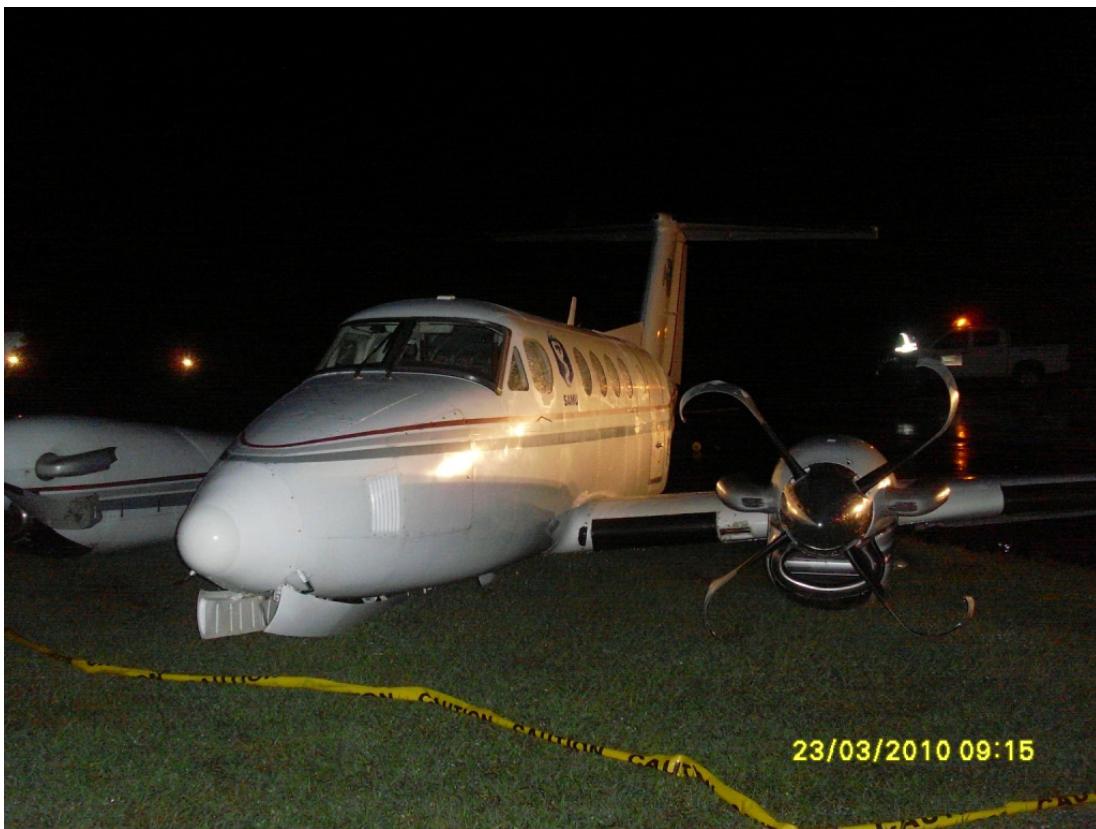
The nose gear doors were in an almost completely open position. The main gear's doors had been scraped as a result of the sustained contact with the runway during the landing, and their position was close to completely open. The landing gear control handle in the cockpit was in the "down" position.

The propeller blades were bent backwards and twisted. The flaps were fully extended.

Nose gear doors and propeller
