# ACCIDENT

## Synopsis

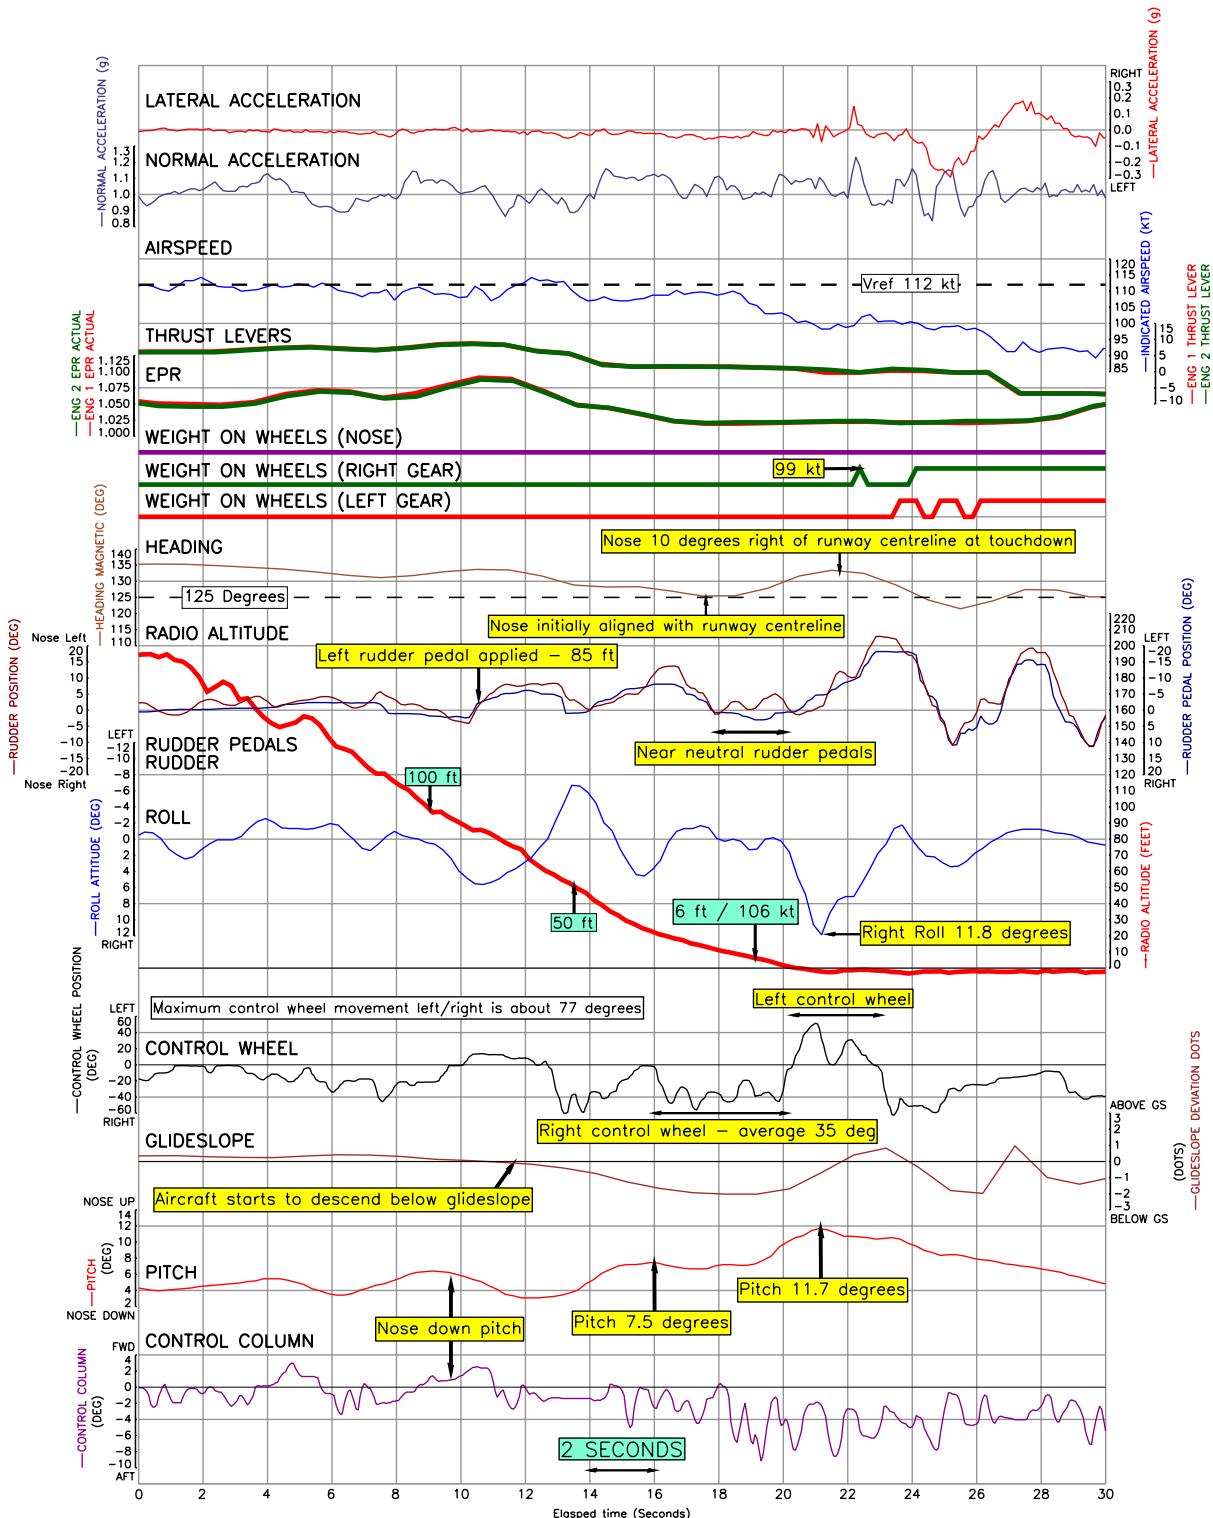
Figure 1

At approximately 100 ft agl a nose-down control column input caused the rate of descent to increase and the aircraft deviated below the glideslope. A right wing-down attitude began to develop and, at 85 ft agl, when the aircraft was about 330 m from the displaced threshold, left rudder was applied. In response the aircraft's nose started to align towards the runway centreline and the aircraft rolled quickly left. The commander reacted to what he believed to be a gust of wind by making a control wheel input to the right. He briefly centred the rudder pedals before re-applying left rudder. At the same time, passing 50 ft agl, he commenced a flare by pitching to about 7.5° nose-up. The wings were then held in a near level attitude which required an average control wheel input of 35° to the right but with the rudder pedals almost neutral. This attitude was maintained for approximately 4 seconds and the nose of the aircraft began to yaw to the right. At 6 ft agl, the airspeed had decayed to 106 KIAS ( $V_{REF}$  minus 6 KIAS).

The commander increased the flare by pitching the nose quickly from about 7.5° to about 11.7°. The aircraft then started to roll right rapidly, so the commander reacted by moving the control wheel to about 50° to the left but the aircraft continued rolling right, reaching 11.8° before responding. In this nose-high attitude, the right wing contacted the runway, although the crew were unaware of the wing strike. Shortly afterwards the right main gear compressed with the right wing 7° down, at an airspeed of 99 KIAS ( $V_{REF}$  minus 13 KIAS). The aircraft then rolled left before rolling right again and landed left of centreline with about 3.5° right wing down.

FDR Salient parameters of the approach starting at 200 ft agl

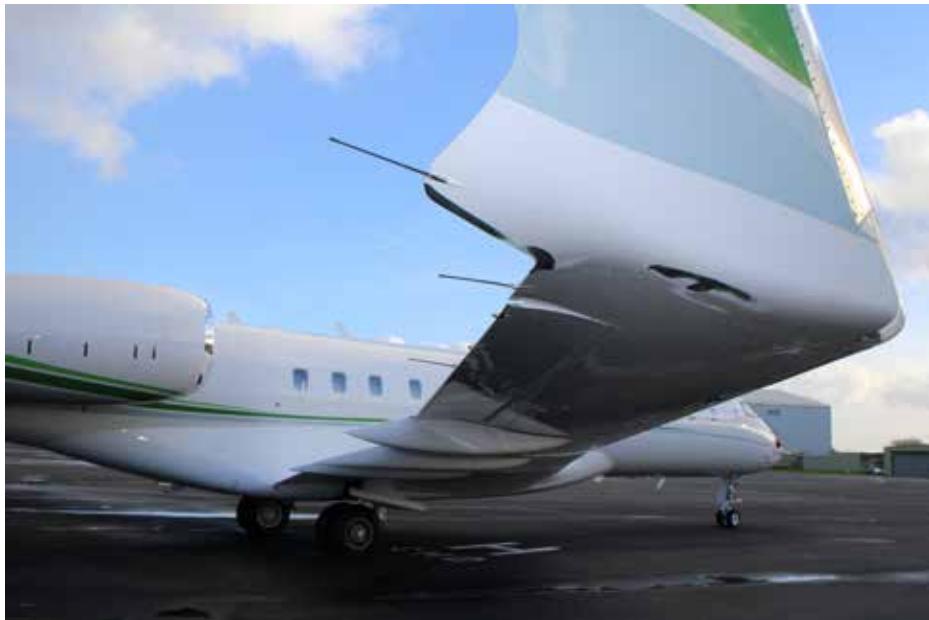
During the accident the aircraft suffered damage consistent with the right wing touching the runway surface at various points across its structure. The composite wingtip had been abraded in three positions, the heaviest contact having worn through the skin exposing the aluminium wing structure beneath. The damage to the rear of the wingtip extended onto the corner of the wing trailing edge. As the flaps and slats had been extended at touch down, the corner of the leading edge slat had been planed flat, as had the rear tip of the outboard flap track fairing. There was also damage to the outboard trailing edge of the aileron and static wick mounts, along with the loss of the two furthest outboard static

wicks fitted to the aileron. No pre-impact technical issues were identified that may have affected the aircraft's handling.

**Figure 2**  
Damage to EC-LTF

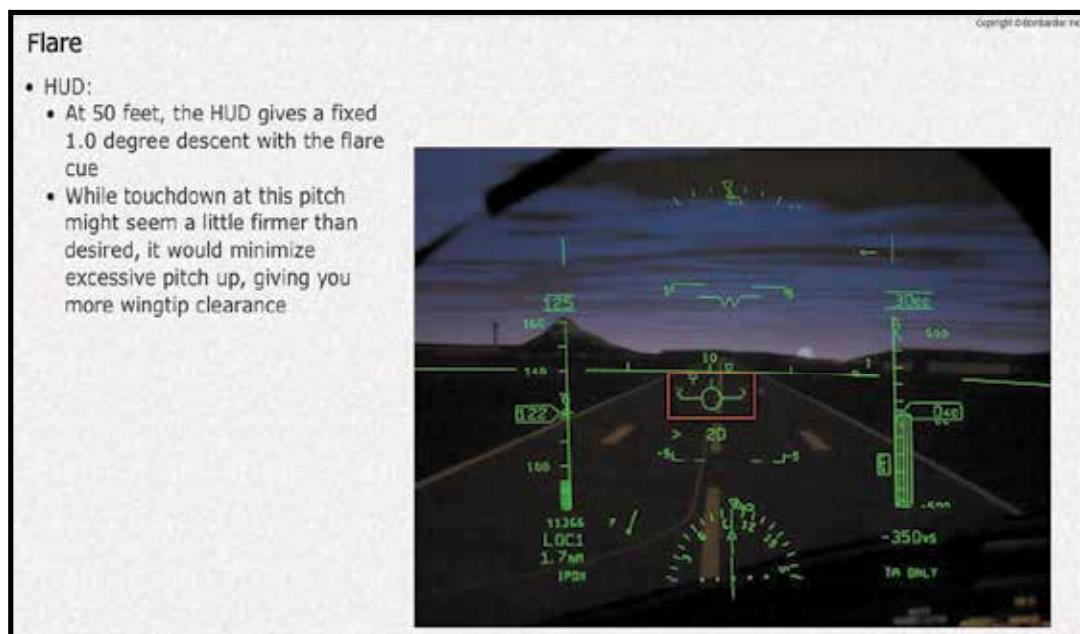
**Figure 4**

A further slide in the material (Figure 4) discussed use of the HUD during a crosswind landing. It mentioned that a flare cue would appear on the screen at 50 ft agl and if this was followed the aircraft would fly a 1° descent path to touchdown. This would lead to a firm touchdown but would protect against a wing strike. The picture in Figure 4 illustrates how the green symbology of the HUD overlays the external vista at night. The red rectangle is not part of the display but is presented on the picture to highlight the flightpath vector with flare cue symbols above each wingtip. When the flare cue appears the pilot is expected to initiate the flare manoeuvre.

Manufacturer's slide indicating HUD guidance during landing flare

brightness level too high and this could cause the HUD symbology to become distracting. Consequently, during a landing with a significant crosswind, for example, a pilot who has set the brightness too high, may fixate on the screen and not discern all the relevant external cues. To reduce fixation on the screen, pilots should aim to use a HUD all the time when available.
