ACCIDENT

Aircraft Type and Registration:	Sikorsky S-76C, G-WIWI	
No & Type of Engines:	2 Turbomeca Arriel 2S2 turboshaft engines	
Year of Manufacture:	2007 (Serial No. 760684)	
Date & Time (UTC):	3 May 2012 at 2155 hrs	
Location:	Peasmash, East Sussex	
Type of Flight:	Public Transport	
Persons on Board:	Crew - 2	Passengers - 2
Injuries:	Crew - None	Passengers - None
Nature of Damage:	None	
Commander's Licence:	Airline Transport Pilot's Licence (Helicopters)	
Commander's Age:	55 years	
Commander's Flying Experience:	10,250 hours (of which 4,800 were on type) Last 90 days - 11 hours Last 28 days - 4 hours	
Information Source:	AAIB Field Investigation

The helicopter descended towards the tops of trees following a discontinued night approach to a private landing site in conditions of reduced visibility and low cloud, when no go-around procedure or routing was available or briefed. One Safety Recommendation is made.

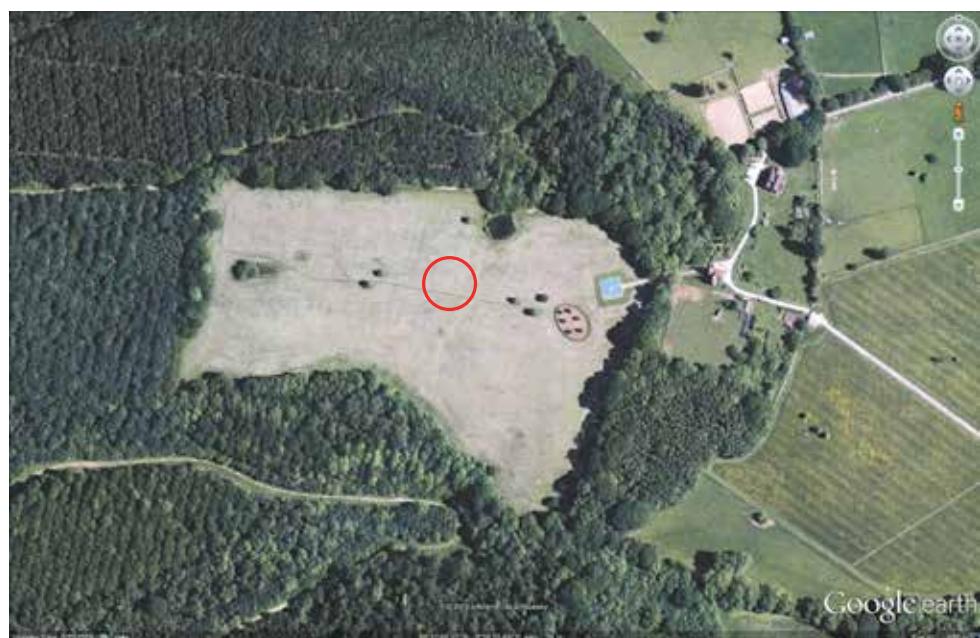
Figure 1

The field containing the landing site near Peasmash; the red circle indicates the position of the triangle of lights

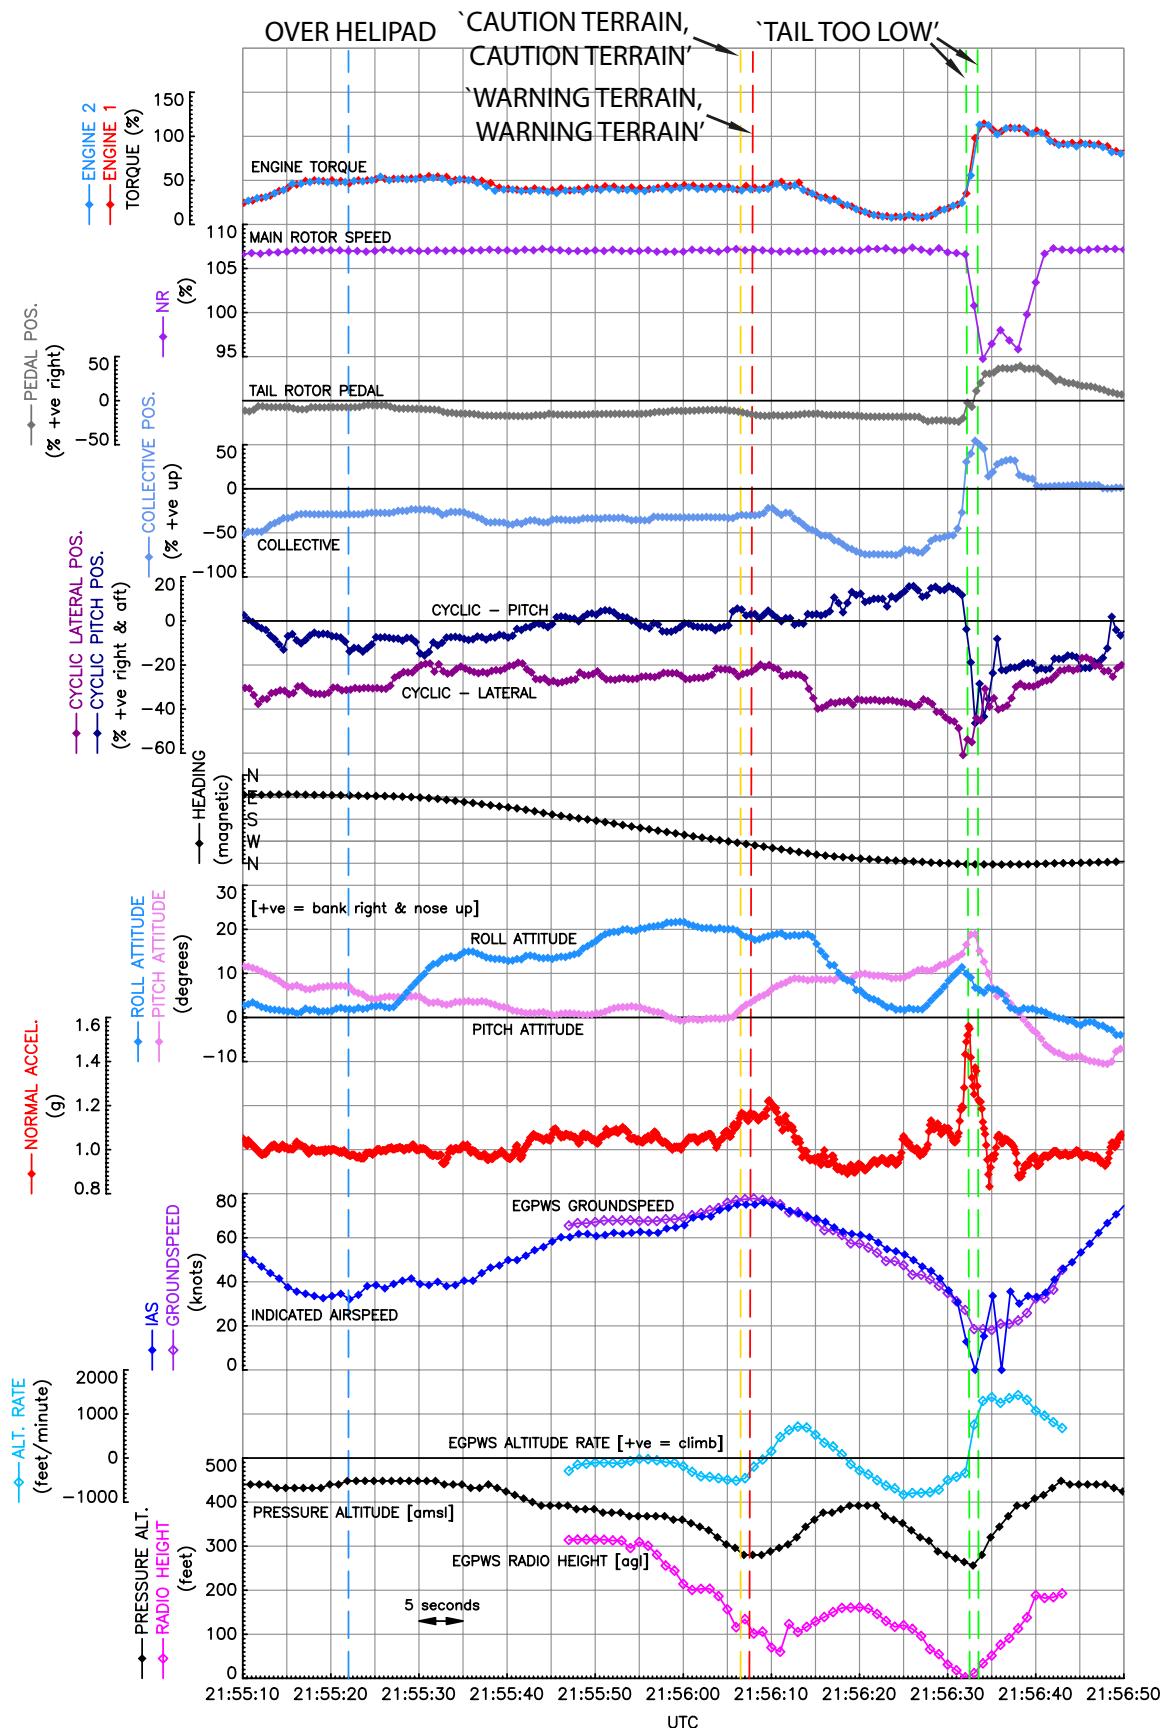
Figure 2
G-WIWI salient flight data from flight recorder and EGPWS

UTC	Event
21:55:27	Helicopter commences right turn from easterly heading. During the turn the helicopter descends and decelerates.
21:56:06	EGPWS recorded issuing a 'CAUTION TERRAIN, CAUTION TERRAIN' audio alert ¹¹ . Helicopter is on a westerly heading, 116 ft radio height and 75 kt indicated airspeed.

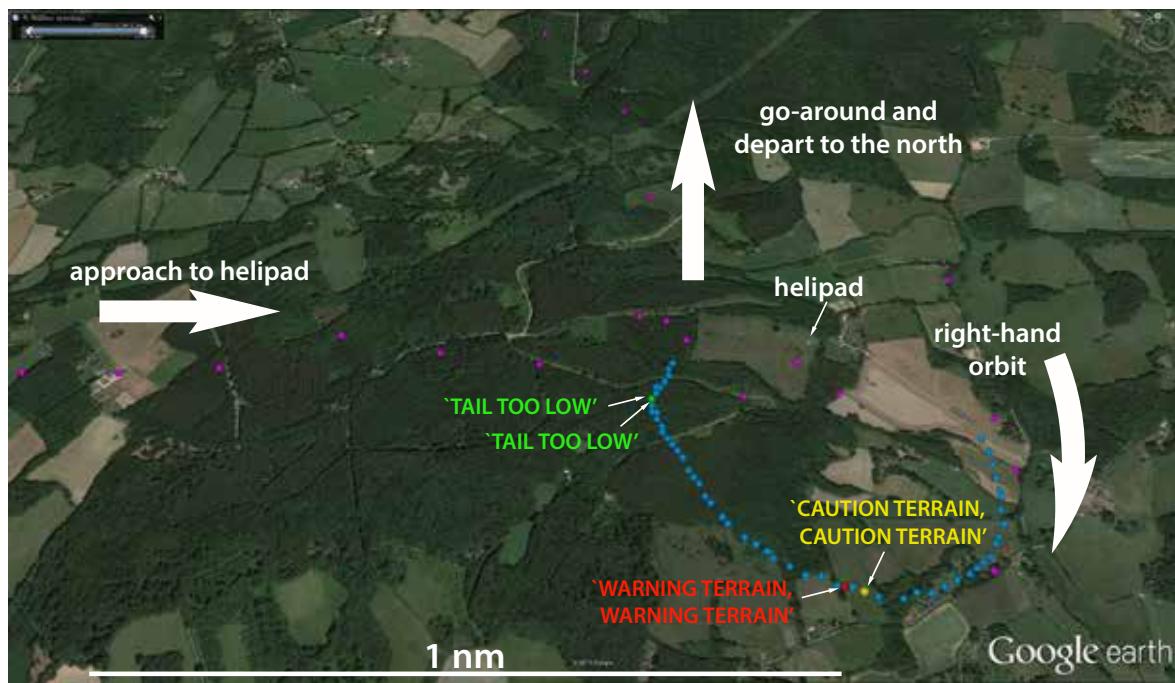
Figure 3

Radar ground track (dark pink) and EGPWS GPS ground track (light blue)

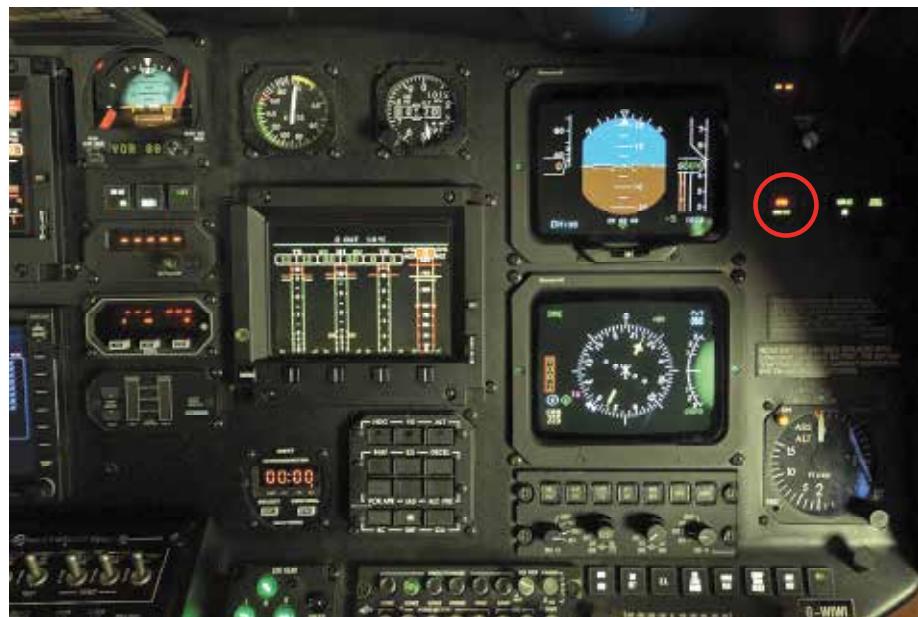
Figure 4

The right hand instrument panel in G-WIWI showing the 'GPWS visual alert (amber, right of the EADI - circled red)
