Final Report No. 2205 by the Swiss Accident Investigation Board SAIB

concerning the accident involving the
Embraer EMB-505 aircraft, CN-MBR

on 6 August 2012

St. Gallen-Altenrhein (LSZR) regional
aerodrome, Thal/SG municipality

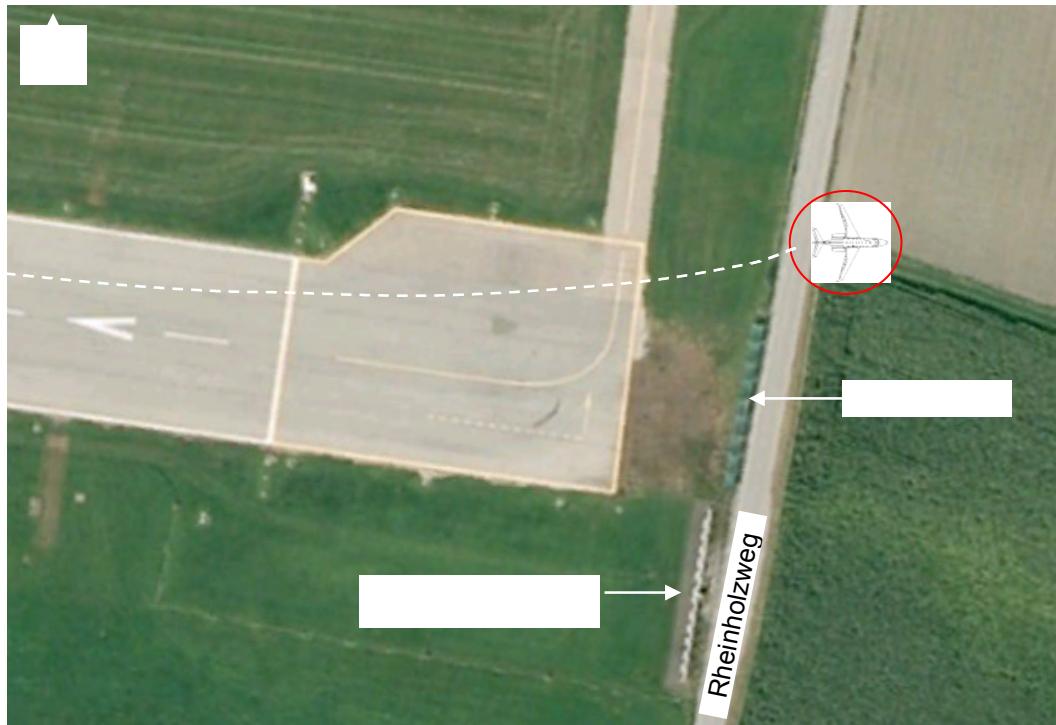
Figure 19: End of runway 10 with the road (Rheinholzweg) running perpendicular to it. Site of the accident marked in red on the edge of a maize field

The site of the accident is the eastern side of the road (Rheinholzweg) running perpendicular to the runway at a distance of 20 metres from the end of the runway, just 30 m from the end of runway 10.

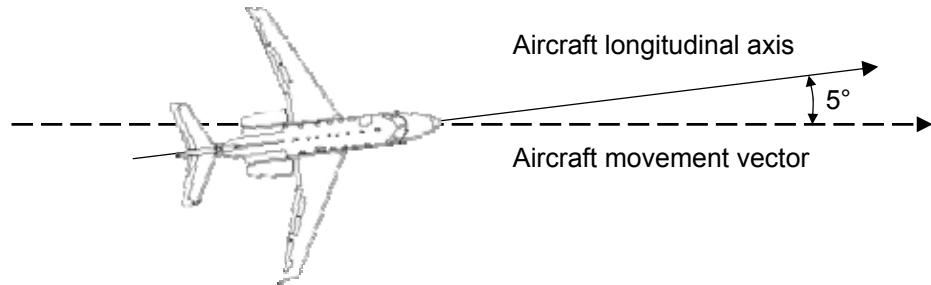
Figure 20: The longitudinal axis was rotated in relation to the movement vector

The longitudinal axis of the aircraft was not parallel to the aircraft's vector of movement; it was rotated approximately 5 degrees to the left.

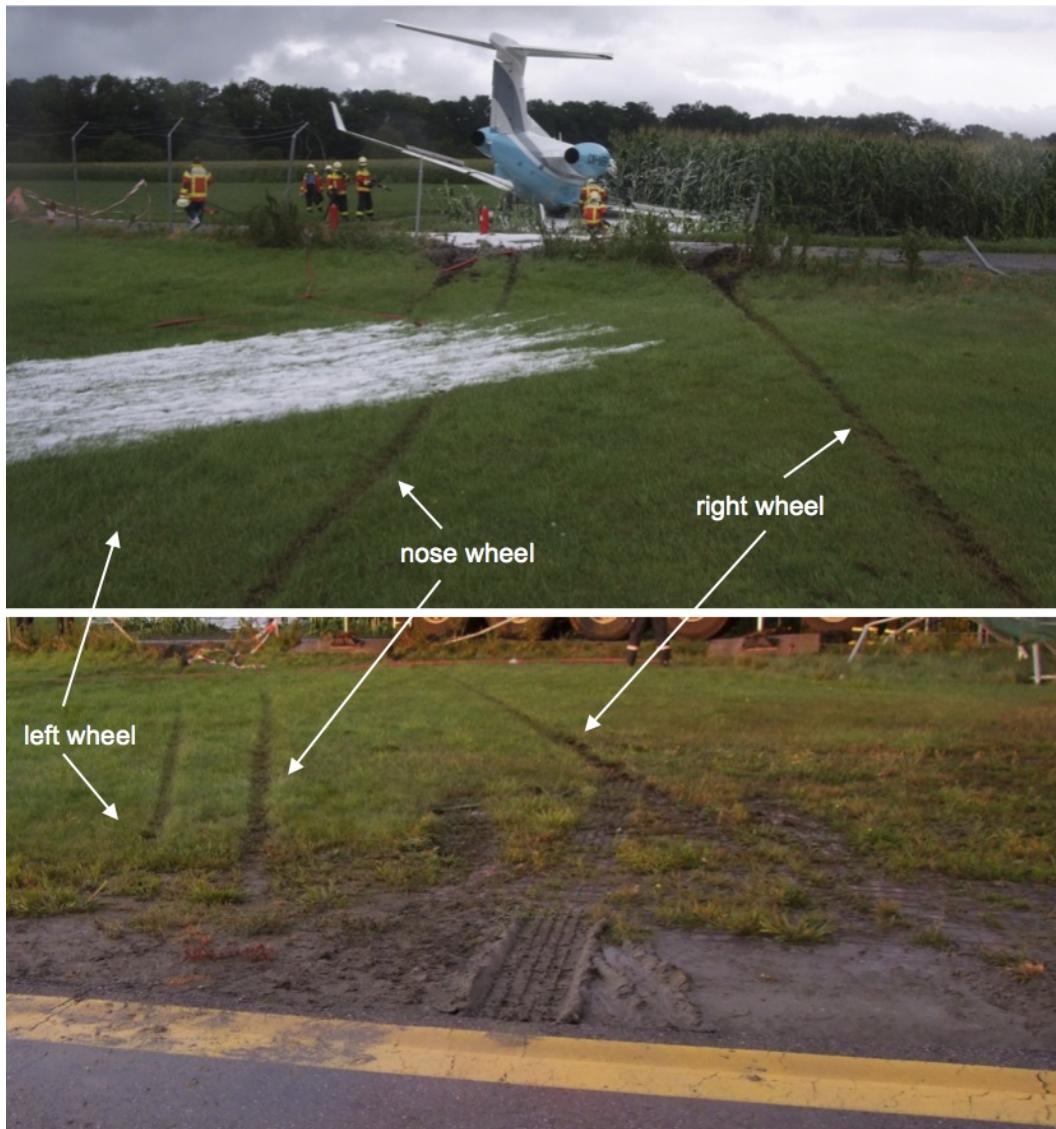
Figure 21: Aircraft wheel marks after it rolled beyond the end of the runway

No real impact occurred, as the aircraft was negatively accelerating, or braking, only in the horizontal direction. The speed of the aircraft when it rolled over the end of the runway was 44 kt, according to the CVDR recordings. The subsequent slow deceleration caused by the roll over the soft ground, the breaching of the perimeter fence and the crossing of the adjacent road took place over a distance of approximately 30 m and was marginal.

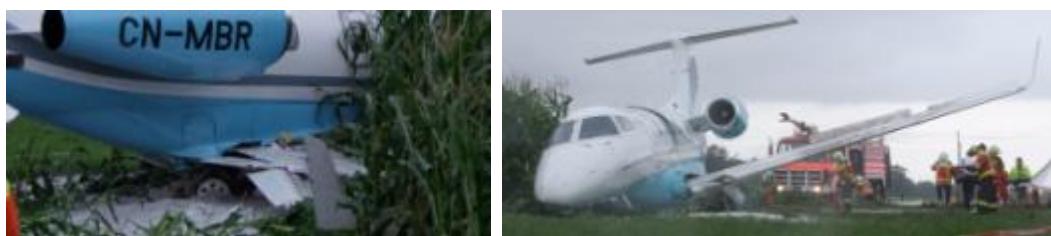
Figures 22 and 23: Right main landing gear and left wing

The lower part of the fuselage and the right wing, including the fuselage-wing panels, was severely damaged.

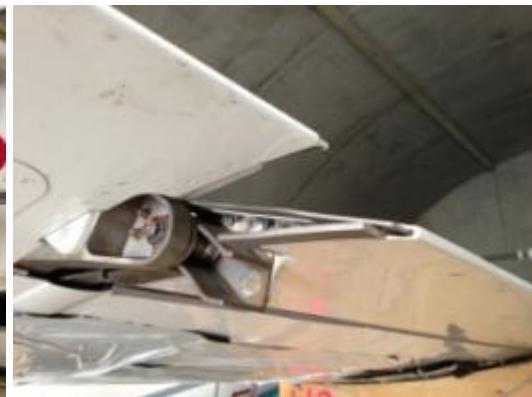
Figure 25: Flaps on left wing, 9.49° extended

The flap selector lever (FSL) was found in position 3. In this position the flaps would have had to extend to 26°. However, they were in a position between 9 and 10°. This corresponded to the recorded values. In view of the general condition of the aircraft, no mechanical functional check of the flap system could be carried out. However, a visual inspection produced no evidence of any pre-existing defects.

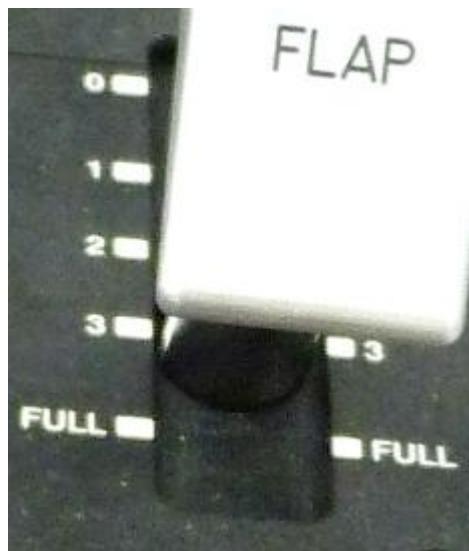
Figure 26: FSL in CN-MBR

In addition, it was also examined whether the FSL had a so-called stopper present, which prevents the flap selector lever from being set in the FULL position, as this position is not permitted. Figure 26 was taken on the day of the accident in the cockpit of CN-MBR. There was no stopper fitted. Figure 27 shows the fitted stopper. This picture was taken on another Phenom 300 aircraft.

In CN-MBR an FSL P/N 780501-7 was installed (cf. chapter 1.16.2.5).

During which of these three FSL replacements the stopper fitted on delivery was lost is not apparent from the available documentation.
